DEPARTMENT
OF
CIVIL AVIATION

REPORT

LOCKHEED HUDSON Mk IV
VH-SMK

CAMDEN N.S.W.

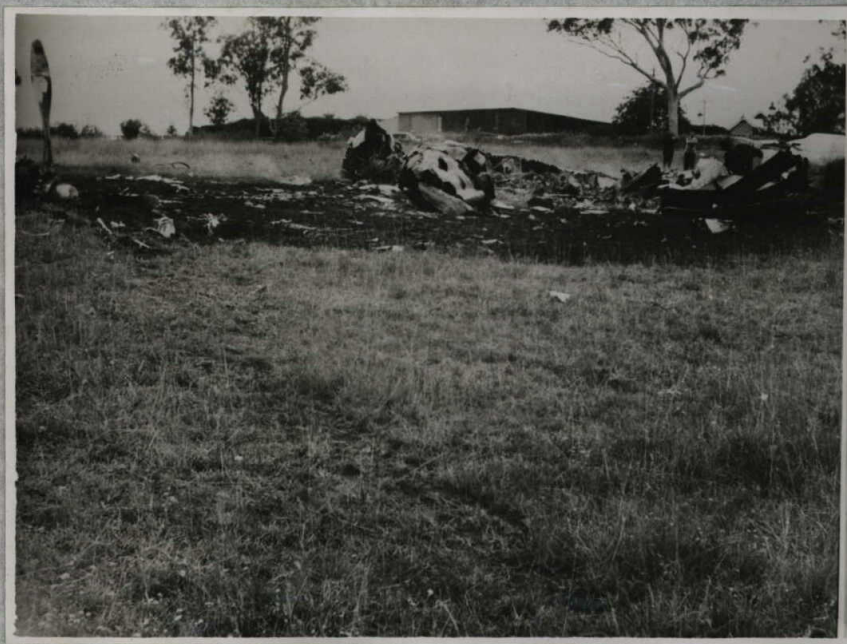
1. Impact mark of the port wing

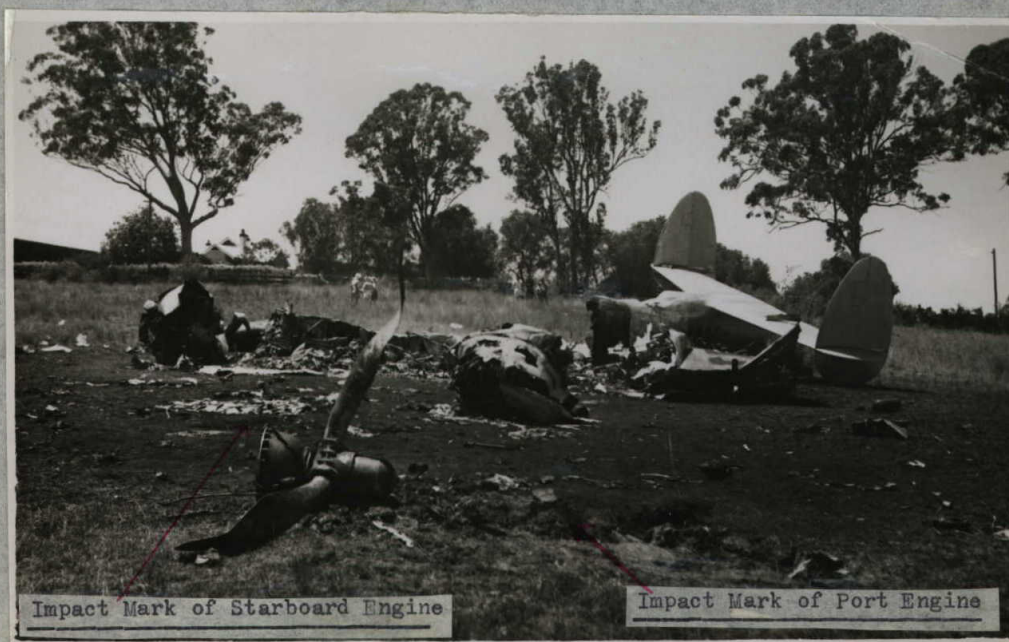
6.2.14 Both engines were completely detached from the airframe and they had either rolled or been dragged some distance in the general direction of movement of the wreckage after impact. The starboard engine came to rest some 40 feet from the point of actual impact and was lying adjacent and slightly to the right of the position where the nose of the fuselage came to rest. The front of this engine was facing the main wreckage and although it had sustained damage to the lower cylinders and reduction gear housing due to impact, there was comparatively little fire damage. The port engine was in a position approximately mid-way between the point of impact and the nose of the aircraft, and was considerably damaged. The whole of the accessory section, including the blower impellers and impeller housing, was almost completely burnt away. (See photographs Nos. 2, 6, 10 and 11, Appendix 32).

2. General view showing extent of fuselage damage, initial impact marks of both engines, and general movement of wreckage to starboard and to the rear.

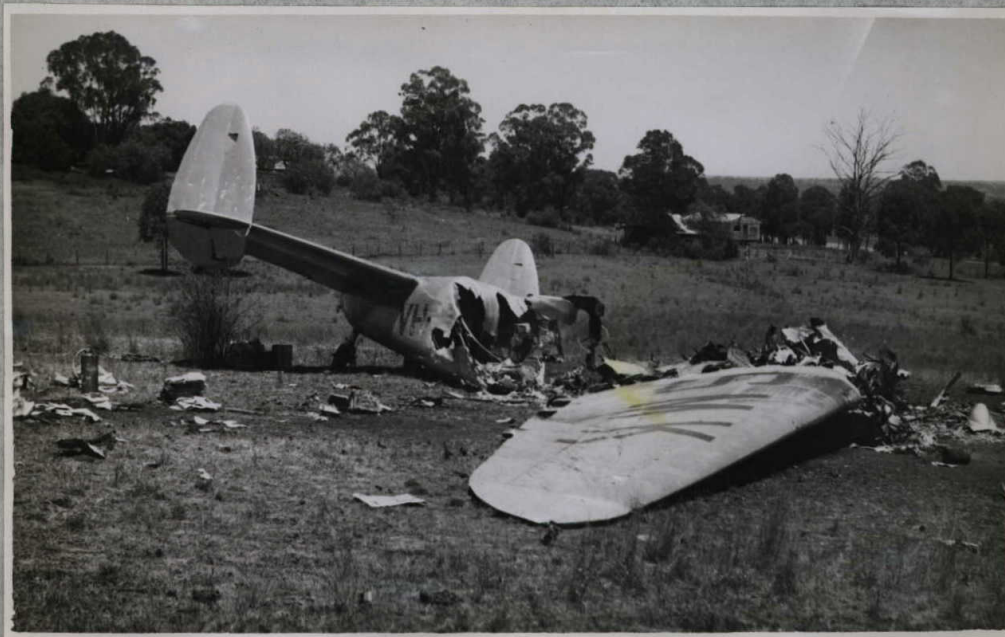
6.2.12 The starboard mainplane was intact outboard of the engine nacelle and was lying in correct relationship with the burnt-out fuselage. The only damage to this section consisted of buckling of the trailing edge at the tip due to contact with the ground after initial impact. The aileron was securely attached at the hinge points and showed no signs of any pre-crash defect. The remaining portion of the starboard flap was in the retracted position. (See photographs Nos. 3, 5 and 6, Appendix 32).

3. Relationship of starboard wing to fuselage.

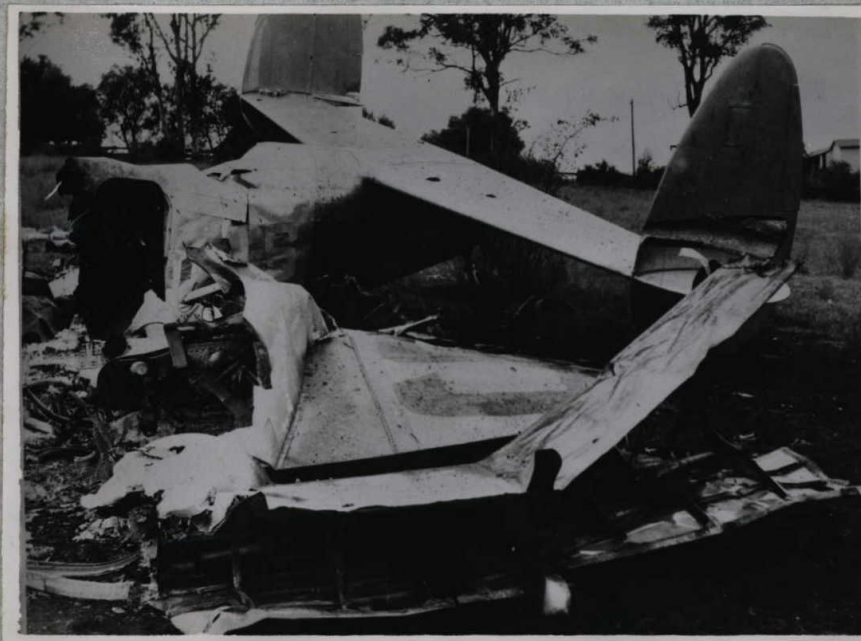
- 6.2.4 The whole of the fuselage from the nose to a position aft of the entrance doorway was completely destroyed by fire, while the starboard mainplane, outboard of the engine nacelle, and the tail assembly showed little signs of damage. The only recognisable portion of the port wing was a small section immediately outboard of the wheel well. Other portions of this wing had disintegrated due to impact or fire. (See photographs 4, 7 and 8 at Appendix 32).

4. Only substantial portion of port wing remaining, consisting of approximately 5 feet outboard of and including wheel well, lying inverted.

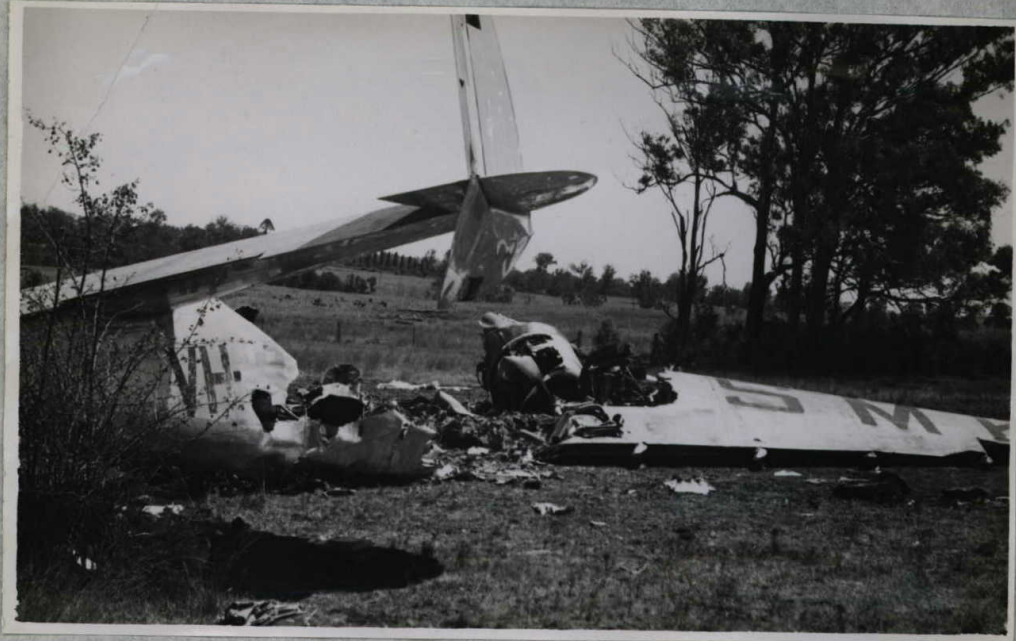
- 6.2.5 The only substantial damage to the tail assembly was the lower section of the starboard fin below the tail plane. This had apparently come in contact with the ground as the aircraft moved to starboard after the initial impact. (See photograph No. 5, Appendix 32). The tail unit showed no signs of any pre-crash failure or abnormality. The starboard elevator trim tab was slightly distorted so that, with the elevator in the neutral position, the inboard tip at the trailing edge was deflected upward $7/16$ inch and the outboard tip $5/16$ inch upward. The port elevator tab was evenly deflected upward by $1/2$ inch. Both elevator trim actuating drums inside the tail plane were at identical settings. The settings of these drums were subsequently applied to Lockheed Hudson VH-SML and it was found to be equal to nine divisions nose down on the indicator in the cockpit. There were no marks on the elevator stops to indicate that the elevator had been moved to the limit of its travel either way with any abnormal force. The rudder trim tabs were in approximately the neutral positions and the rudders showed no signs of any unusual application of control. All control surfaces on this unit were capable of being moved freely through the range of movement.

5. Damage to starboard fin and rudder

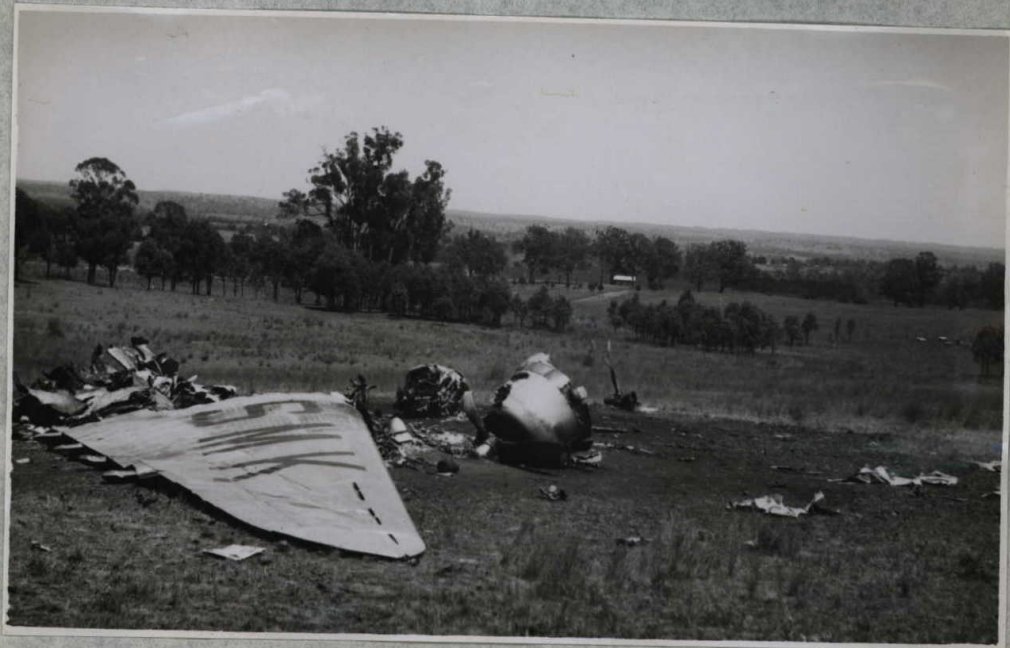
6. Damage to starboard wing at trailing edge of outer section and showing position of starboard engine.

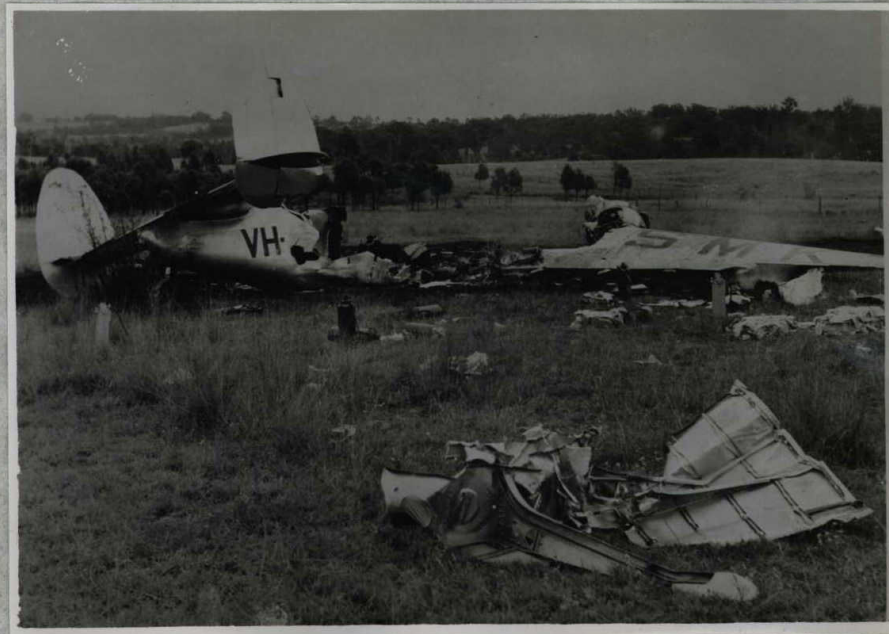
these being a portion containing a flap runner which was in a position some 15 feet to the right of the starboard tailplane. (See photograph No. 7, Appendix 32). Eyewitnesses gave evidence of a substantial explosion taking place after the initial impact and it is considered that this explosion could account for that portion of the port mainplane, which was more or less in one piece, being found in the inverted position. It would also account for the complete disintegration and scattering of the outer section of that mainplane including the aileron.

7. Position of portion of port wing relative to wreckage.

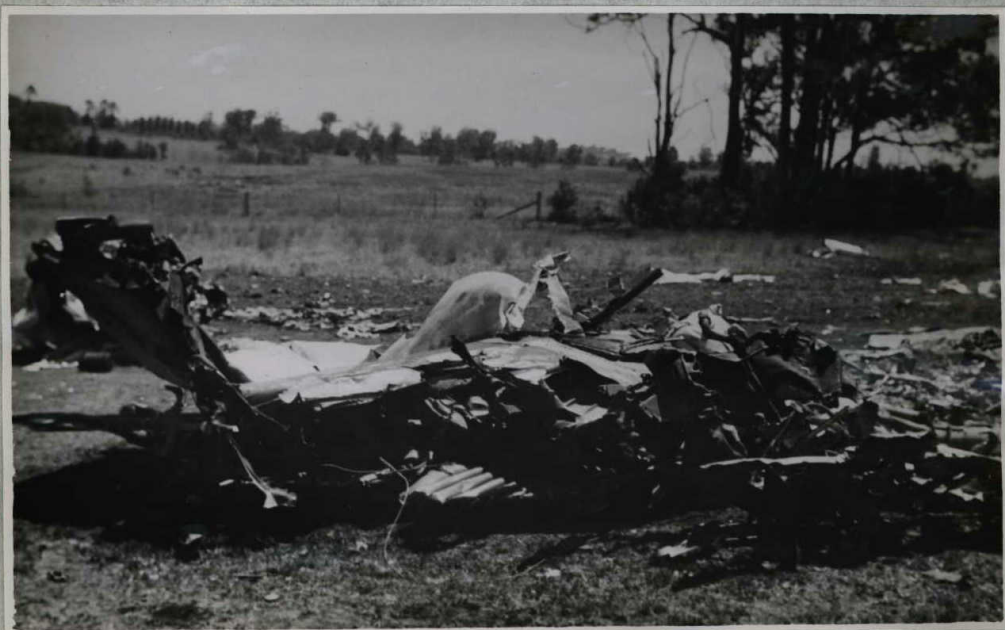
8. Remains of port mainplane viewed from tail of the aircraft, leading edge faces camera.

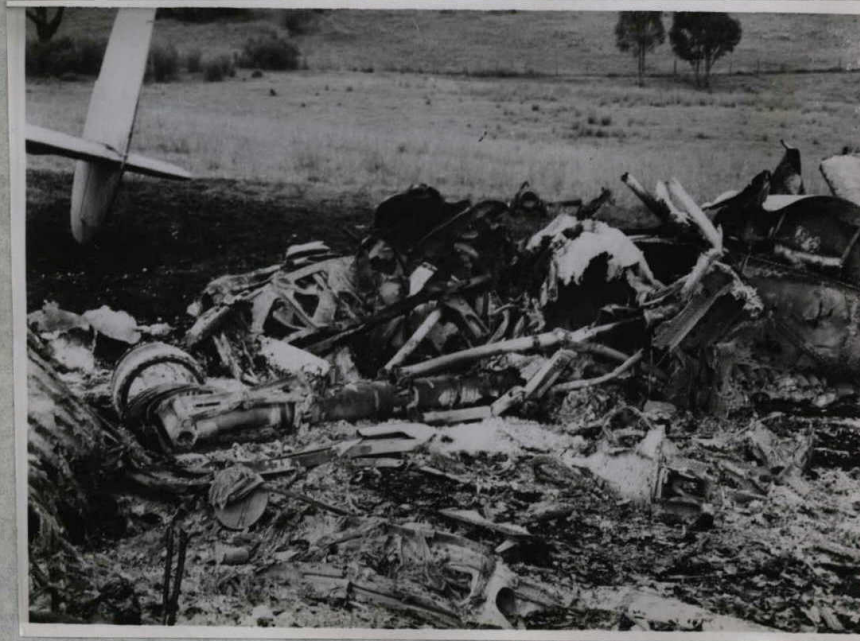
9. Front wheel well and undercarriage.

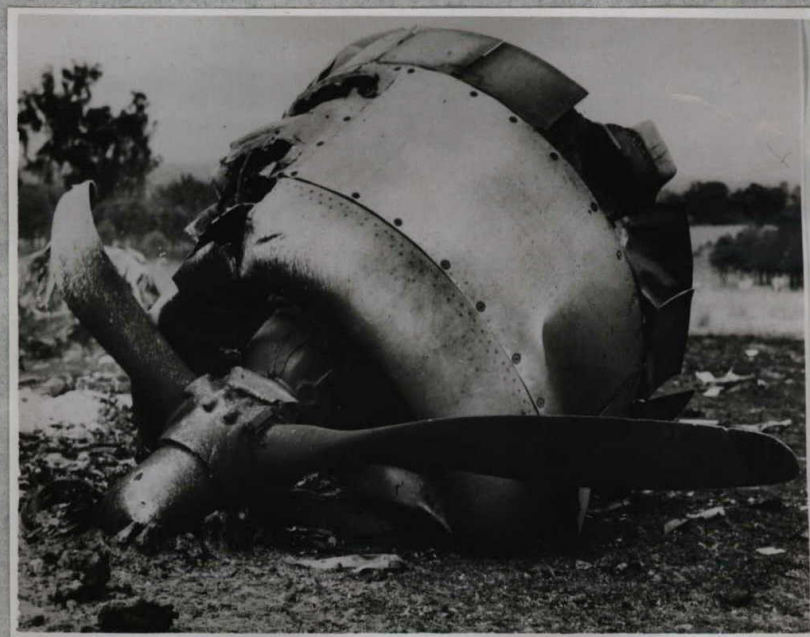
- 6.2.23 Two blades of the starboard airscrew remained attached to the engine. One of these was bent backward and also partly burnt away in the fire, the other was comparatively undamaged and had obviously not struck any object with force. The third blade had been torn away from the hub at the root and was found near to the starboard engine in the area of the main fuselage wreckage. Although the outer third of this blade had been burnt away it was clear that it had been bent backwards in a manner similar to the other damaged blade of this airscrew. The general damage to the starboard airscrew

- 6.5.1.6 The dissimilarity of the marks made on the ground by the airscrews during impact and the resultant damage to them has already been discussed at paras. 6.2.22 and 6.2.23. Photographs Nos. 10, 12 and 14 at Appendix 32 show these dissimilarities. The fact that all three blades of the port airscrew were considerably twisted as well as bent, and that one blade became deeply embedded in the ground before breaking away from the hub at the root, is strongly indicative of a high rotational speed at the time of striking the ground. As the speed of the aircraft is considered to have been comparatively low at the time of impact, it would seem that any high rotational speed of the airscrew could only have been due to power being applied. On the other hand, two blades of the starboard airscrew were bent backwards with very little twisting and the third blade was practically undamaged and did not strike the ground during impact. It is clear that this airscrew did not complete one revolution after striking the ground although the impact forces were much less than those on the port airscrew. It is strongly suggestive, therefore, that this airscrew was rotating at a much lower speed.

10. Starboard engine, one airscrew blade bent to rear and burnt, second blade showing only superficial damage.

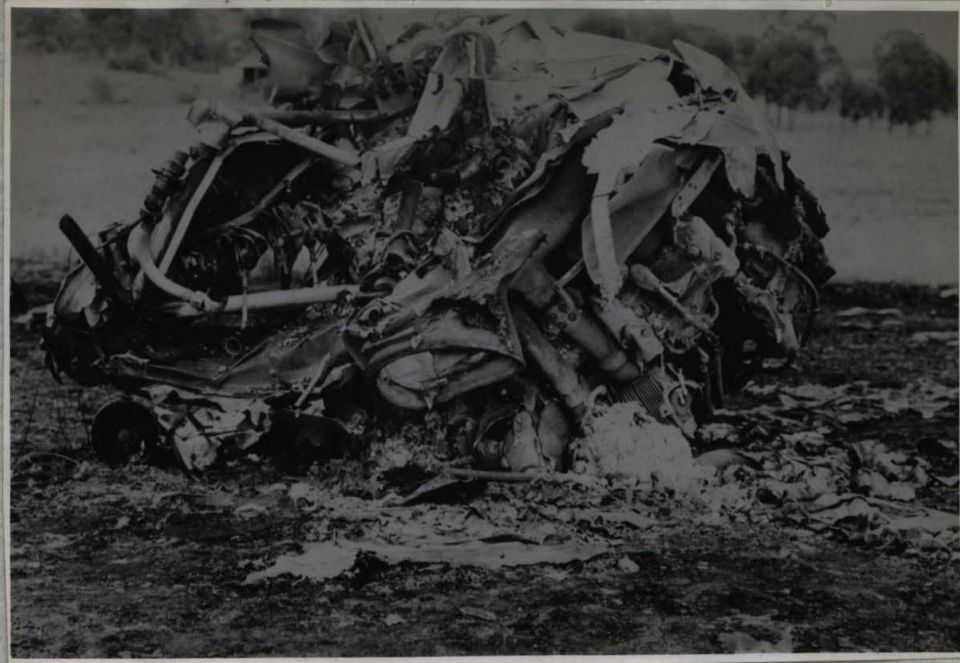
11. Port Engine

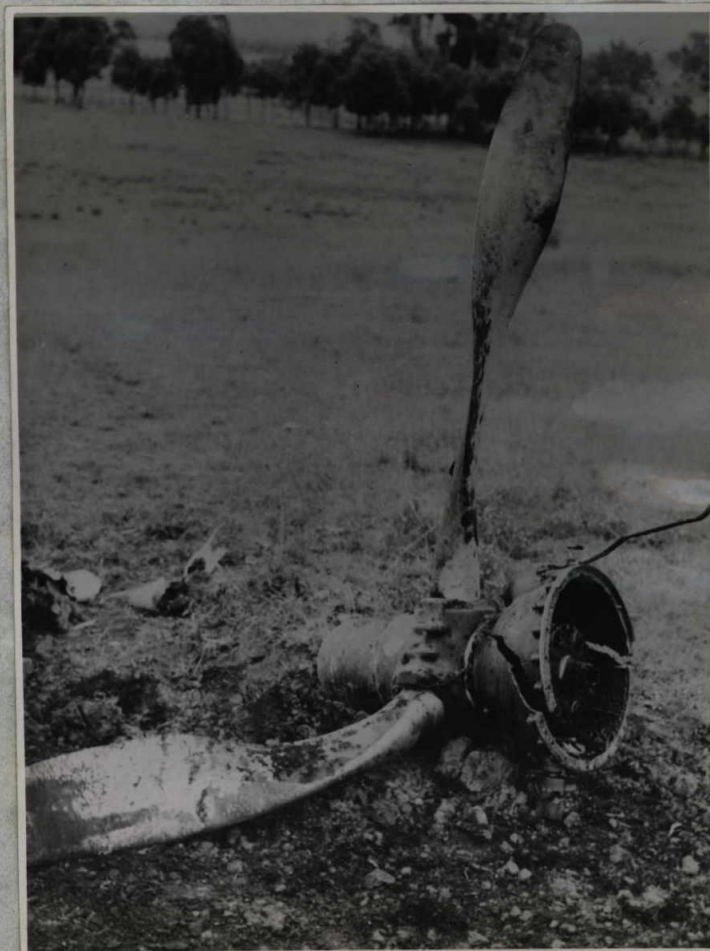
- 6.2.22 The port airscrew and reduction gear housing had torn away from the engine on the initial impact. One blade of this airscrew had broken away from the hub at the root and remained embedded in the ground. The remaining two blades still attached to the hub were lying near the point of initial impact and were considerably bent and twisted as a result of striking the ground. The marks on the ground, the bending and twisting of all three blades, together with the fact that one blade remained deeply embedded in the ground indicate that this airscrew was revolving at high speed. As the aircraft was in a stalled condition at the time of impact it is considered that any high rotational speed of the airscrew could only have been due to the engine operating under power. (see photographs 12, 13 and 14, Appendix 32).

12. Port airscrew and reduction gear cover detached from engine on impact showing nature of blade damage.

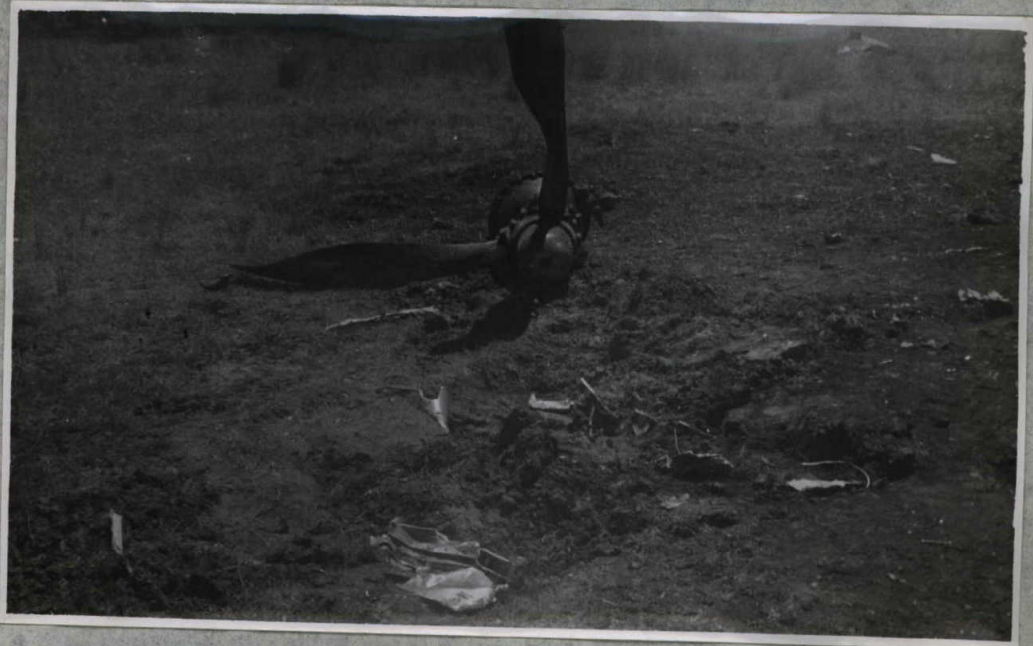
13. Detached port airscrew assembly showing ground slice marks, area of main impact and shank of buried blade.

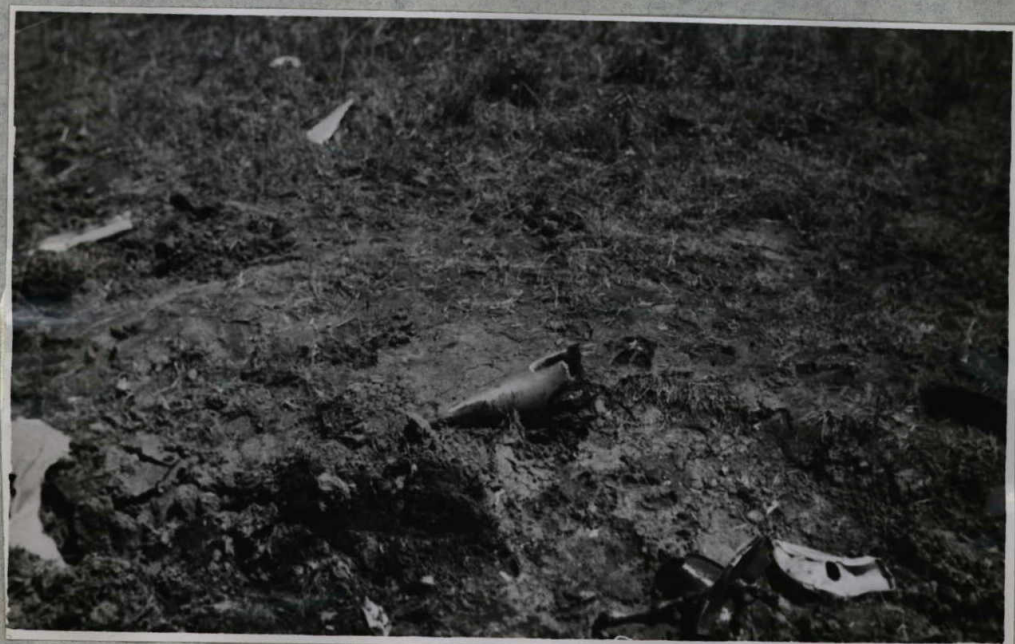
14. One detached port airscrew blade buried, shank only visible above the ground.

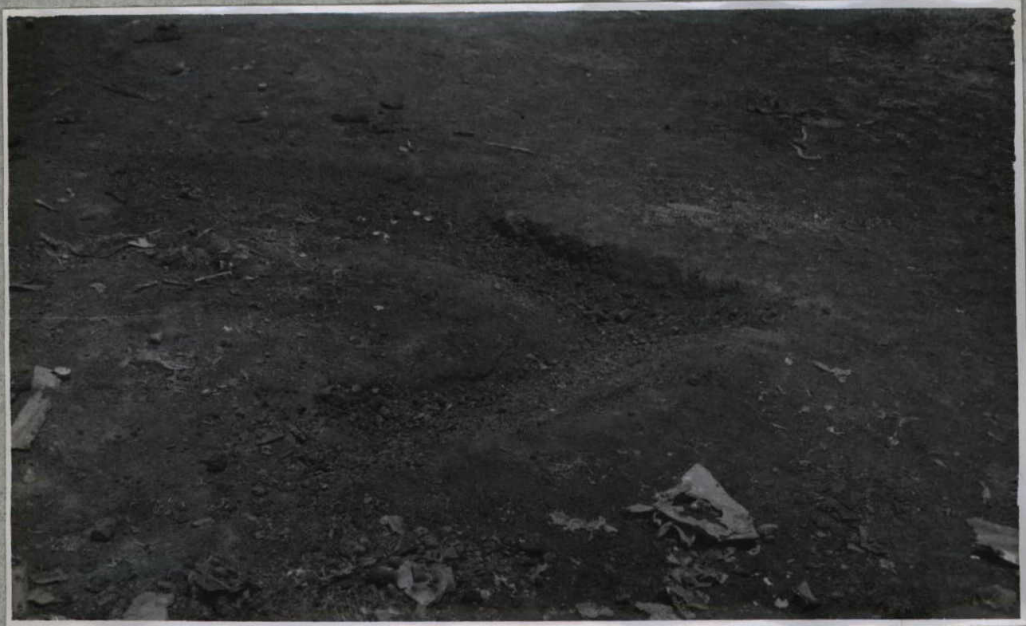
15. Ves-shape of initial impact mark of starboard engine.

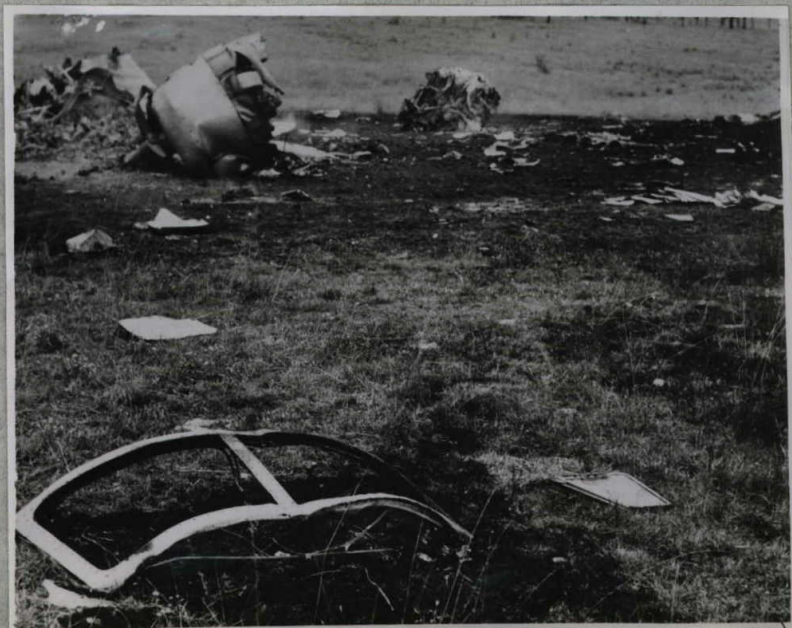
- 6.2.30 The only other portion of the wreckage of any significance was the cockpit escape hatch which was found in a position 90 feet to starboard of the centre

line of the fuselage. The canvas sun blind attached to the underside of this hatch had burnt away and, in so doing, had burnt a small area of grass immediately beneath the hatch. This burnt patch was quite separate from the area of grass affected by the main fire and there is little doubt that the canvas blind had been ignited prior to the escape hatch coming to rest. No evidence was obtained to support any suggestion that this hatch may have been freed from the fuselage prior to impact. On the other hand, the position in which it was found and the ignition of the canvas blind are consistent with it having been detached either on impact or by the subsequent explosion.

16. Escape hatch relative to main wreckage.
