Investigation Report

Type of Occurrence:	Serious incident
Date:	9 February 2010
Location:	Cologne/Bonn Airport
Aircraft:	Transport aircraft
Manufacturer / Model:	Airbus / A 300 B4-203F
Injuries to Persons:	None
Damage:	Minor damage to aircraft
Other Damage:	None
State File Number:	BFU EX003-10

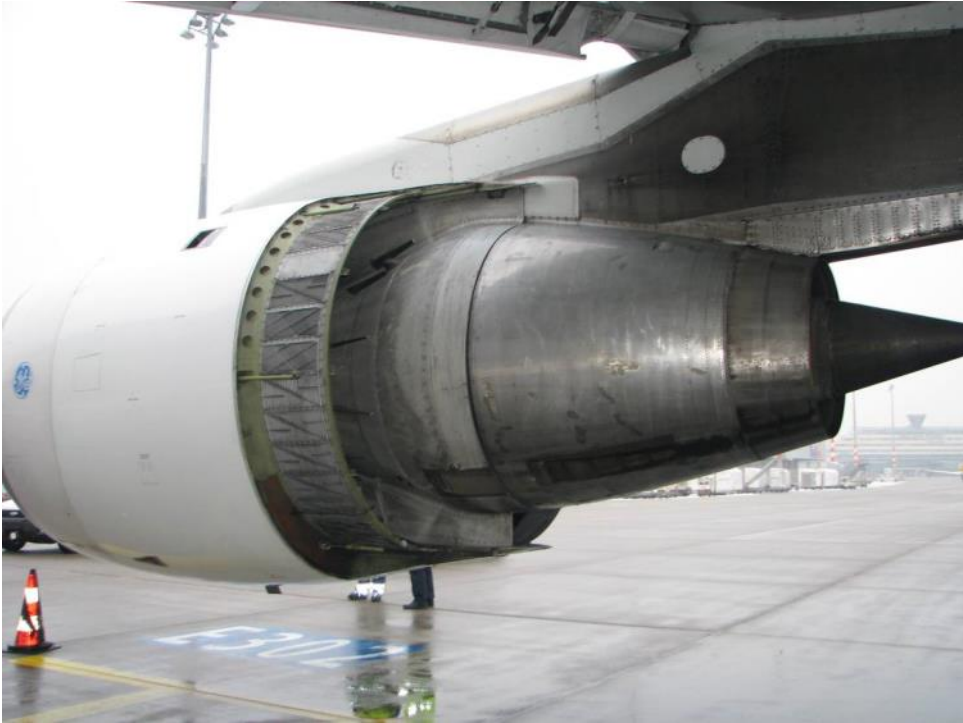
The left fan reverser translating cowl of the right engine was missing (Appendix Image 1). The type plate of the fan reverser translating cowl showed the following information: Model-No CF6-50 TR-CF-6-F3; Assy Ident No 9007M60G46; Serial No MBC 00280; MFR Ident No 38597. The upper and the centre ball screw were in the position of a retracted thrust reverser cowl. The connecting tube including bracket were present (Appendix Image 2). The lower ball screw was extended by 22 cm (between partition plate and transport nut). The connecting tube to the cowling was torn off (Appendix Image 3). The cascades were abraded in the area of the bracket of the upper and centre ball screw. The partition plate between drive and thrust reverser cascades were ground out in the area of the lower shaft feed through (Appendix Image 3). The toggles for the blocker doors were fractured. Together with the fan reverser translating cowl the blocker doors had fallen off.

Image 1: Left side of the right engine (facing the fuselage)

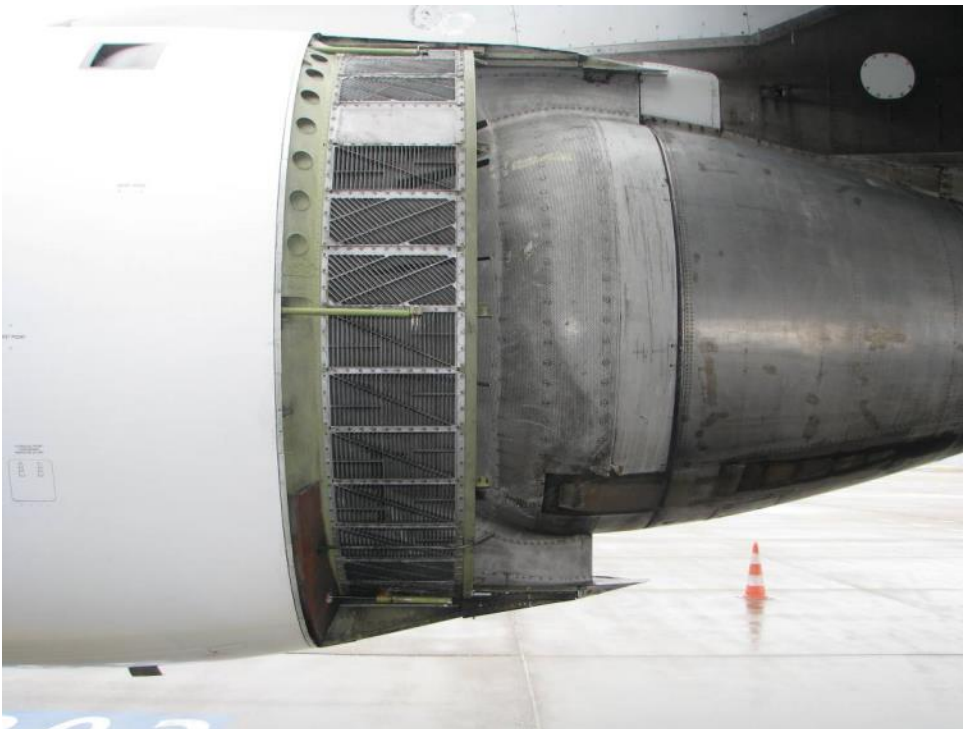
Image 2: Upper, centre, and lower ball screw shaft

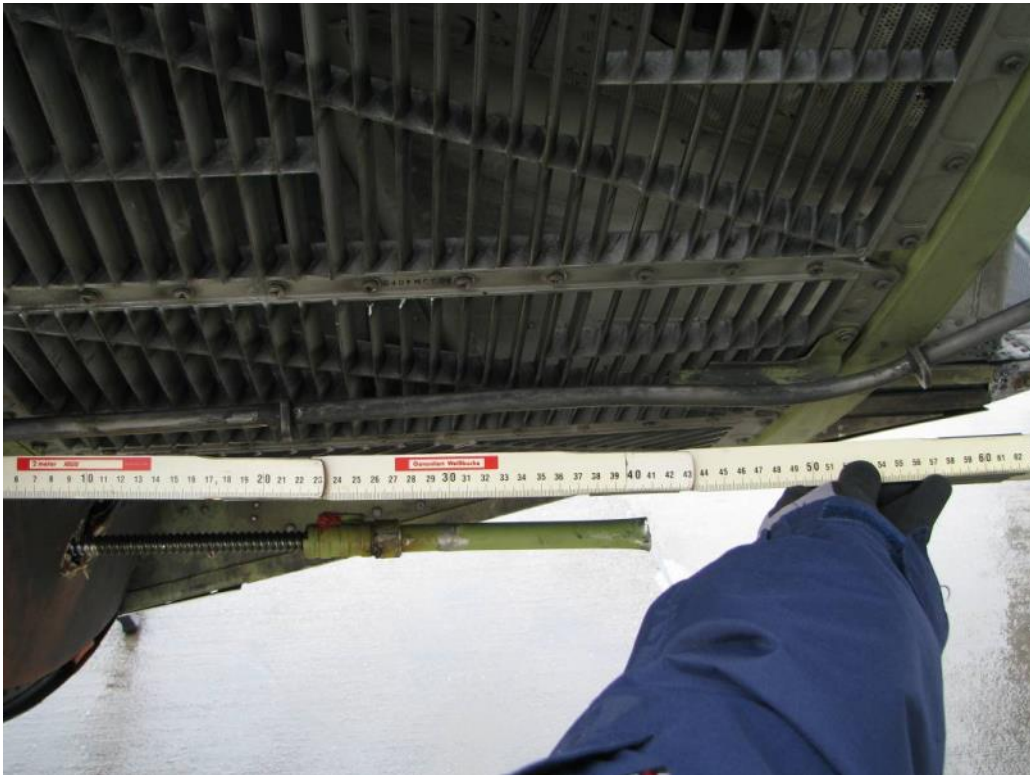
Image 3: Extended and fractured ball screw shaft

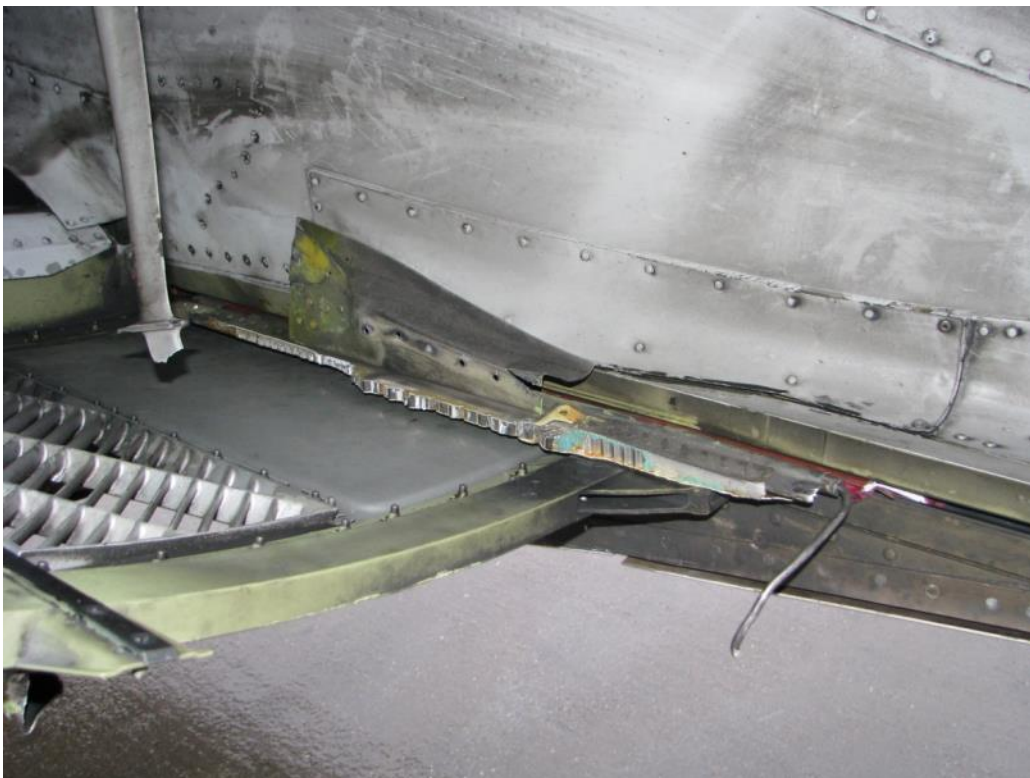
In the lower area of the fan reverser translating cowl the rivet holes between inner and outer cowling in the vicinity of the lower carriage were heavily ground out. The cowling had been torn off the rail. The carriage and part of the structure were still stuck in the rail on the engine (Appendix Image 4).

Image 4: Remnant of the torn off fan reverser translating cowl stuck in the rail

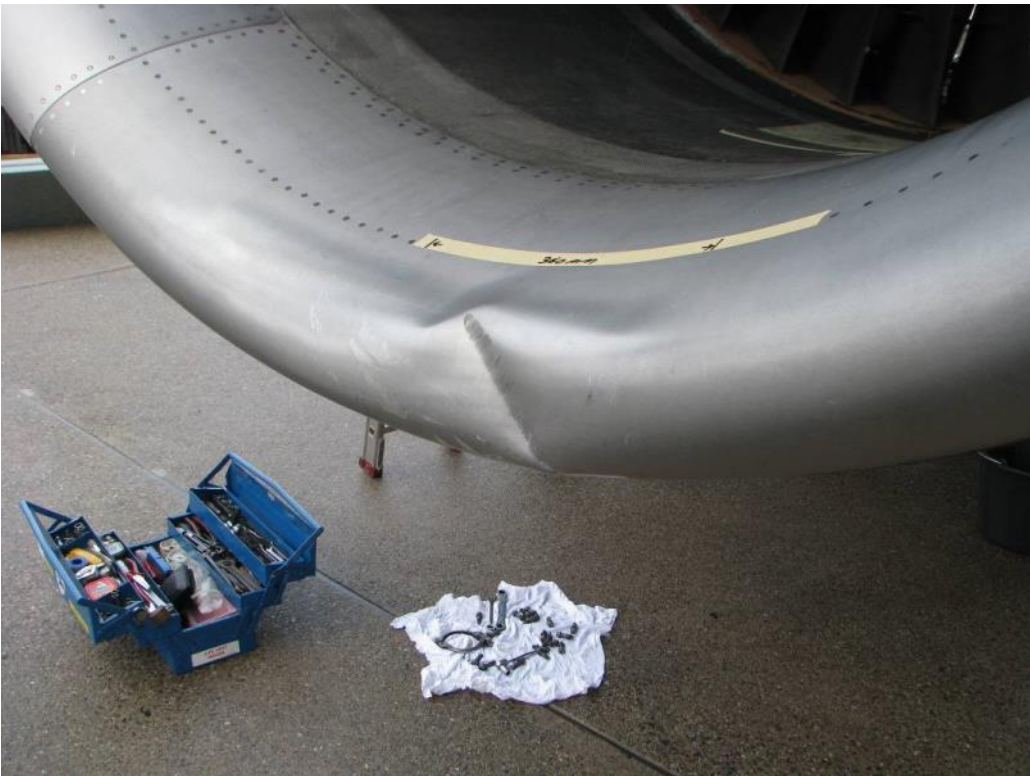
The air intake of the right engine of the B767, who landed after the A300, was dented (Appendix Image 5), the wheel on the positions 4 and 8 on the right main landing gear were damaged. The air intake and wheel No 4 were replaced.

Image 5: Indented air intake of the right engine of a Boeing B767

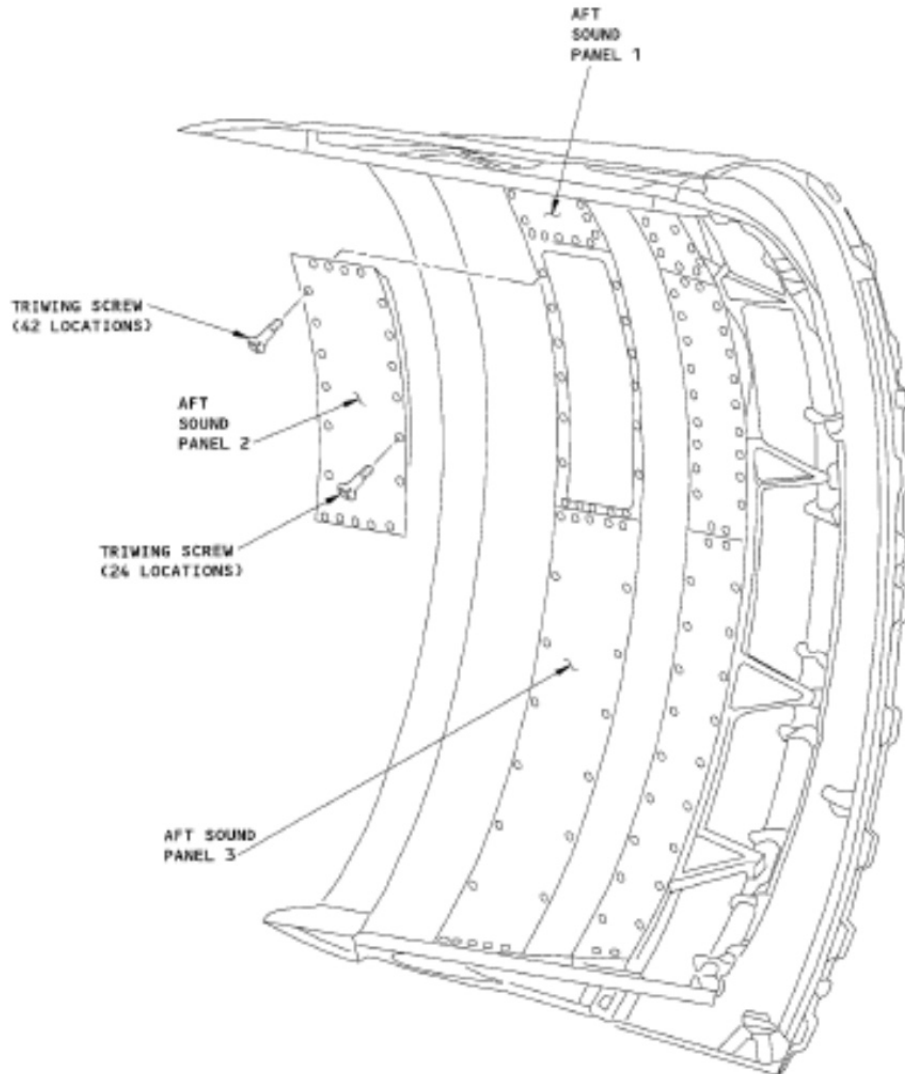
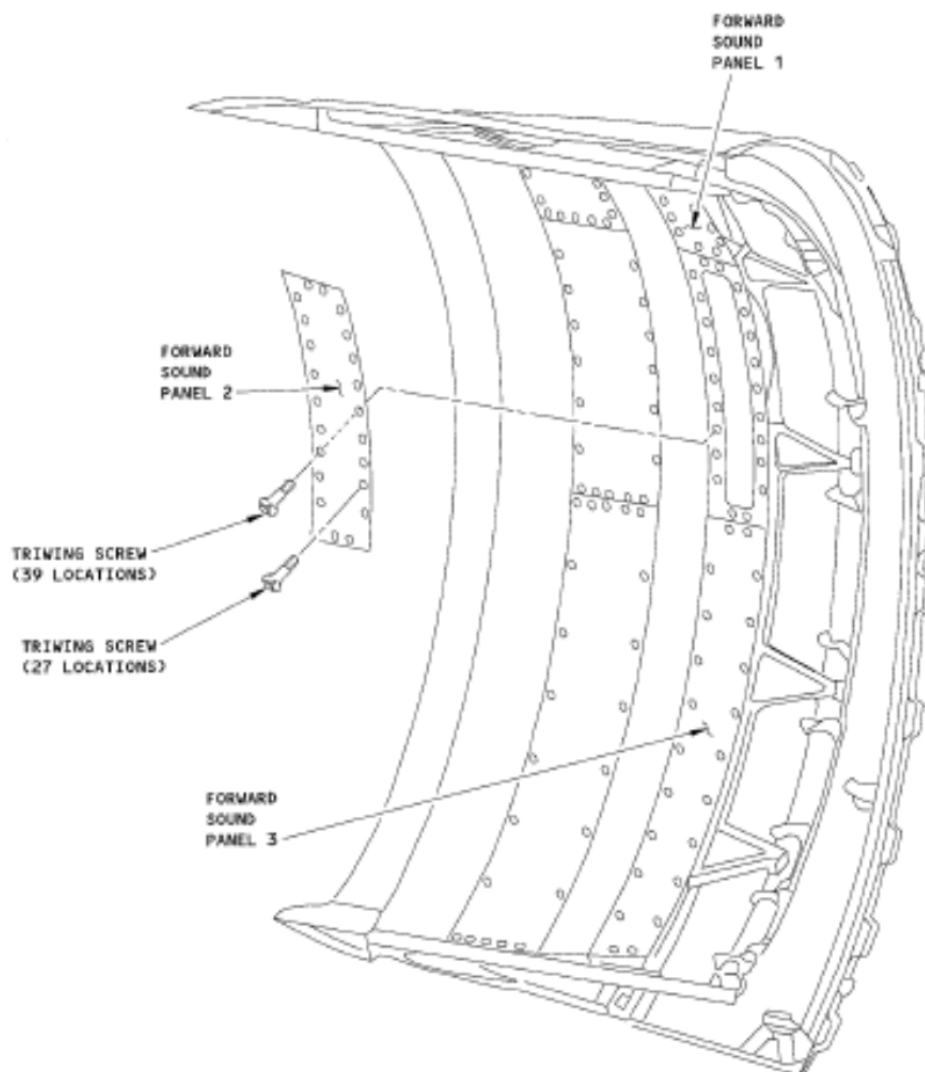
Translating Cowl Sound Panel Removal and Installation
Figure 1, Sheet 1 of 2

- 3) Refer to Figure 1, Sheets 1 and 2. Remove the three aft and the three forward sound panels from the inner surface of the translating cowl. Retain the attaching hardware. Inspect each sound panel per CF6-6 Engine Manual GEK 9266 Section 78-32-02 or CF6-50 Engine Manual GEK 50481 Section 78-32-02.

- 14) Refer to Figure 1, Sheets 1 and 2. Install three aft and three forward sound panels in the translating cowl using the hardware retained in Step 3 per CF6-6 Engine Manual GEK 9266 Section 78-32-01 or CF6-50 Engine Manual GEK 50481 Section 78-32-01.

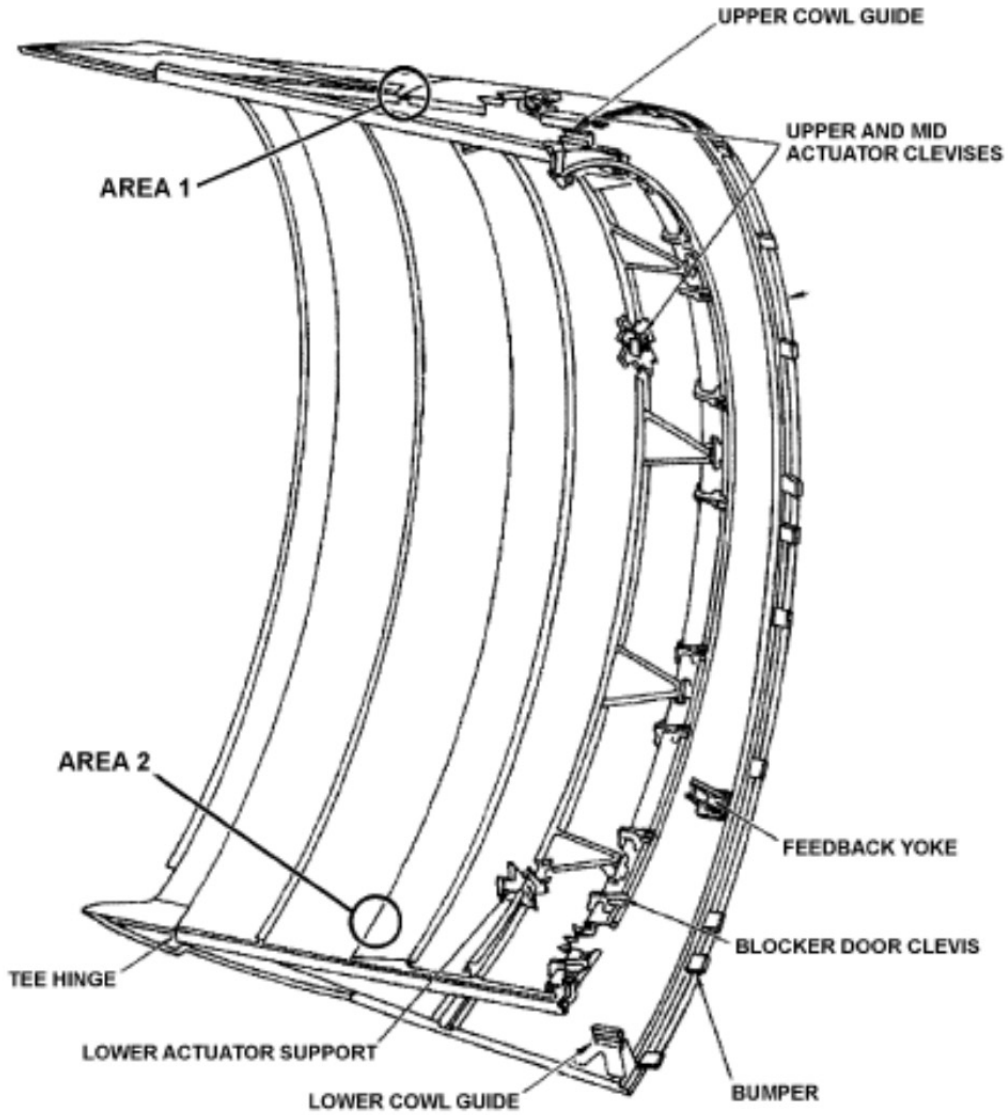
Translating Cowl Inspection Areas
Figure 2, Sheet 1 of 3

- 2) Refer to Figure 2, Sheet 1. Inspect the upper and lower cowl guides and adjacent structure for serviceability, wear, missing or torn wear strips, and looseness per CF6-6 Engine Manual GEK 9266 Section 78-32-01 or CF6-50 Engine Manual GEK 50481 Section 78-32-01.

- 3) Refer to Figure 2, Sheet 1. Inspect the translating cowl bumpers located on the forward edge of the cowl for wear. Inspect the thrust reverser fixed structure adjacent to the translating cowl bumpers and deactivation lockplates for any indication of contact or damage. If contact or damage has occurred, adjust and shim the bumpers or deactivation plates per CF6-6 Engine Manual GEK 9266 Section 78-32-01 or CF6-50 Engine Manual GEK 50481 Section 78-32-01. Refer to Figure 6 for translating cowl bumper and lockplate to fixed structure clearances.

- 5) Reposition the translating cowl on a suitable holding device so that the inner (concave) surface is facing up.
- 6) Refer to Figure 2, Sheets 1 and 2. Inspect "Area 1" of the translating cowl.

- (a) Visually inspect the inboard surface of the forward closeout frame that joins the forward and aft outer bondments. Visually inspect the frame from the upper end to the lower end for cracks, disbonds and corrosion per CF6-6 Engine Manual GEK 9266 Section 78-32-01 or CF6-50 Engine Manual GEK 50481 Section 78-32-01.

- (b) Cracks, each having a maximum allowable length of 11 inches (279 mm), can be repaired at the upper and lower edges of the translating cowl forward closeout. Repair cracks per Repair 029 of CF6-6 Engine Manual GEK 9266 Section 78-32-01 or per Repair 031 of CF6-50 Engine Manual GEK 50481 Section 78-32-01.

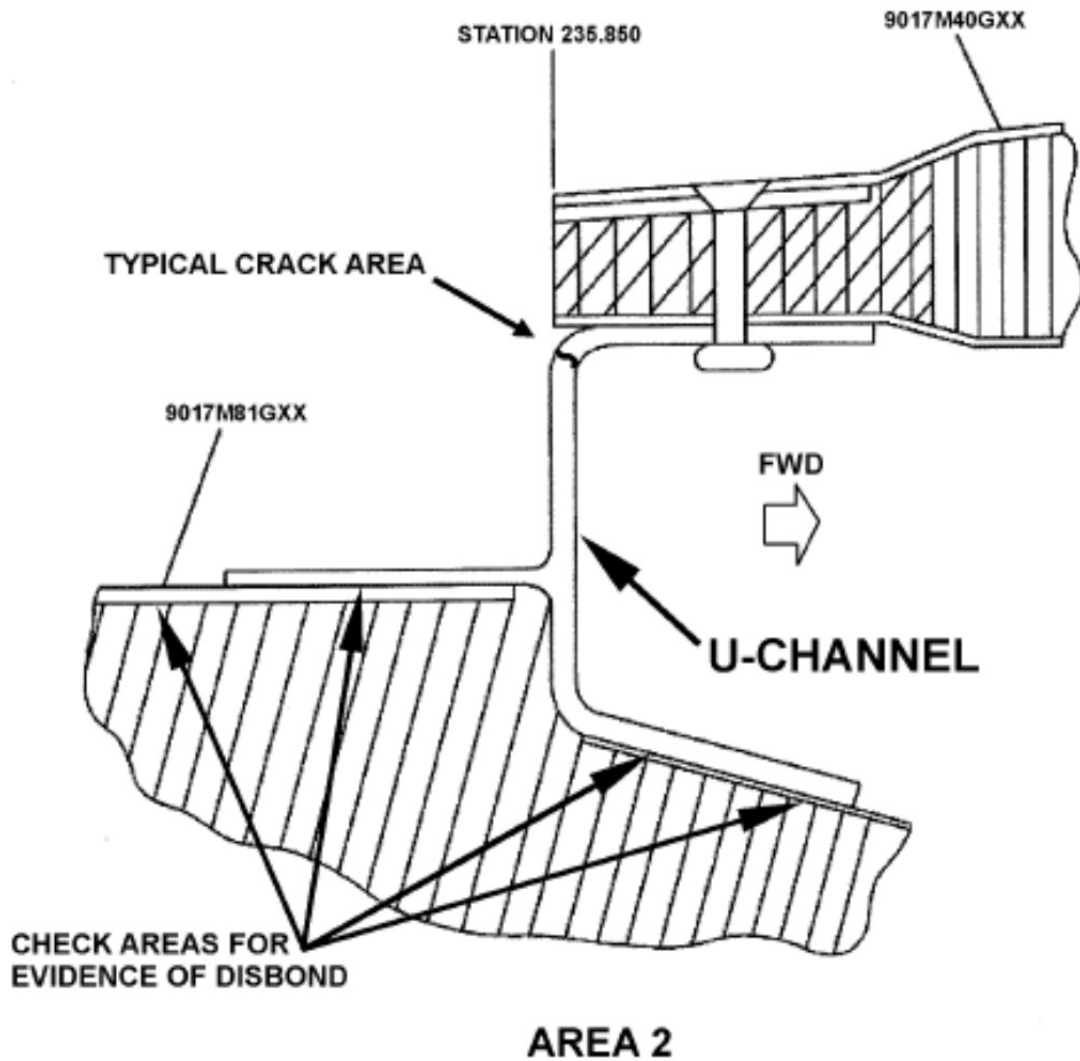
Translating Cowl Inspection Areas
Figure 2, Sheet 3 of 3

- 7) Refer to Figure 2, Sheets 1 and 3. Inspect "Area 2" of the translating cowl.
- (a) Visually inspect the inboard surfaces of the U-channel that joins the inner and outer bondments. Inspect the channel from the upper end to the lower end for cracks, disbonds and corrosion per CF6-6 Engine Manual GEK 9266 Section 78-32-01 or CF6-50 Engine Manual GEK 50481 Section 78-32-01. Tap check any area where a disbond is suspected.

- (b) Cracks, each having a maximum allowable length of 25 inches (635 mm), can be reinforced by installing a locally manufactured doubler per Repair 027 of CF6-6 Engine Manual GEK 9266 Section 78-32-01 or per Repair 027 of CF6-50 Engine Manual GEK 50481 Section 78-32-01.

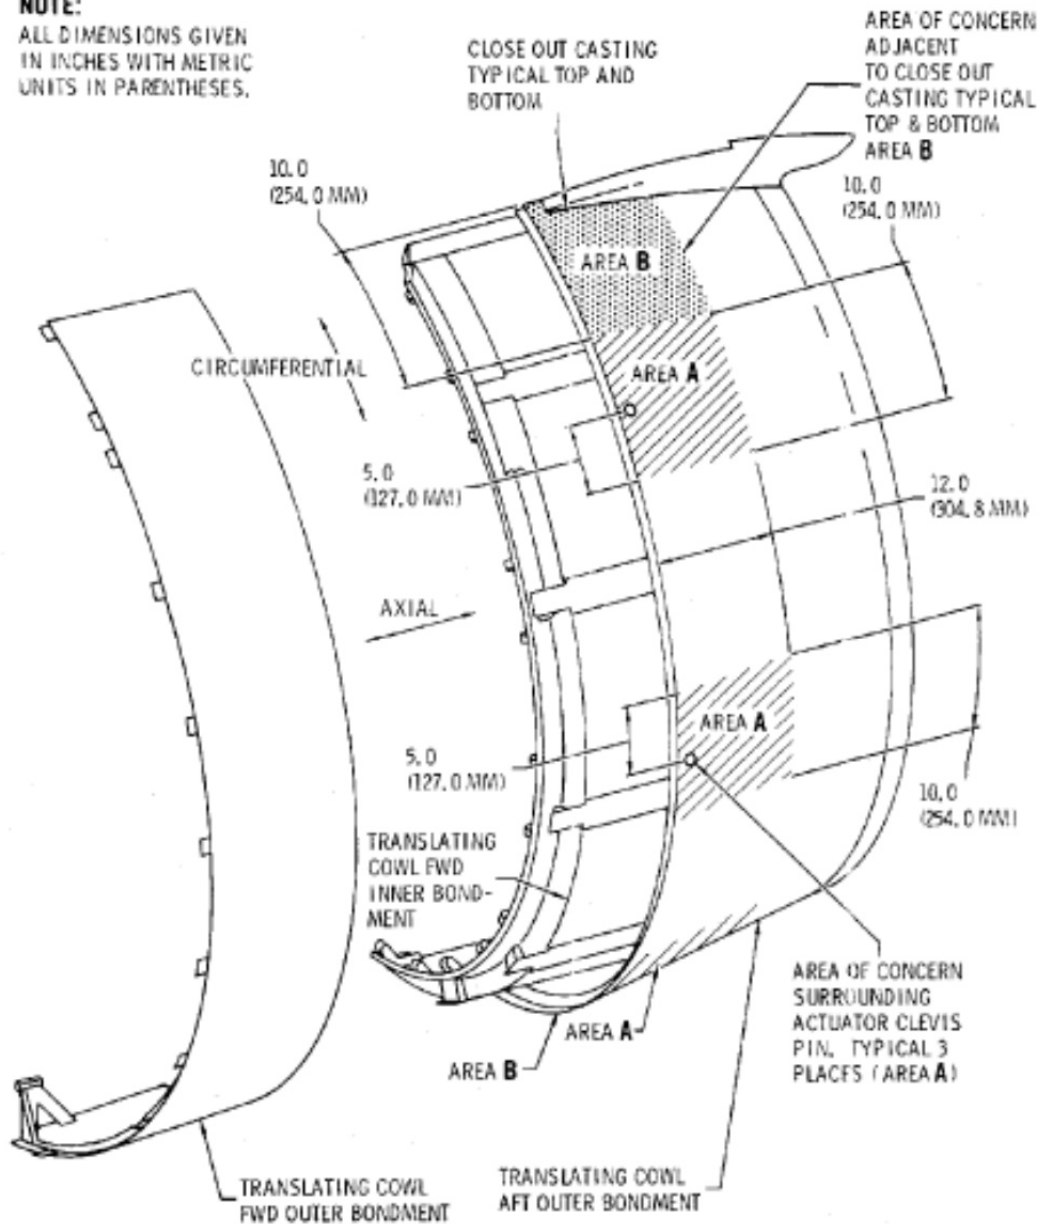
Translating Cowl Disbonds Areas of Concern
 Figure 3

- 1) Refer to Figure 3. Inspect the three actuator clevis areas marked "AREA A" and the two close-out casting areas marked "AREA B" for the following:
 - (a) Visually inspect the outer skin for any signs of cracking or any indication of loose or missing rivets at fastener locations.

- 4) Perform a tap test of the translating cowl outer bondment "areas of concern" shown in Figure 3 to inspect for disbonds.
- (a) Actuator Clevis "Area A" (three areas per translating cowl)

- 8) Refer to Figure 3. Inspect the three actuator clevis areas marked "AREA A" and the two close-out casting areas marked "AREA B" for the following:
- (a) Visually inspect the outer skin for any signs of cracking or any indication of loose or missing rivets at fastener locations.

- Repair Method: Repair 004 or Repair 019 of CF6-6 Engine Manual GEK 9266 Section 78-32-01; Repair 004 or Repair 020 of CF6-50 Engine Manual GEK 50481 Section 78-32-01

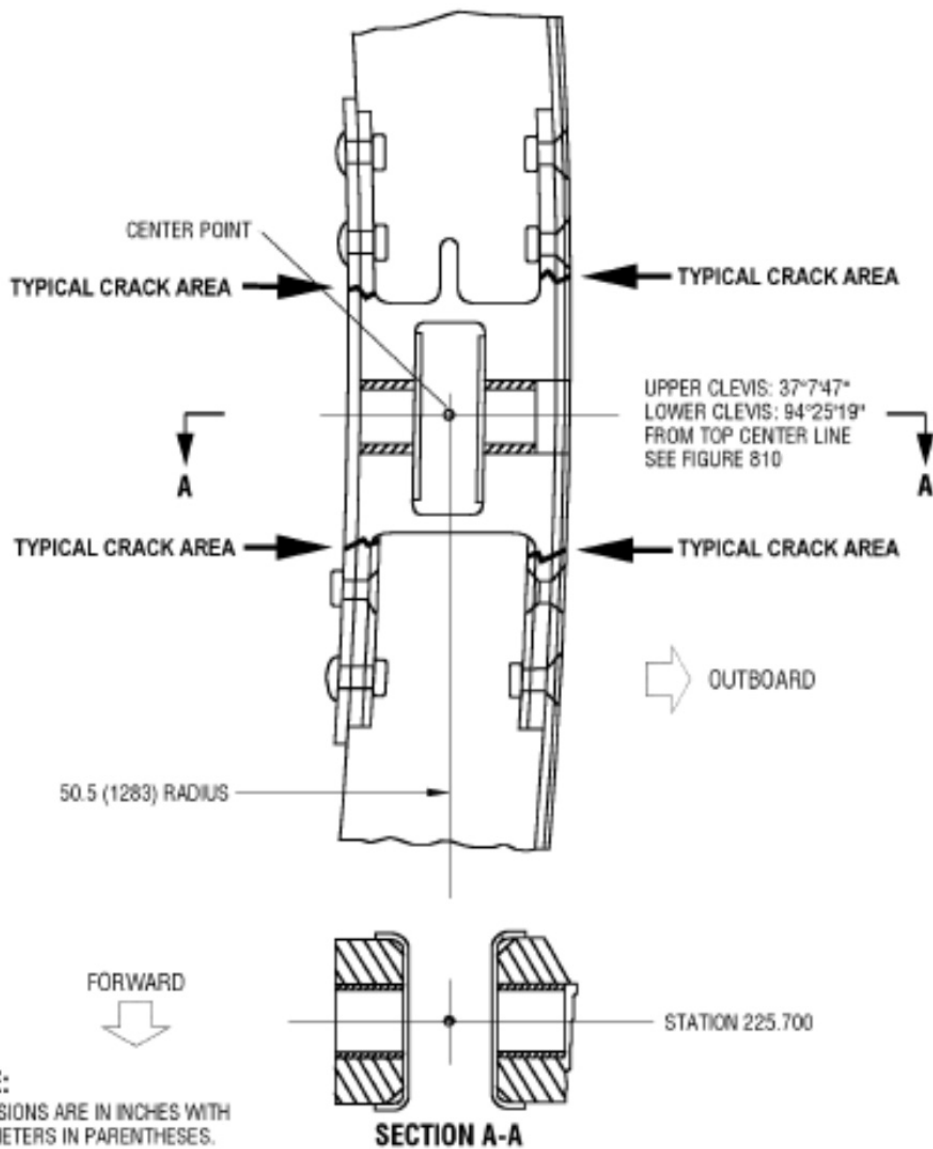
Translating Cowl Upper and Mid Clevis Area Inspection
Figure 4

- (b) Visually inspect for a cracked, broken or dislodged lower actuator support assembly. Refer to Figure 5 for an example.
 - (c) Visually inspect for cracked, broken or dislodged upper actuator clevis and mid actuator clevis. Refer to Figure 4 for examples.

- (c) Visually inspect for cracked, broken or dislodged upper actuator clevis and mid actuator clevis. Refer to Figure 4 for examples. Repair per Repair 007 of CF6-6 Engine Manual GEK 9266 Section 78-32-01 or Repair 010 of CF6-50 Engine Manual GEK 50481 Section 78-32-01.

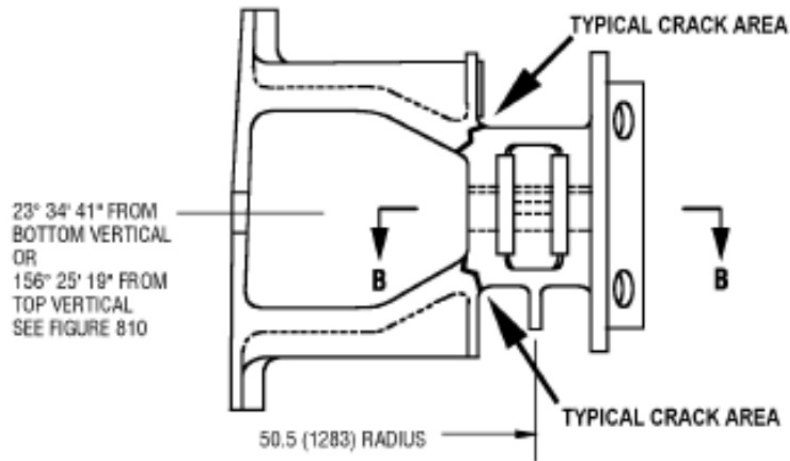
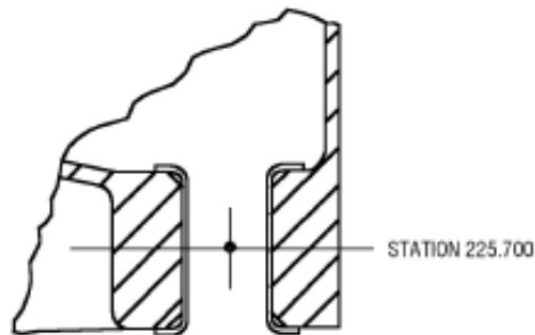
Translating Cowl Lower Actuator Support Inspection
Figure 5

- (b) Visually inspect for a cracked, broken or dislodged lower actuator support assembly. Refer to Figure 5 for an example. Repair damage per Repair 006 of CF6-6 Engine Manual GEK 9266 Section 78-32-01 or Repair 009 of CF6-50 Engine Manual GEK 50481 Section 78-32-01.

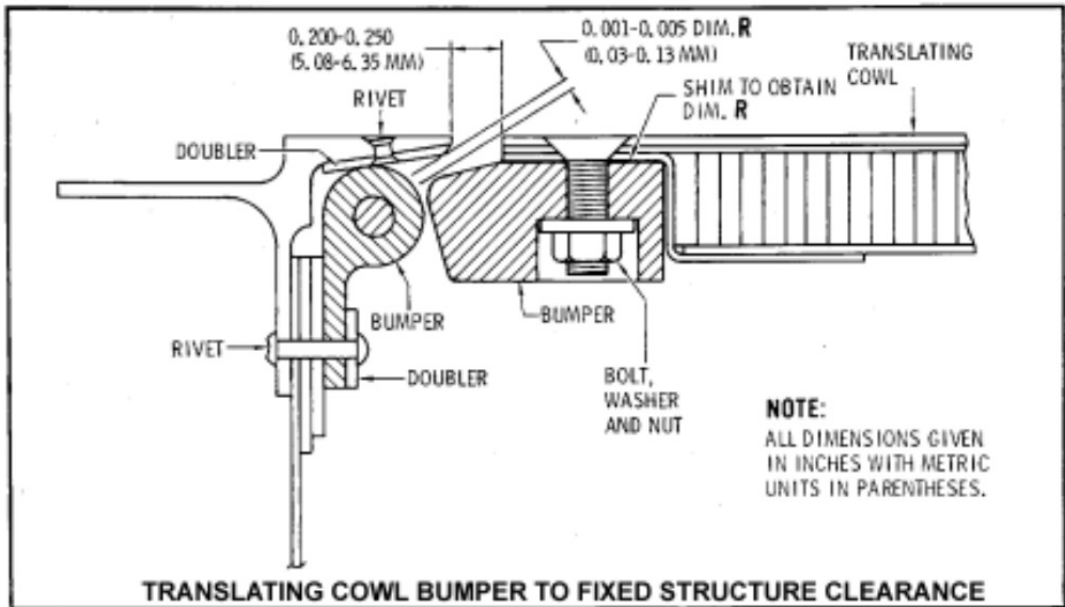
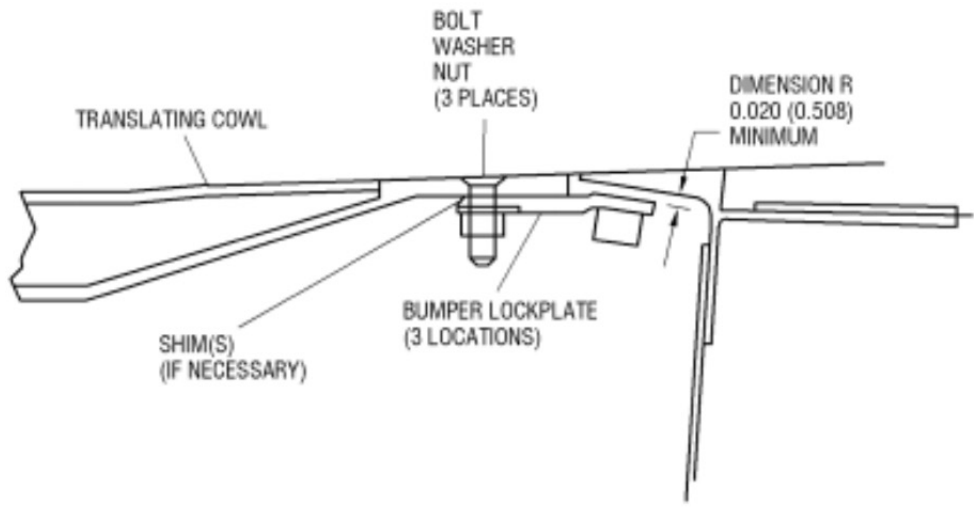
Translating Cowl Bumper and Lockplate to Fixed Structure Clearances
Figure 6

- 15) Install the translating cowl on the fan reverser per the applicable Aircraft Maintenance Manual (AMM).
- 16) Refer to Figure 2, Sheet 1. Inspect the thrust reverser fixed structure adjacent to the translating cowl bumpers and deactivation lockplates for any indication of contact or damage. If contact or damage has occurred, adjust and shim the bumpers or deactivation plates per CF6-6 Engine Manual GEK 9266 Section 78-32-01 or CF6-50 Engine Manual GEK 50481 Section 78-32-01. Refer to Figure 6 for translating cowl bumper and lockplate to fixed structure clearances.
