Factual Report

Type of Occurrence:	Incident
Date:	19 May 2017
Location:	Wartenberg
Aircraft:	Cargo airplane
Manufacturer / Model:	Boeing Company / B 747-400 F
Injuries to Persons:	None
Damage:	Minor damage to aircraft
Other Damage:	None
State File Number:	BFU17-0540-TX

During the approach the track hinge fairing of the right outer flap drive separated from the airplane.

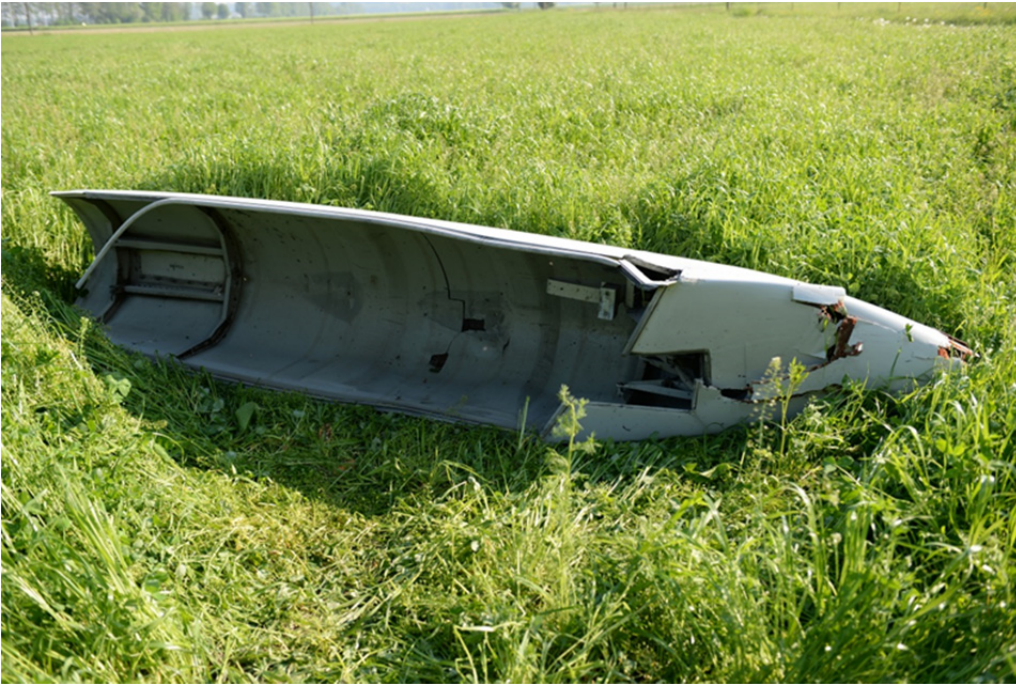
After the airplane had reached the parking position at the apron it was determined that the track hinge fairing of the outer flap drive (No 8) on the right wing was missing. Some brackets and connection rods in the vicinity of the flap track and carriage were fractured or bent (see Appendix Image 1). The aft flap was slightly dented on the lower surface in the area of the right, outer flap drive.

Image 1: Location of the track hinge fairing

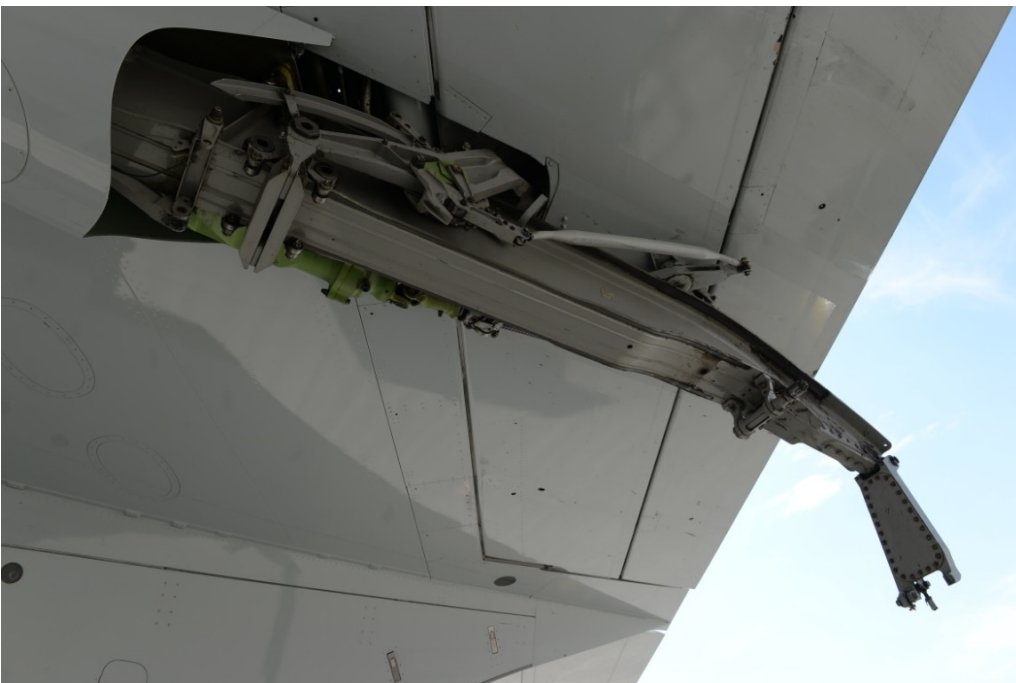
In the vicinity of the township Wartenberg (about 2 km south-west) a fairing, originating from an aircraft, was found on a meadow (see Appendix Image 2). It was located about 12 km east of the threshold 26R in the area of the approach centreline.

Image 2: Outer flap drive and flap track and carriage on the right wing

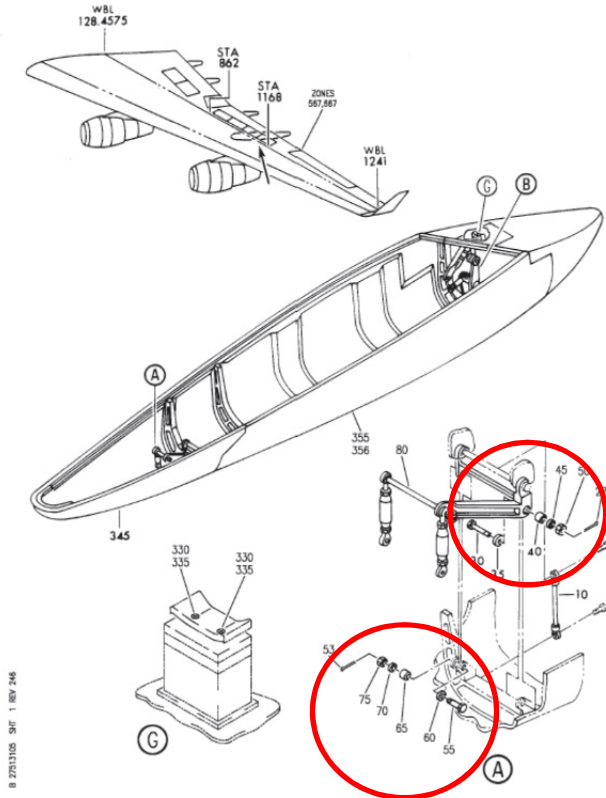
Image 3: Front mounting of the fairing (red circles)

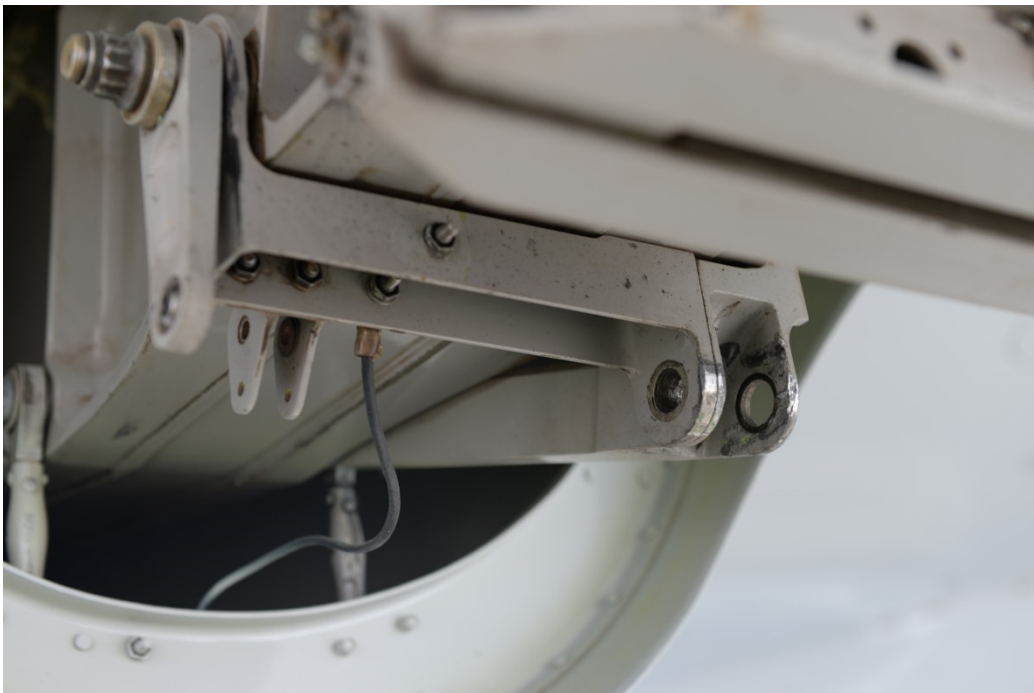
The two bolt lead-throughs of the front mounting points (see Appendix Image 3) showed scratching and friction traces on the flap track and carriage and the fairing side (see Appendix Images 4 and 5). Both bolt connections were missing. The bolts were neither found in the periphery of the flap drive nor at the meadow.

Image 4: Front mounting points on the flap track and carriage

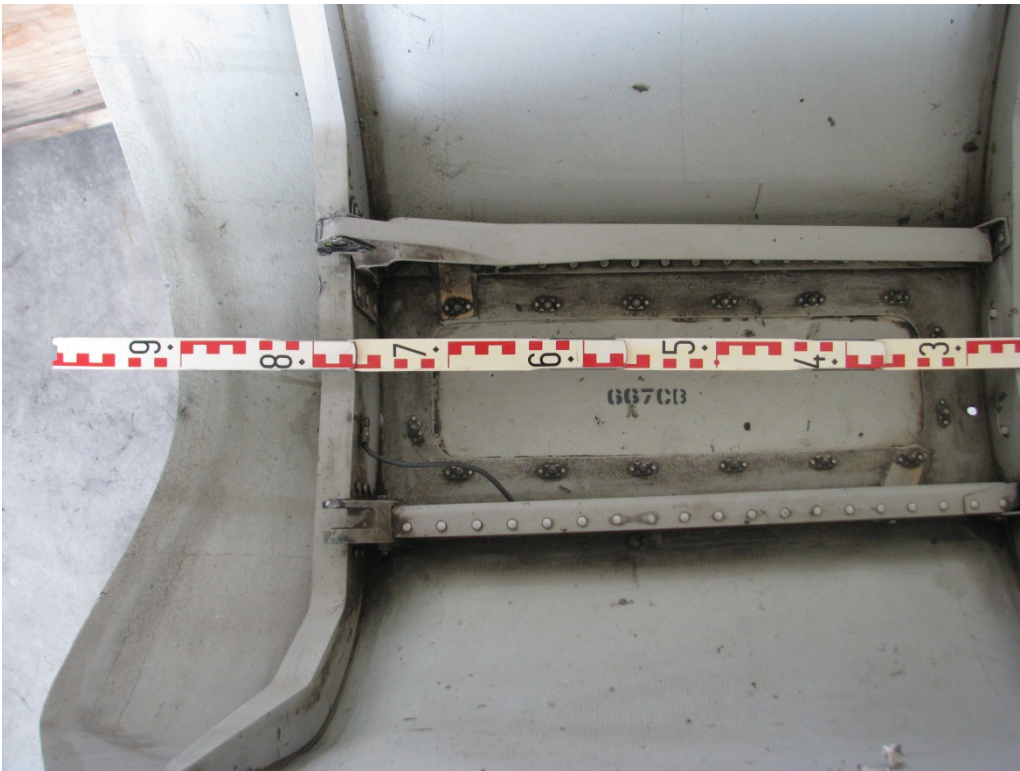
Image 5: Front mounting points on the fairing

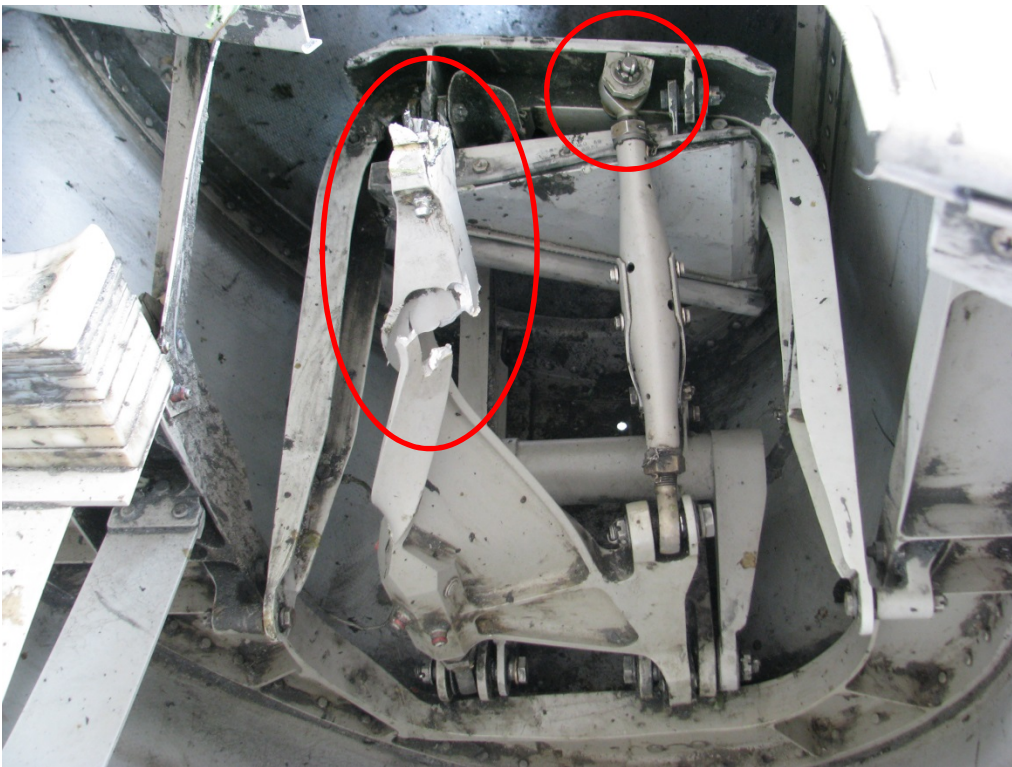
On the aft fairing extension mechanism the support fitting had been turned by almost 180° and ripped. The bolt receptacle had forcibly been torn out (see Appendix Image 6). The bolt was found in the support fitting on the wing. The bolt receptacle of the adjustable rod had been torn off the support fitting of the wing. This bolt was found in the fixing eyelet of the adjustable rod.

Image 6: Aft mounting points (red circle)
