Investigation Report

Identification

Type of Occurrence:	Accident
Date:	25 March 2018
Location:	Near Koblenz-Winningen Airfield
Aircraft:	Helicopter
Manufacturer / Model:	Homebuilt / RotorWay Exec 162F
Injuries to Persons:	None
Damage:	Aircraft severely damaged
Other Damage:	None
State File Number:	BFU18-0292-3X

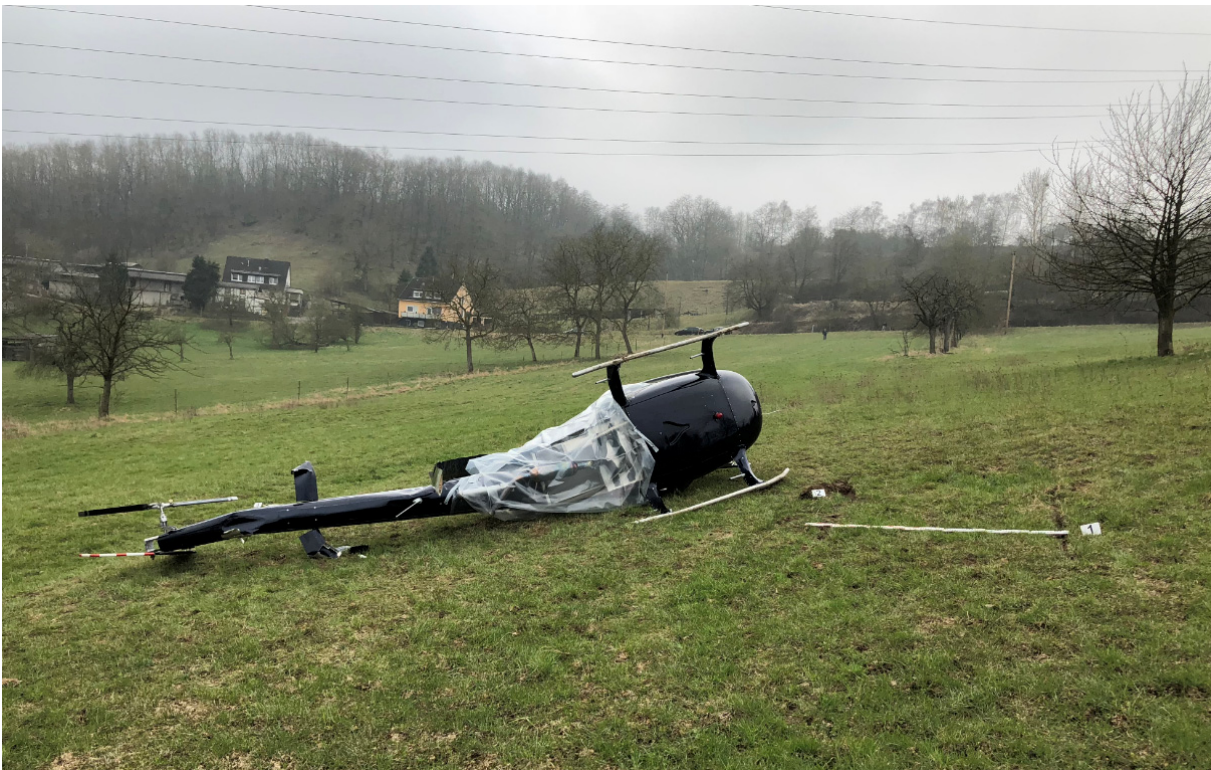
The helicopter touched down hard at a downward sloping meadow south-west of Bisholder in the vicinity of an overhead power line. Up until the helicopter rolled over the engine was running with decreased power.

Accident site overview: Power line, downward slope, ground traces, and damages

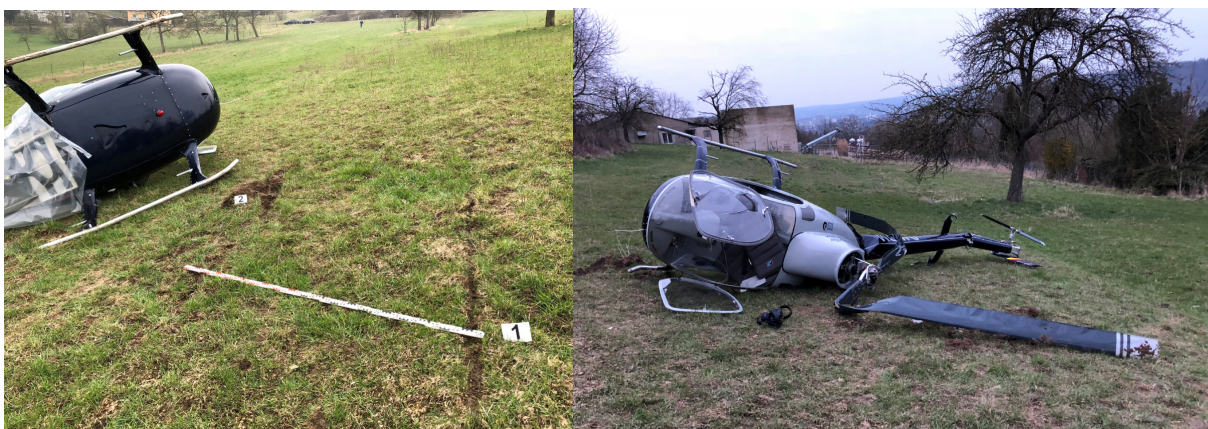
The helicopter was laying on its left side on a downward sloping meadow, the nose pointed west. North of the helicopter a skid mark in the ground was found. The left skid indentation was deepest in the front.

Accident site and helicopter damages

The main rotor blades were bent and the tail boom was twisted. At the site fuel leaked. At the accident site no evidence was found that the controls had been impaired. The engine and the respective aggregates did not show any leakages or loose connections.

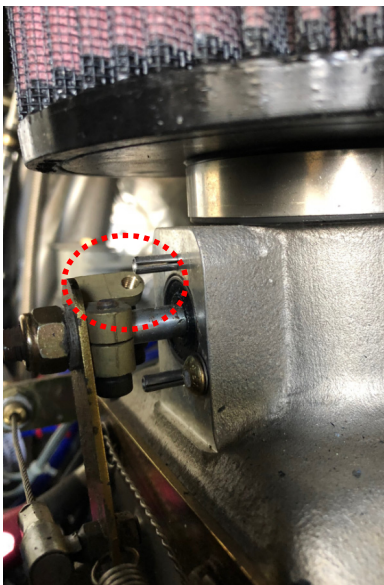
On the linkage of the throttle a stop bolt was missing. It could not be determined as to how long the stop bolt had been missing. The pilot stated that the bolt had been part of the construction kit. In case such a stop bolt loosens by vibration it would restrict the maximum deflection of the throttle more and more.

Missing stop bolt at the throttle and contaminated fuel filter

failure. The manufacturer stated that contrary to the technical drawings the stop bolt for the maximum position of the throttle is not installed.

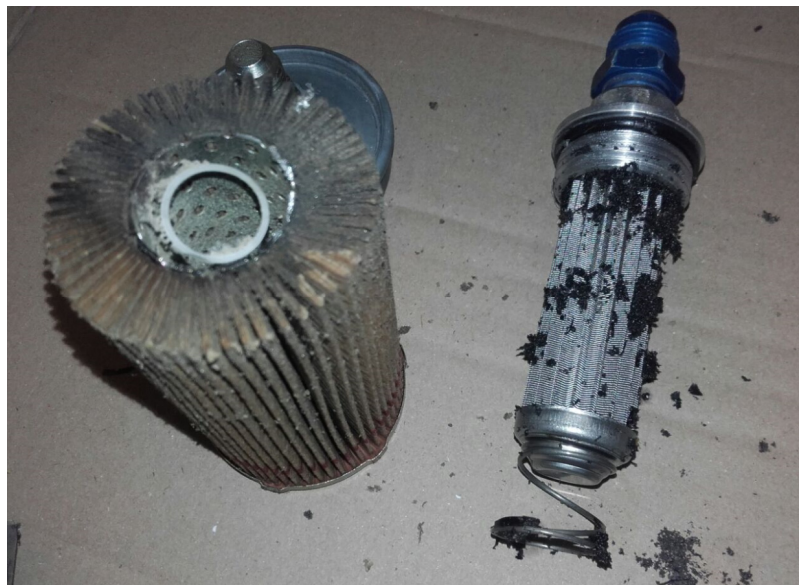
The two fuel filters were opened. They showed severe contamination. Part of the contamination seemed to be black plastic which showed similarities with the tank material.
