# Status Report

Type of Occurrence:	Serious incident
Date:	3 November 2011
Location:	Munich
Aircraft:	Transport aircraft
Manufacturer / Model:	Boeing / B 777-300 ER
Injuries to Persons:	None
Damage:	No damage to aircraft
Other Damage:	Crop damage
Information Source:	Investigation by BFU
State File Number:	BFU EX010-11

B 777 Runway Excursion

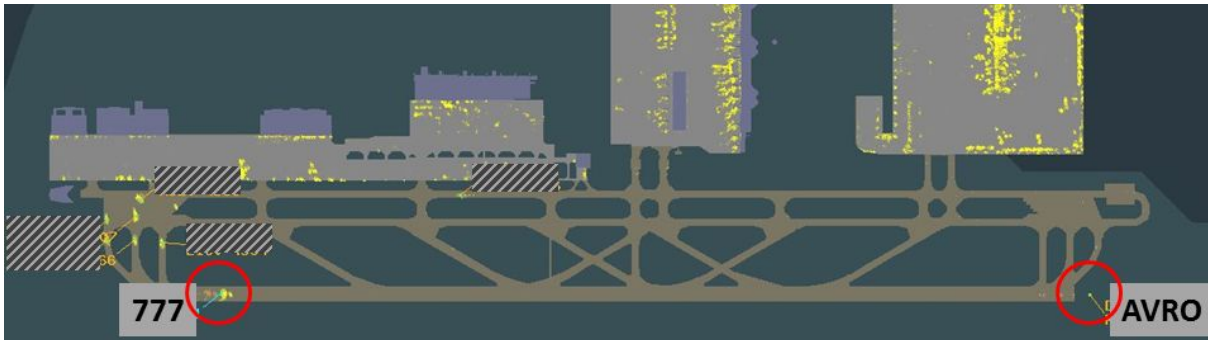
At 12:07:53 hrs as the B 777 was about 2.9 NM prior to the runway 08R, one aircraft each was at the CAT II/III holding position of taxiways B1, B2 and B3 and two aircraft were farther north of them. An additional airplane taxied on taxiway S towards the west. An airplane (BAe AVRO) taxied at the same time over the High Speed Taxiway B4 onto the runway and started the take-off run about 20 seconds later. At that time the B 777 was about 2.1 NM prior to the runway in an altitude of about 700 ft AGL. At 12:09:09 hrs the B 777 crossed the threshold of runway 08R in an altitude of 40 ft. Six seconds later the BAe AVRO left the end of the runway in an altitude of about 380 ft. At 12:09:29 hrs the BAe AVRO overflew the ILS localizer antenna of runway 08R in 740 ft.

Position of the AVRO at the time the B 777 touched down

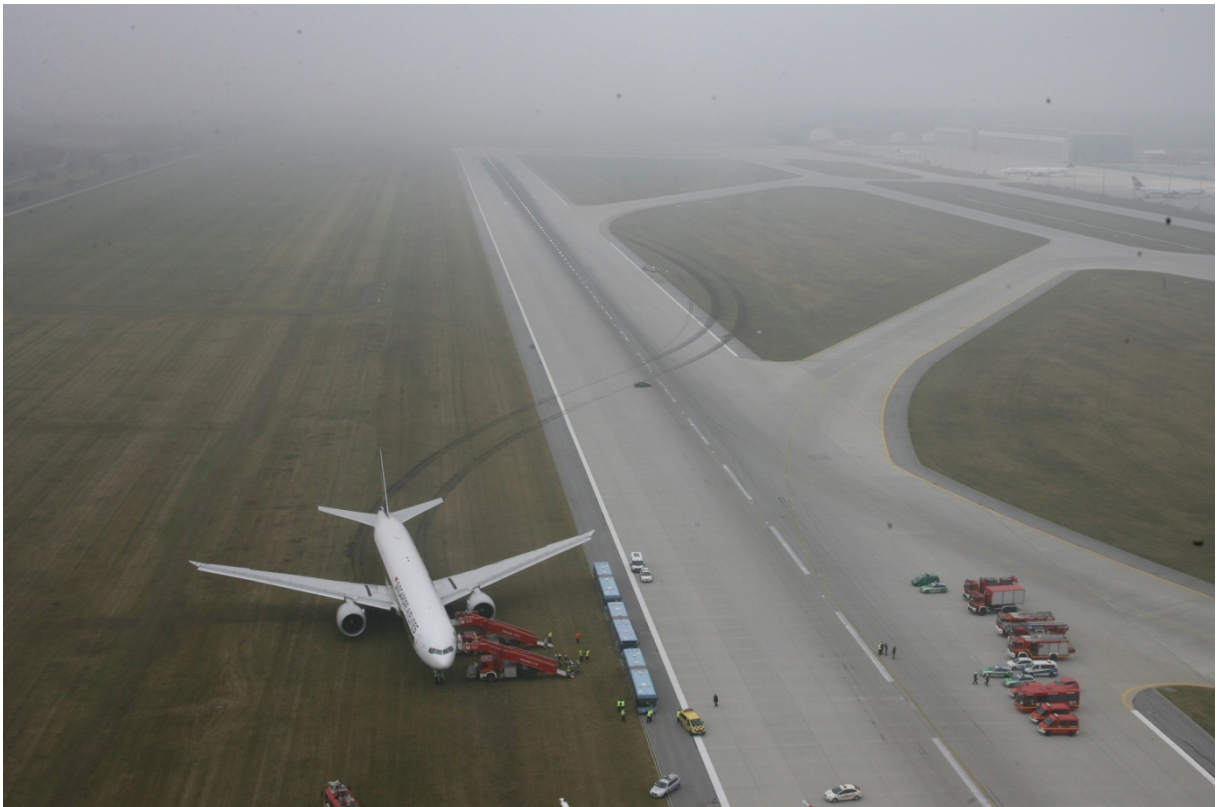
Location of the aircraft after coming to a standstill

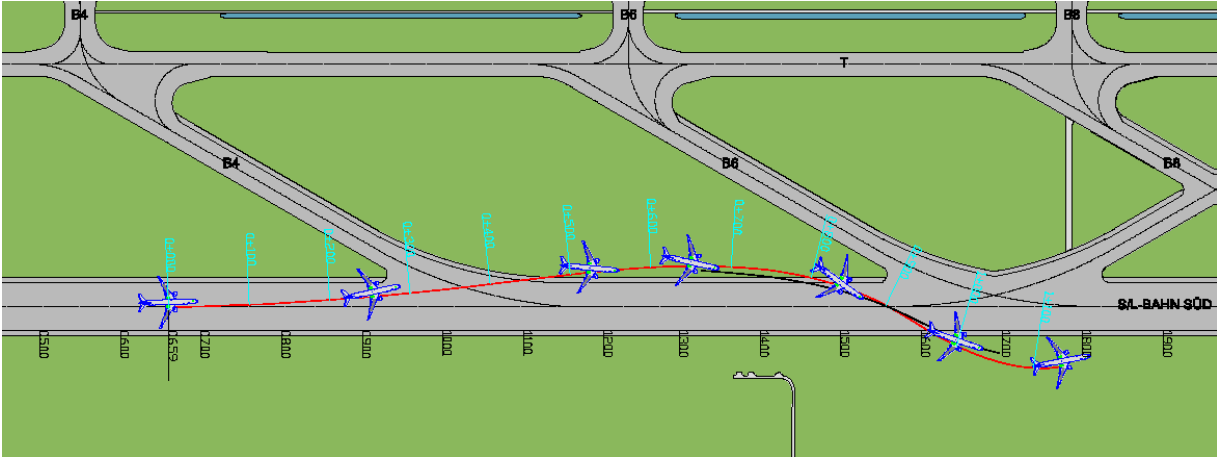
The first visible traces were determined about 659 m after the beginning of the runway. About 1,100 m after the beginning of the runway the airplane left the runway at taxiway B4 and moved over grass. After about 1,300 m the airplane reached with about 40 m the largest lateral deviation to the north of the runway centre line. The airplane turned 46° to the right and crossed the runway between 1,450 m and 1,620 m with a heading of 121°. The maximum lateral deviation towards the south

was reached at 1,740 m with about 60 m from the runway centre line. The airplane came to a stop in the grass after about 1,780 m.

Aircraft path

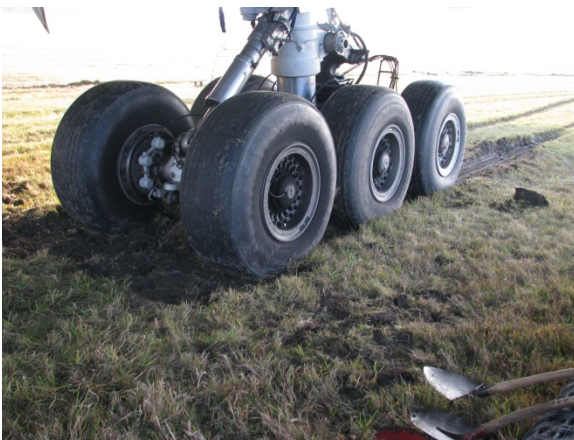
There were no damages on the airplane safe for some grass and dirt on the right engine and the landing gear. The tyres tracks were up to 15 cm deep.

Right main landing gear

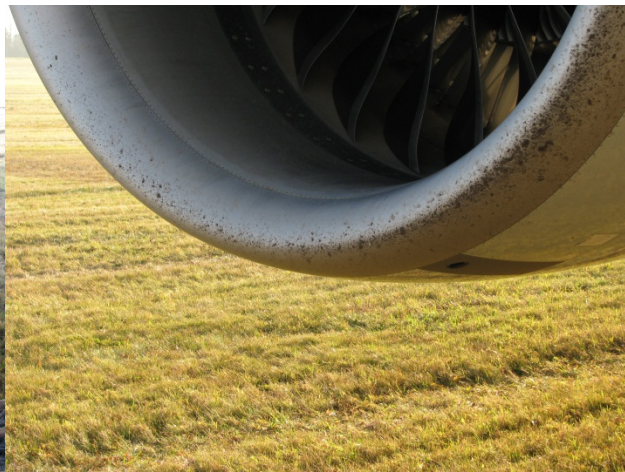
Dirt on the right engine

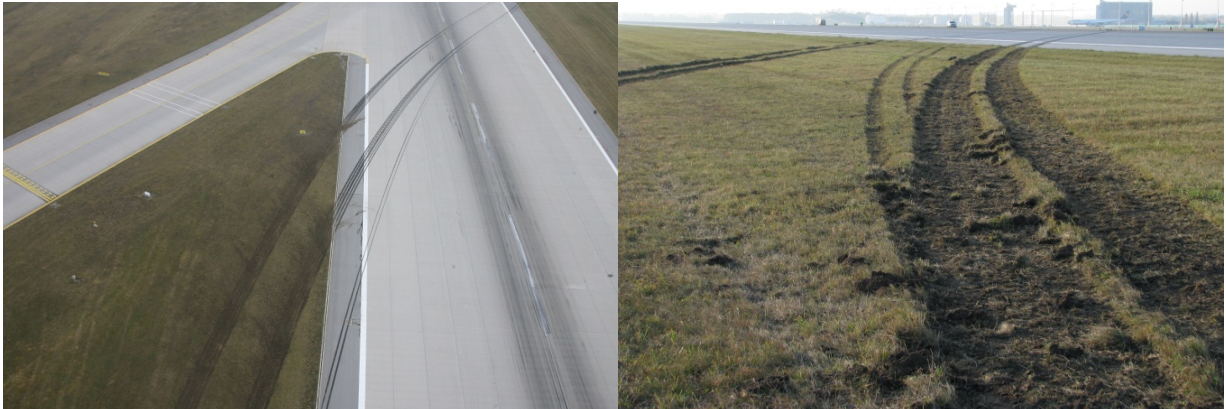
Aircraft path in landing direction

Aircraft path opposite to the landing direction

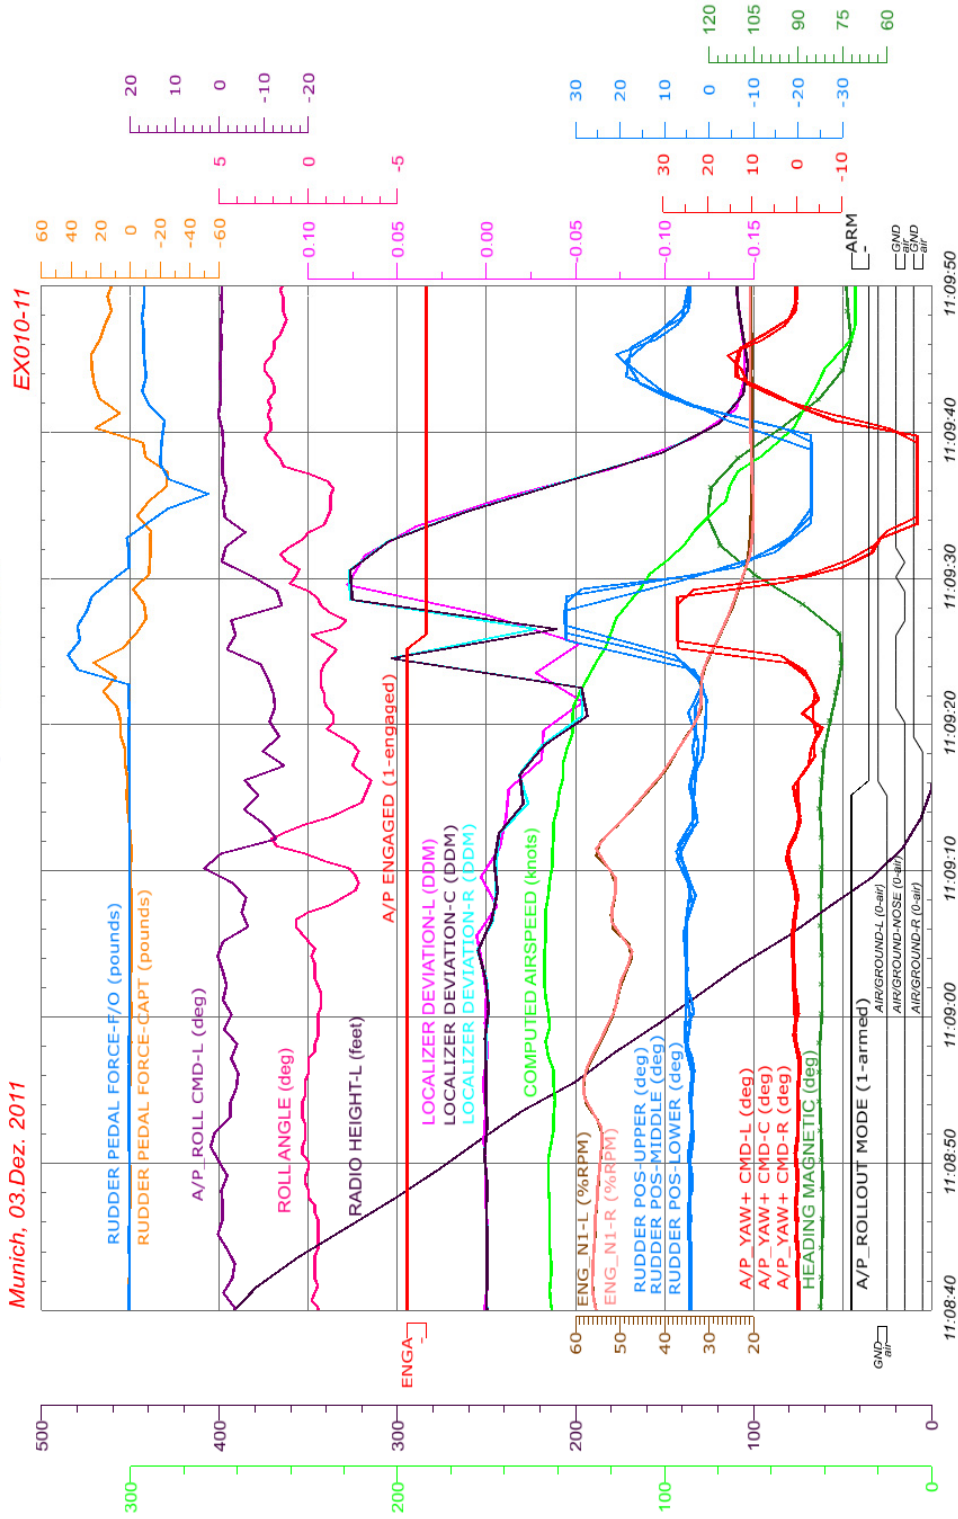
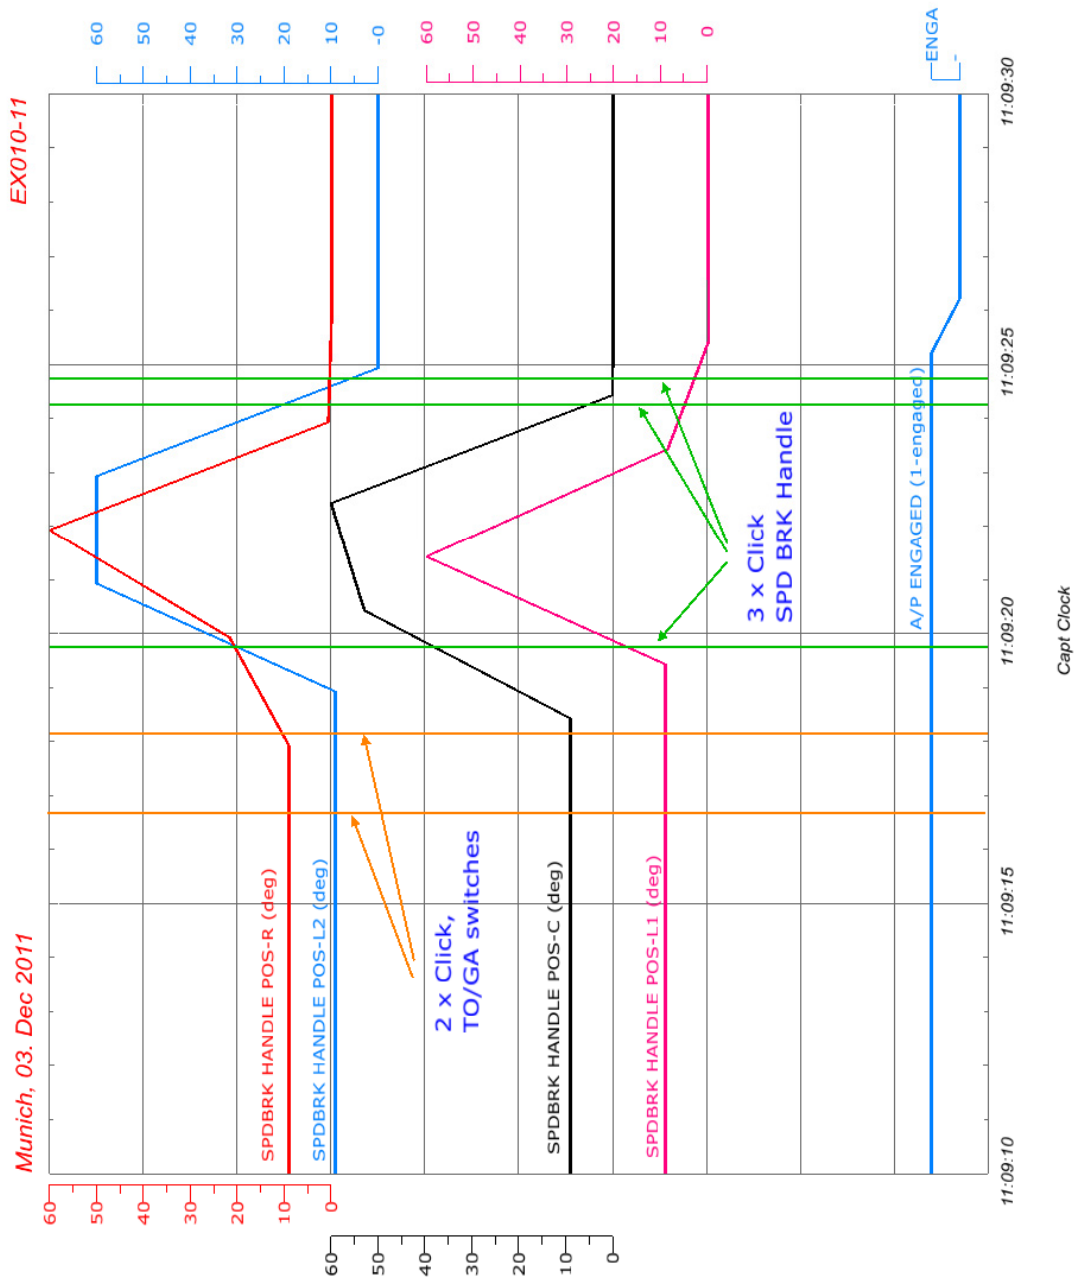
Appendix 1

Until 11:09:00 UTC the approach occurred without incidents. Between 11:09:02 UTC (altitude about 110 ft) and 11:09:10 UTC (altitude about 30 ft) the three parallel working localizer antennas aboard the airplane recorded signals which showed an irregular beam deviation. From 11:09:10 UTC on signals were recorded which showed an

increasing beam deviation from the extended centre line or runway centre line, respectively, towards the right.

The airplane began to roll to the left and at 11:09:16 UTC reached a maximum bank angle of 3.5° when it touched down with its left main landing gear. At the time the autopilot was still engaged; the approach mode changed into rollout mode.

At 11:09:22 UTC both pilots pushed down on the right rudder pedals - the PIC with 23 lbs and the co-pilot with 41 lbs - and over-steered the autopilot which disengaged immediately afterwards.

Between 11:09:14 UTC and 11:09:24 UTC the ground spoiler deployed for about 5 seconds and retraced again.
