Investigation Report

Type of Occurrence:	Accident
Date:	9 September 2017
Location:	Straubing-Wallmühle Airfield
Aircraft:	Airplane
Manufacturer / Model:	Cirrus Design Corporation / SR 22
Injuries to Persons:	None
Damage:	Aircraft severely damaged
Other Damage:	Airfield border damaged; Damage due to fuel leakage
State File Number:	BFU17-1231-CX

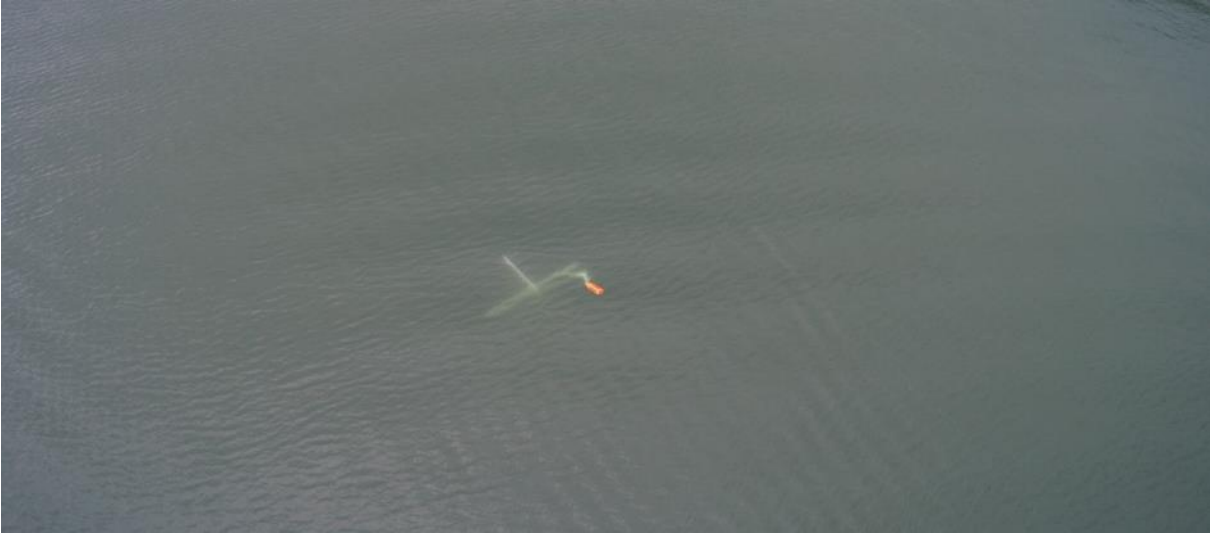
The accident site was located approximately 100 m south of the runway in a pond. The airplane had sunk at almost right angle into the pond approximately 600 m west of the threshold of runway 27.

Accident site

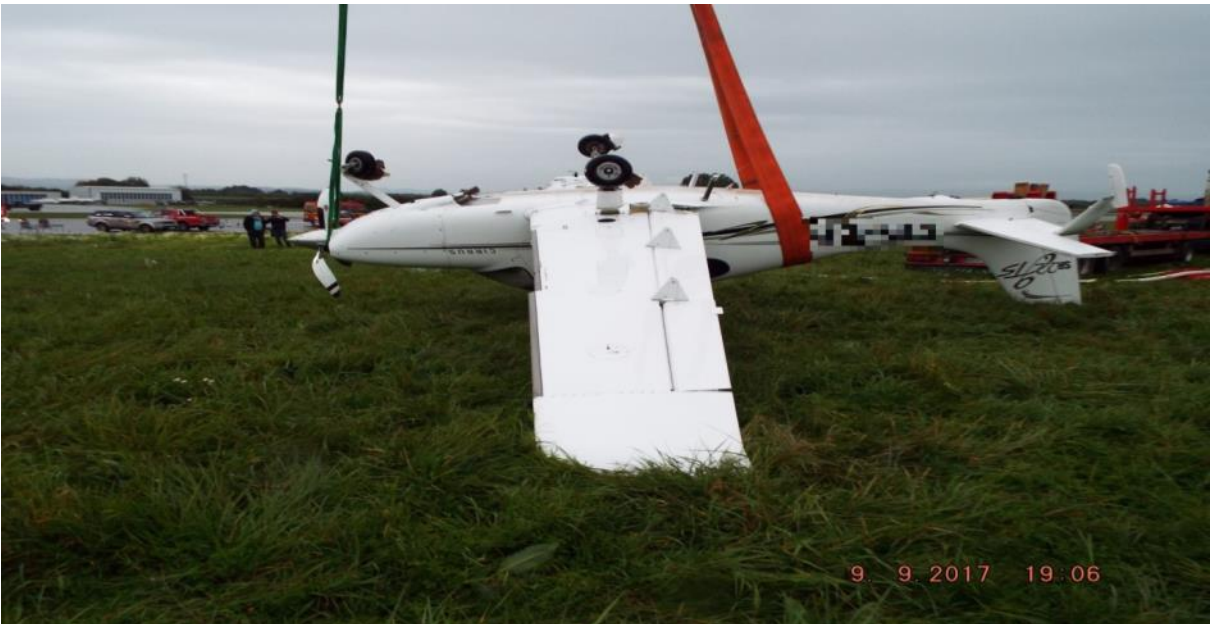
Aircraft during salvage operation

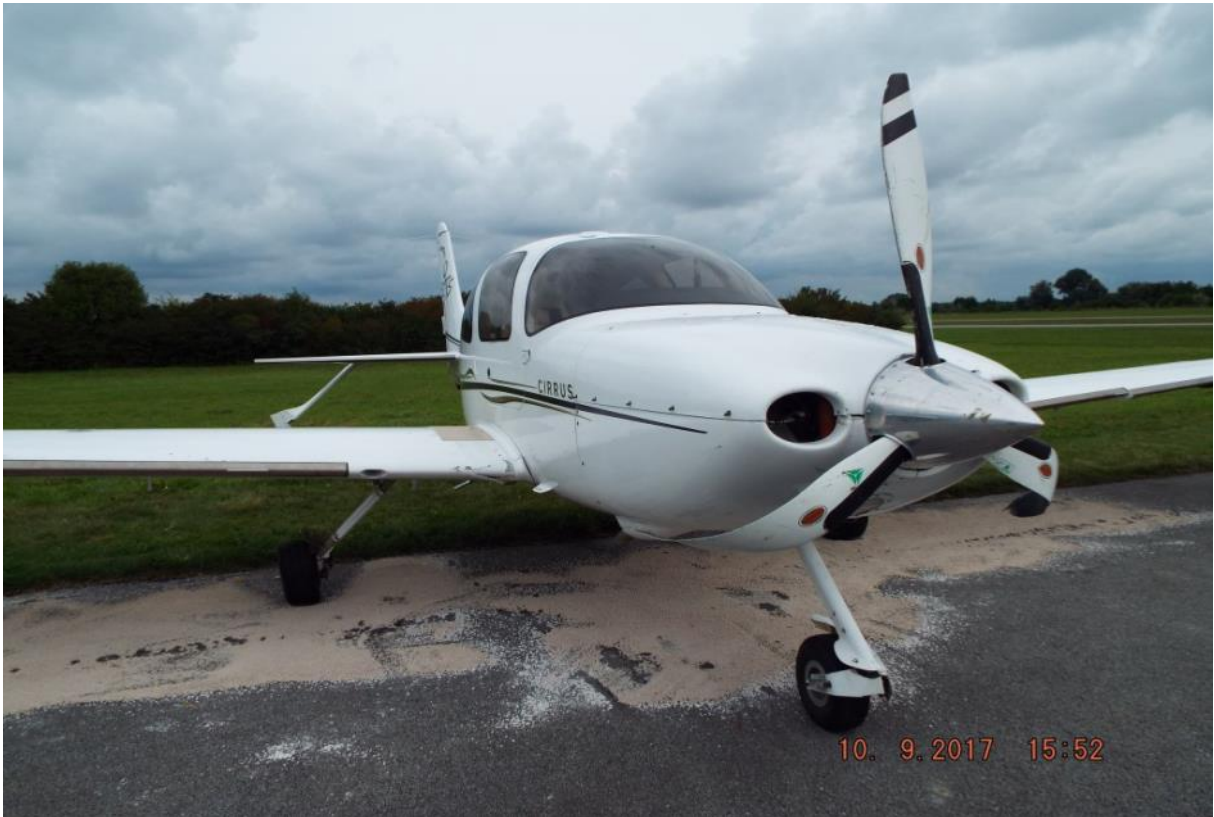
Aircraft after salvage operation

The fuselage was scratched and some places showed delamination. Two of the three propeller blades had been bent backward; all three were damaged.

Approximately in the middle, the right elevator trim tab had been bent downward.

In the area of the wing tip the left wing had been deformed and split. It showed a hole about 40 cm from the wing tip.

The leading edges of both wings were deformed and in the root area delaminated.

The landing gear cowlings were damaged and torn off.

All components of the aircraft showed water damage.
