Interim Report

Type of Occurrence:	Serious incident
Date:	20 December 2012
Location:	Phuket, Thailand
Aircraft:	Airplane
Manufacturer / Model:	Airbus / A 330-223
Injuries to Persons:	No injuries
Damage:	Minor damage to aircraft
Other Damage:	None
Information Source:	Investigation by BFU
State File Number:	BFU 6X015-12
Published:	February 2013

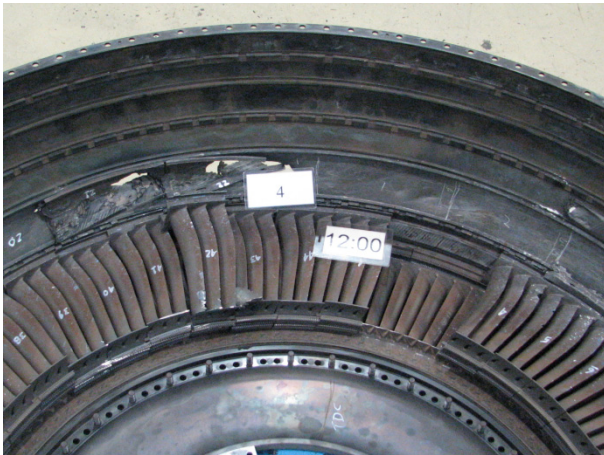
The investigation determined a 425 mm long circumferential and 45 mm wide axial hole in the area of the 4th stage and several other smaller holes in the casing of the LPT. Beginning with the 4th stator stage all subsequent rotor and stator stages showed damages in various degrees. For the investigation purposes, the vane clusters were labelled clockwise from 1 to 44 starting at the 12 o'clock position. The 4th stage vane clusters with the position numbers 2 and 3 were no longer in their original places. One complete 4th stage vane cluster was found loose in the debris in the LPT 4th stage. For the investigation purposes, it was labelled with "A". No pieces of the second missing 4th stage vane cluster were identified. The 4th stage vane clusters number 4 and "A" exhibited visual gusset fillet cracking. Two vane clusters next to the missing vane clusters showed rub marks on the rear face of their inner platforms. All of the 4th stage airfoils had a notch rubbed in the leading edge at the airfoil platform fillet radius. Eleven of the 130 4th stage turbine airfoils had a flat, planar fracture surface. The remaining 4th stage turbine airfoils had a coarse, grainy, and irregular fracture surface.

The 4th stage stator stage with two missing vane clusters

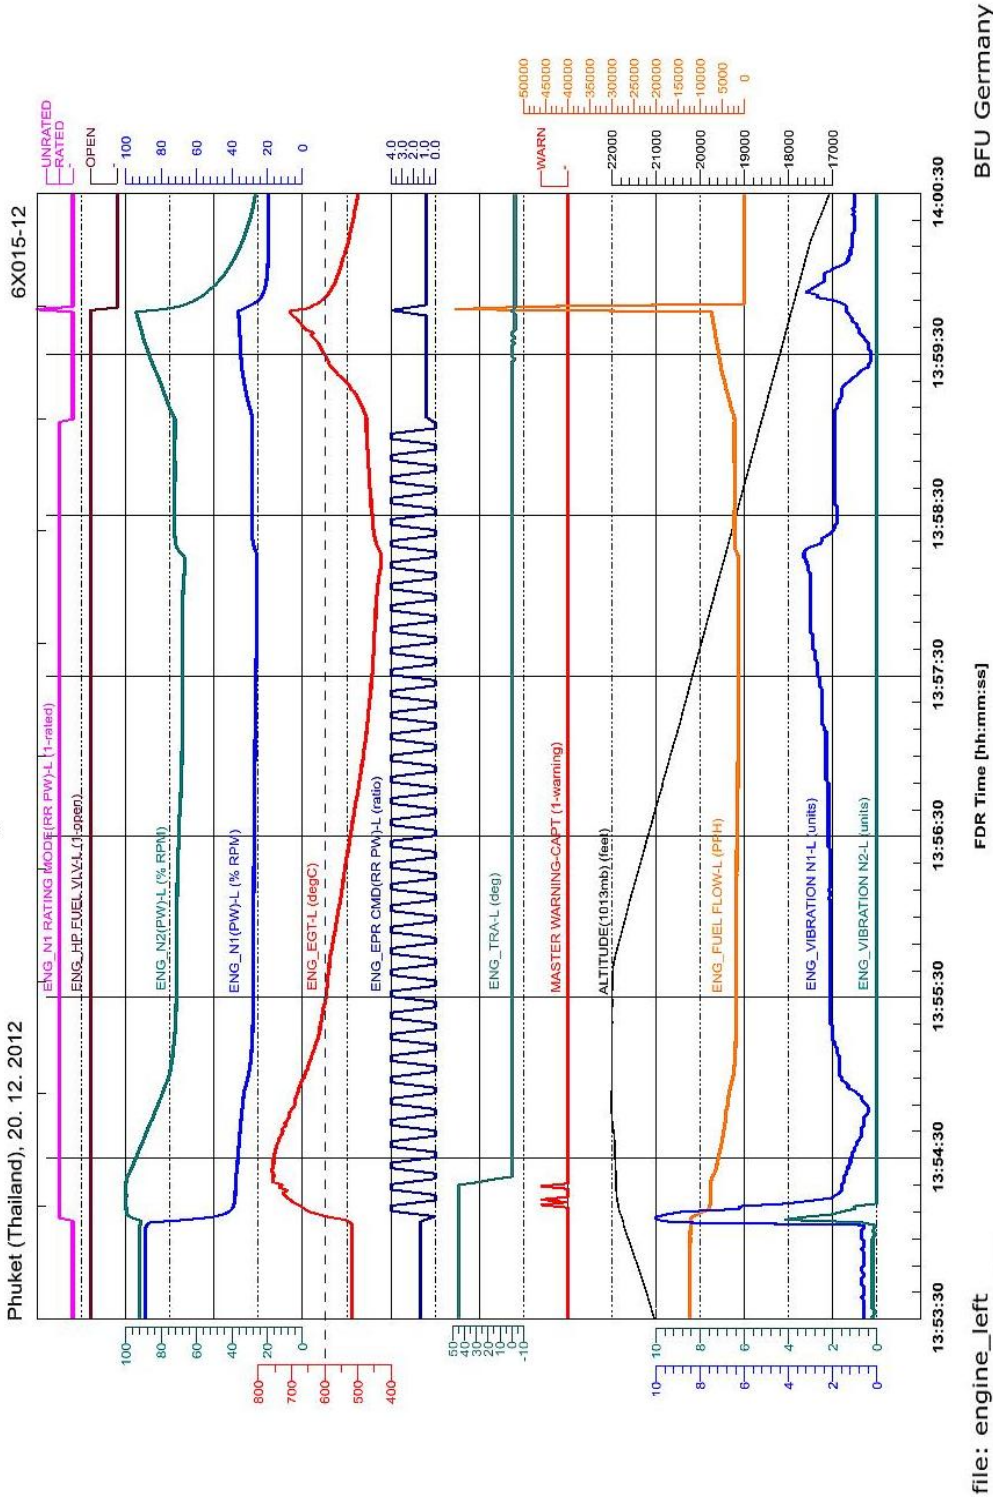
Excerpt of engine FDR data

The sound was coupled with a decrease of Engine 1 rotational speed of the low pressure compressor (N1) and an increase of rotational speed of the high pressure compressor (N2). The Flight Data Recorder (FDR) data showed that the vibration level and the Exhaust Gas Temperature (EGT) increased simultaneously. During the occurrence the Master Warning occurred three times and on the ECAM-system the warnings ENG1 EGT OVER LIMIT and ENG1 N2 OVER LIMIT were indicated, among others; autothrust disengaged automatically. The crew reduced Engine 1 thrust to flight idle. The Engine 1 EGT decreased and about one minute and 15 seconds later dropped below the limit of 600°C. The FDR recording showed that five minutes after the first occurrence the EGT increased again and exceeded the limit after another 25 seconds. Simultaneously, N2 increased. A short time later the engine was shut off.

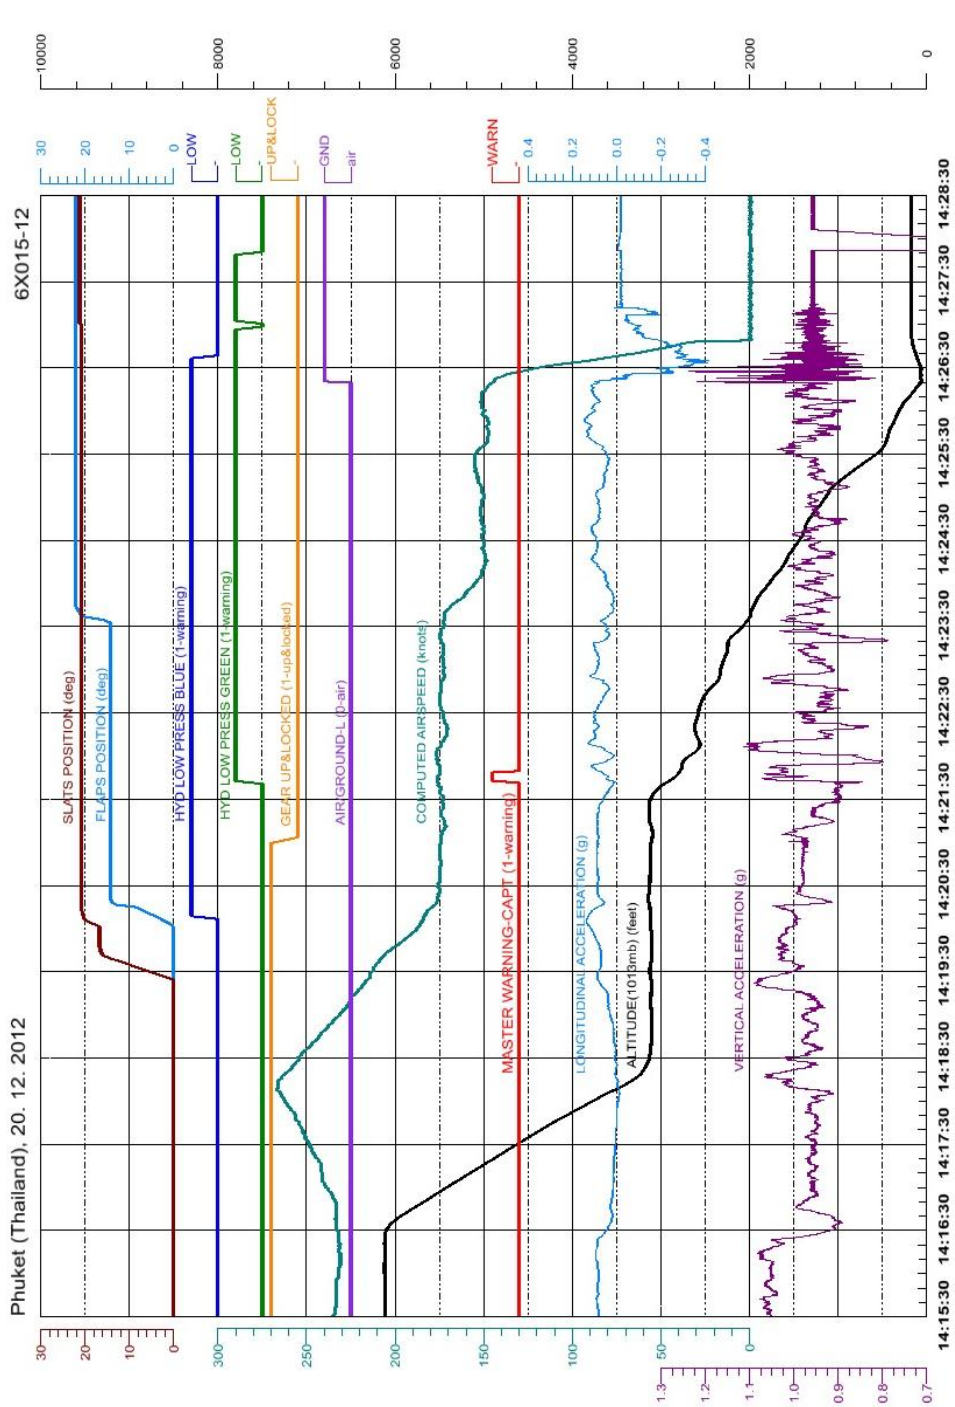
Excerpt of engine FDR data

Immediately after the first indication of an engine failure the crew decided to perform an In-Flight Turn Back (IFTB) and return to Phuket Airport. The crew declared emergency and concluded to fly a holding pattern to prepare for landing. The crew decided to conduct an overweight landing. For the calculation of the landing distance they assumed an aircraft mass of 200 t and landing configuration 3. On the flight back to Phuket Airport ECAM indicated Hydraulic G System Leak and shortly afterwards a low pressure warning for the blue System appeared. It was not clear to the Pilot in Command (PIC) which overall problems he was facing when the ECAM indicated hydraulic problems and therefore decided to hand controls over to the co-pilot in order to attend to the ECAM and the system page. The crew selected flaps/slats configuration 2 at 1420 hrs and extended the landing gear. Immediately afterwards the low pressure warning for the green system appeared and flight controls changed into F/CTL ALTN LAW mode. At 1423 hrs, at about 2,000 ft, flaps/slats configuration 3 was selected.

At 1426 hrs an overweight landing with a mass of 198 t was conducted. During the subsequent braking manoeuvre using alternate brake pressure without anti-skid three tires burst. The airplane came to a stop in the area of the intersection of taxiways F and G. The passengers disembarked via the stairs. No one was injured.
