Interim Report

Type of Occurrence:	Accident
Date:	5 December 2012
Location:	Neustädter Bucht
Aircraft:	Helicopter
Manufacturer / Model:	Eurocopter / AS 350BA
Injuries to Persons:	Pilot and system operator fatally injured
Damage:	Aircraft severely damaged
Other Damage:	None
Information Source:	Investigation by BFU
State File Number:	BFU CX024-12
Published:	February 2013

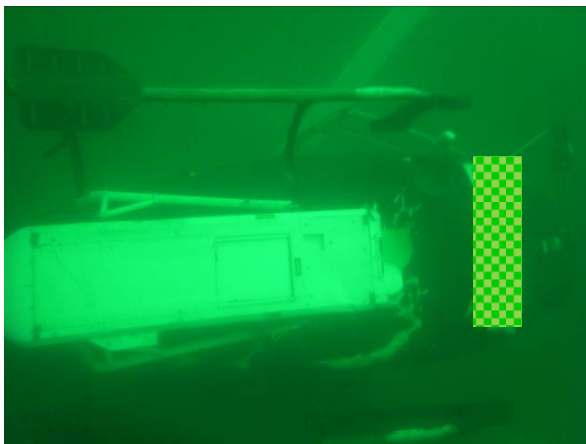
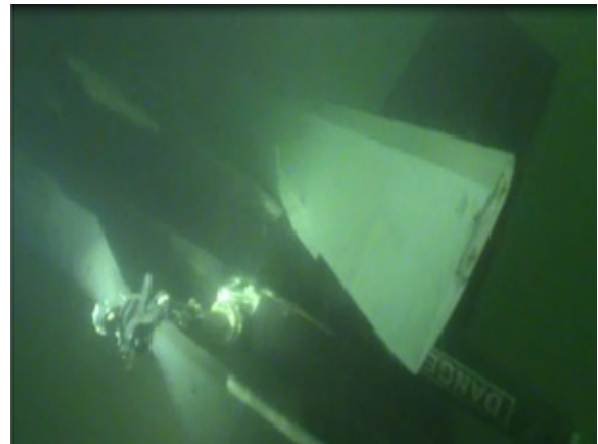
The helicopter was lying on the seabed of the Neustädter Bucht on its main rotor hub, tilted right toward the left fuselage side. The tail boom had been severed and was found next to the fuselage beneath the skid cross beam opposite to the fuselage direction with the horizontal stabiliser horizontally on the ground and the tail skid pointing upward. One of the main rotor blades jutted out and pressed down on the tail boom prior to the vertical fin with its trailing edge. In this area the trim edge of the rotor blade was damaged. The right cabin door, the safety belts on the seats front right and rear right were open. On the left front seat one of the two transport wheels for the helicopter was fastened with the seat belt.

Fuselage lying on its side with open cabin door and tail boom

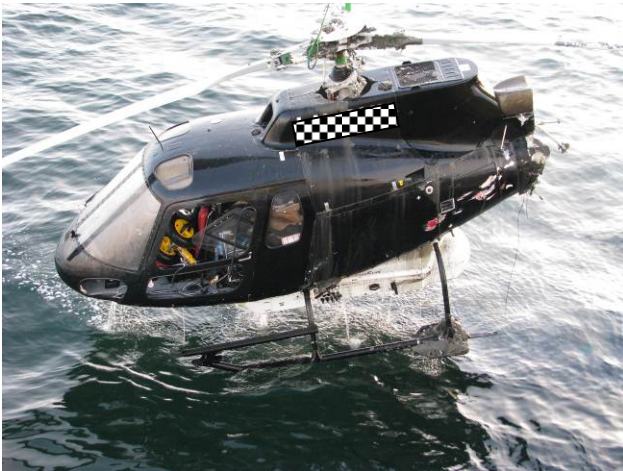
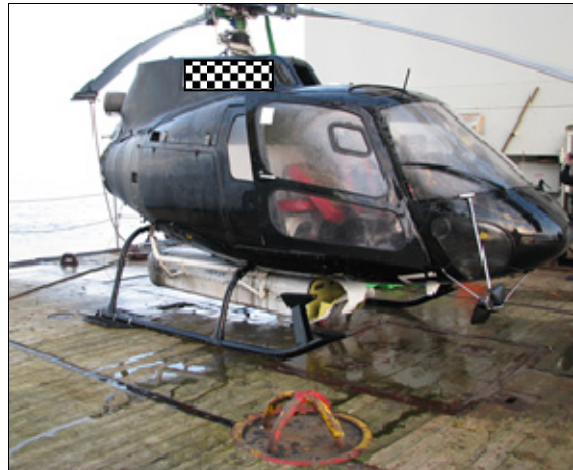
Fuselage and tail boom were recovered individually of each other. After the fuselage had been recovered it was determined that all maintenance compartment doors and fairings were closed and secured. The cabin's front windows and the window panes on the right side and the door were intact. The window panes of the left side were pushed inside the fuselage. The left bottom window pane was missing. The left lower fuselage side and the area of the front skid cross tube were pushed in. The front part of the TopEye™ cargo container was pushed in and torn open.

Fuselage after recovery

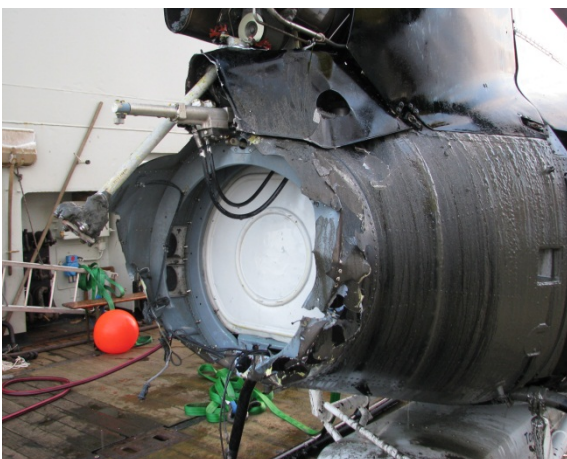
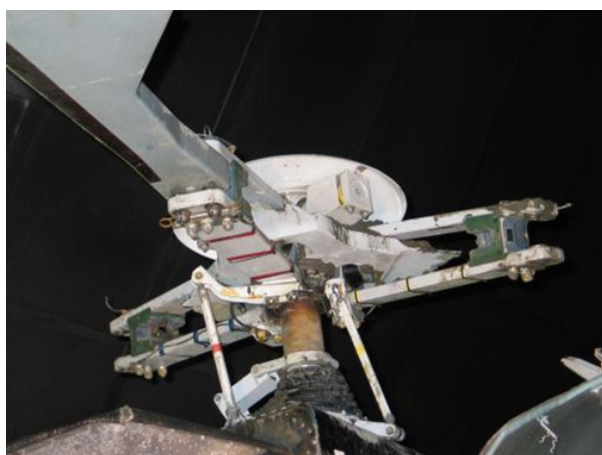
The main gear box, the engine, the control units and the hydraulic system did not show any apparent damages after the mud had been washed off. The fuel control lever was locked in position "flight". Of the three main rotor blades only the "yellow" showed slight damages in the area of the trim edge and the "red" blade had a bent wing tip at the end of the blade. On the rotor head the Star-Flex to all three blade grips was torn off. The power transmission from the turbine to the drive shaft, main gear box and main rotor shaft was connected. The free-wheeling unit opened and locked as designed. The forward tail rotor drive shaft protruded from the aft fuselage section. The sheet metal of the fracture area on the aft fuselage section where the tail boom had been torn off was dented on the underside, the right side was warped and the left stretched.

Damages on the aft fuselage and the Star-Flex

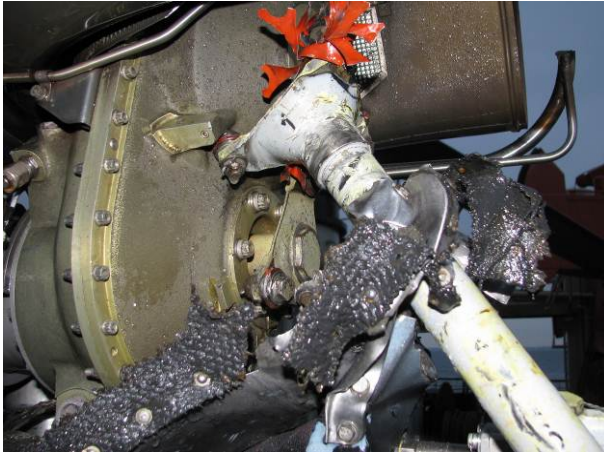
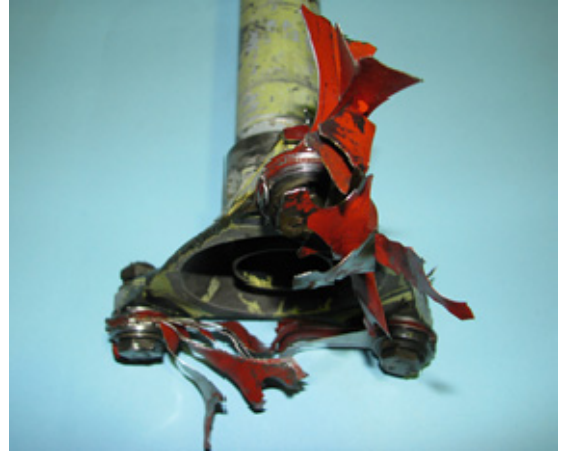
The forward flexible coupling of the tail rotor drive shaft on the engine's backside was torn. The fairing in this area and the two half shells surrounding the beginning of the drive shaft showed rotation tracks, were torn out of their mountings and damaged.

Damages on the forward coupling of the tail rotor drive shaft

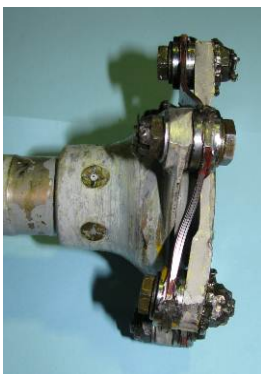
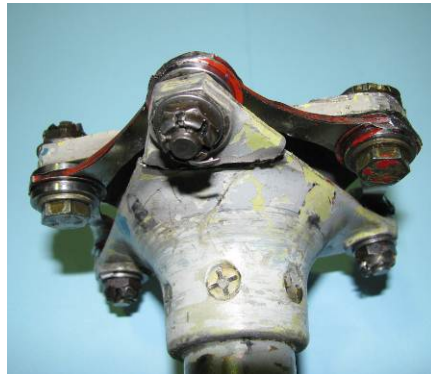
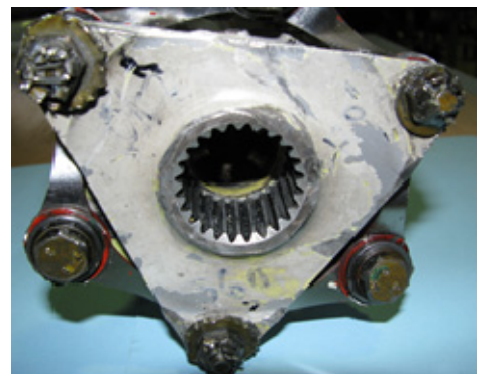
On the rear end of the tail rotor drive shaft the flexible coupling was pushed in, the flanks of the flanges were bent and one flange was torn off. On the outer side of the splined flange rotation tracks were found. The securing nuts were deformed and the washers were partially jaggedly pushed in.

Damages on the rear coupling

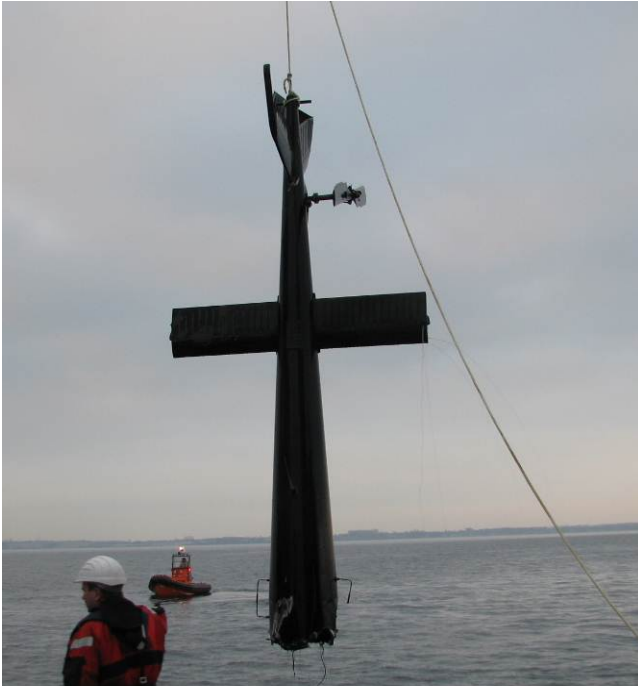
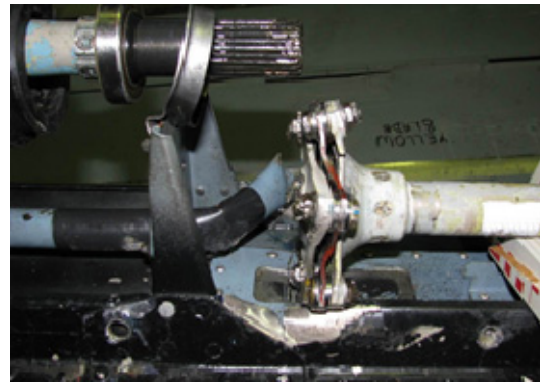
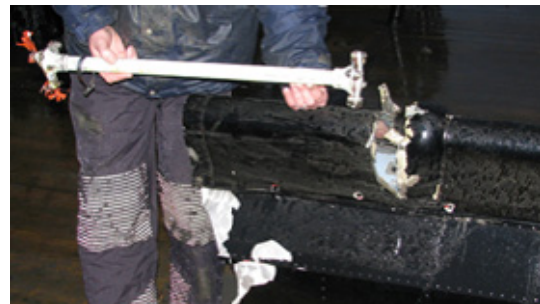
After the tail boom was recovered it was determined that the tail rotor was undamaged. Soot and combustion residue had not been washed off the tail rotor. One of the two pitch links was slightly bent. Except for the most forward tail rotor drive shaft fairing all segments of the fairing were intact. The rear tail rotor drive shaft could be turned soundlessly and without resistance. The tail rotor gear box transmitted the rotation and the tail rotor turned. The chip detector of the tail rotor gear box was free of chips. The tail rotor gear box was filled with water. The foremost segment of the tail rotor shaft fairing was milled from the inside out in the area of the

flexible coupling. The foremost three quick release fastener on the left side were torn out. The inside of the fairing showed straight scratch marks stretching from the milling groove to the forward fairing opening.

Damages on the forward tail rotor drive shaft fairing and coupling
