Interim Report

Type of Occurrence:	Accident
Date:	5 March 2013
Location:	Chicago, USA
Aircraft:	Transport aircraft
Manufacturer / Model:	Airbus / A330-300
Injuries to Persons:	None
Damage:	Aircraft severely damaged
Other Damage:	None
Information Source:	Investigation by BFU
State File Number:	BFU 2X001-13
Published:	May 2013

As the aircraft was rotating during take-off for a flight from Chicago, USA, to Munich, Germany, the aft fuselage section touched the ground. The National Transportation Safety Board (NTSB) has delegated the investigation into the occurrence to the BFU.

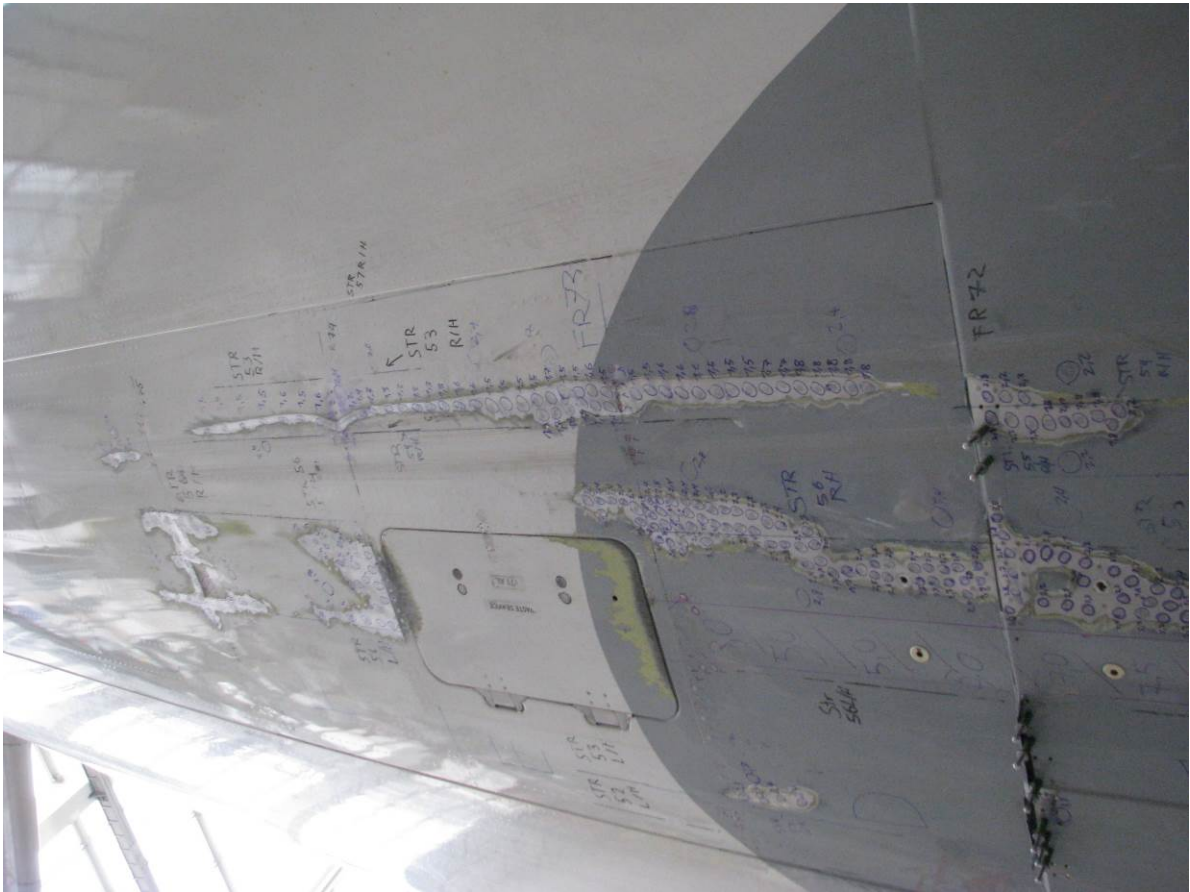
The outer damages on the airplane were found on the lower surface of the tail section. Affected were frames 69 to 76 with a length of about 4.5 m. Laterally the damage affected stringer 53 left up to stringer 53 right. The stringer at the lowest part of the fuselage is stringer 57. The area showed rub marks, scratches, paint abrasion and dents (Appendix). Several rivet heads were either partially or entirely abraded.

Damages on the lower surface of the tail section (flight direction right)

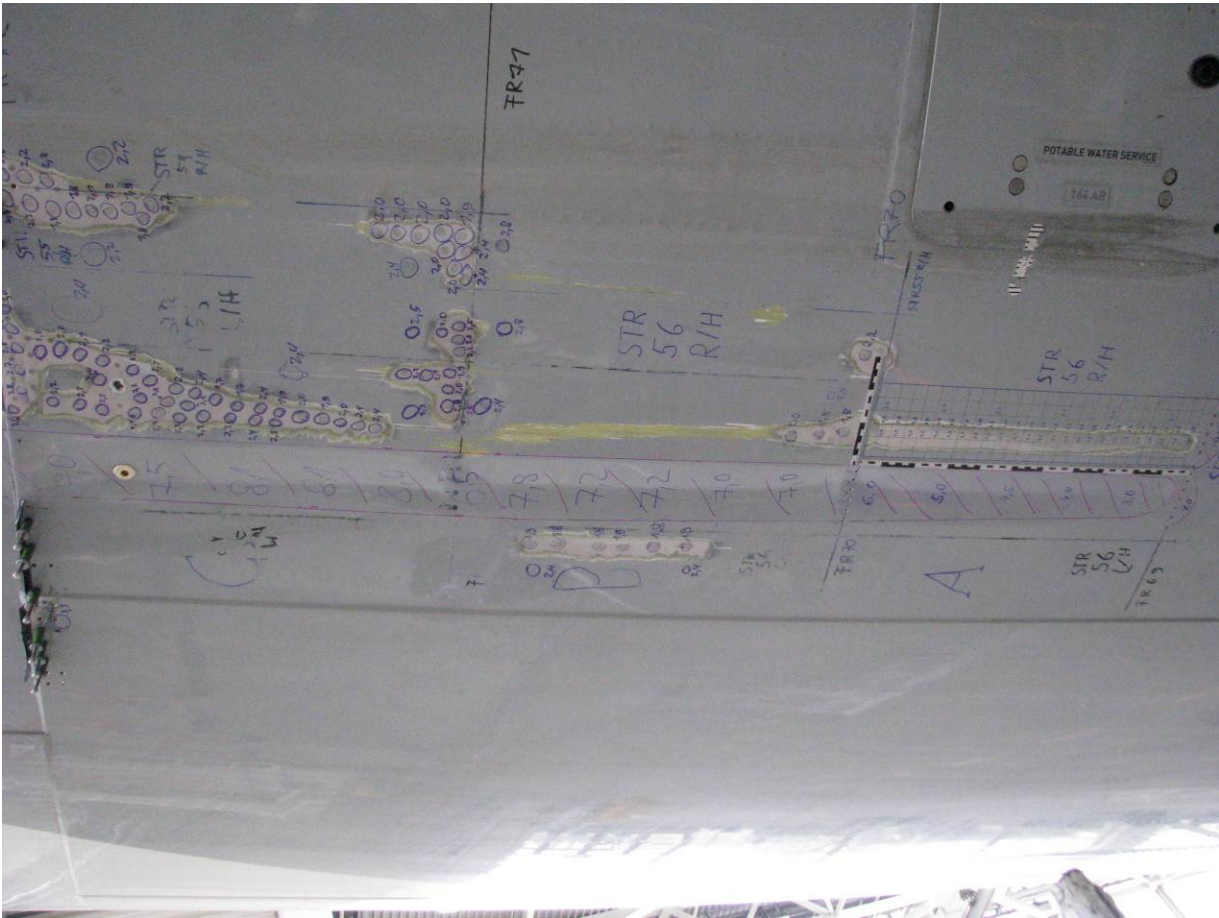
Damages on the lower surface of the tail section (flight direction right)

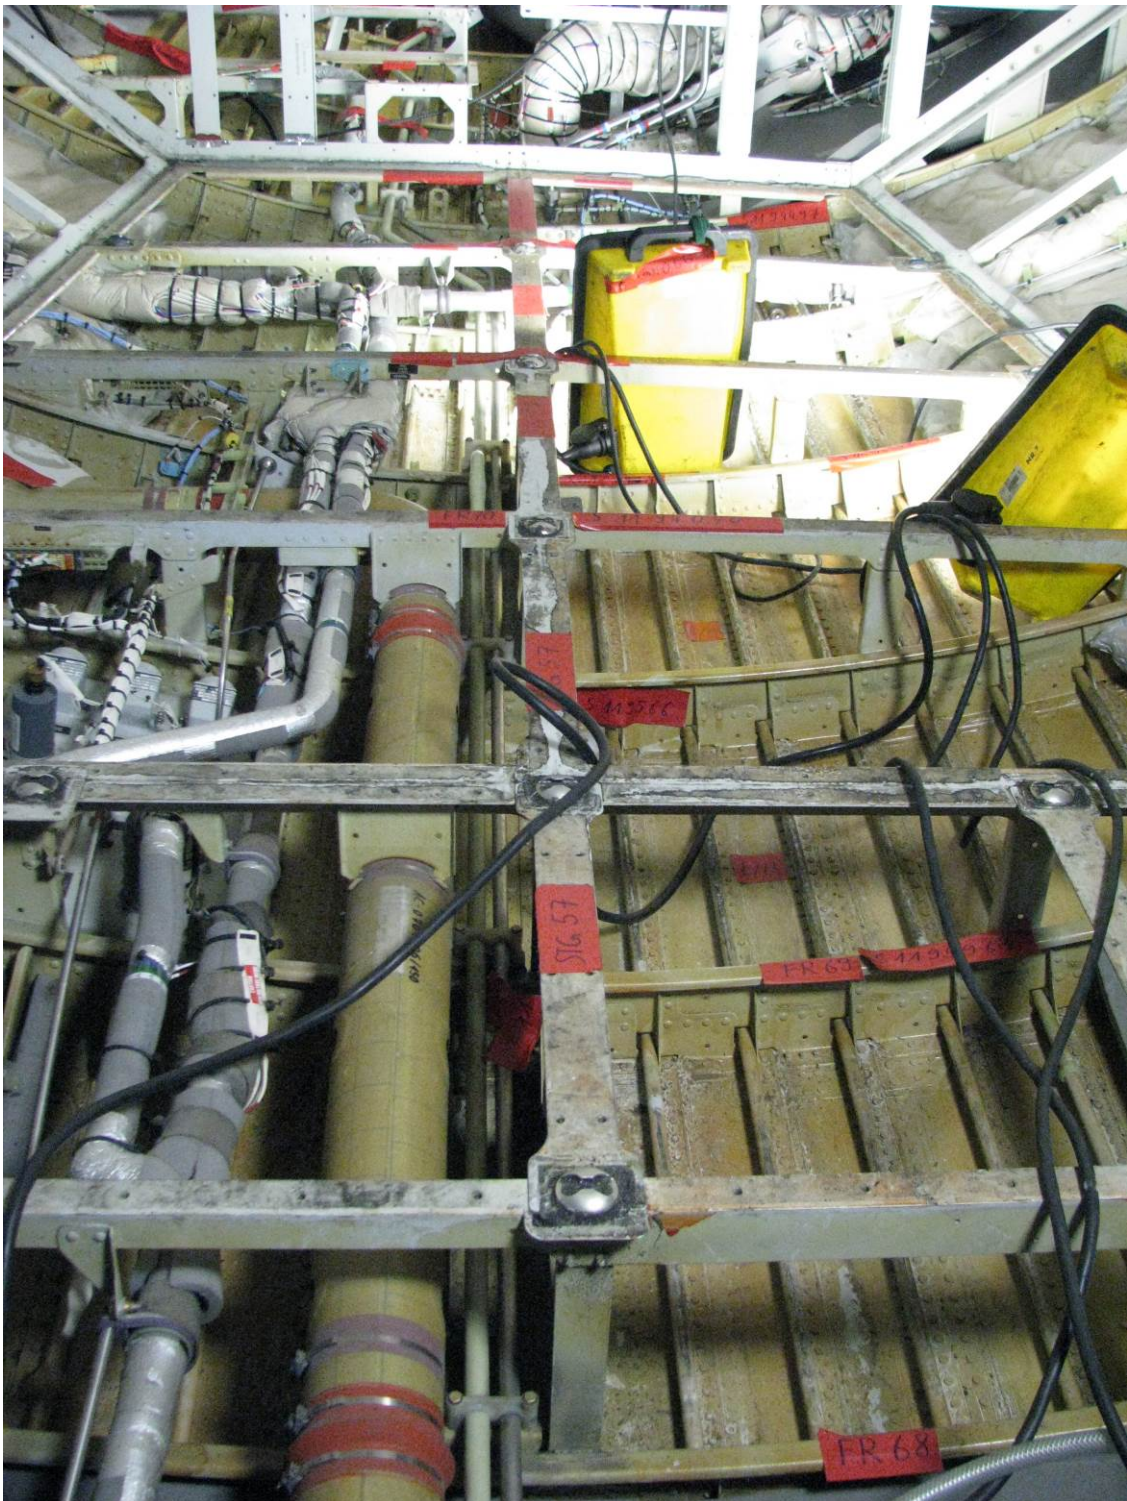
On the inside of the fuselage the web plates of stringer 57 between frames 69 and 73 were deformed (Appendix). The cross beams of frames 70 to 73, onto which the floor of the aft cargo compartment was mounted, were also deformed.

Damaged area inside the fuselage, in the foreground frame 68 (FR 68), in the middle stringer 57

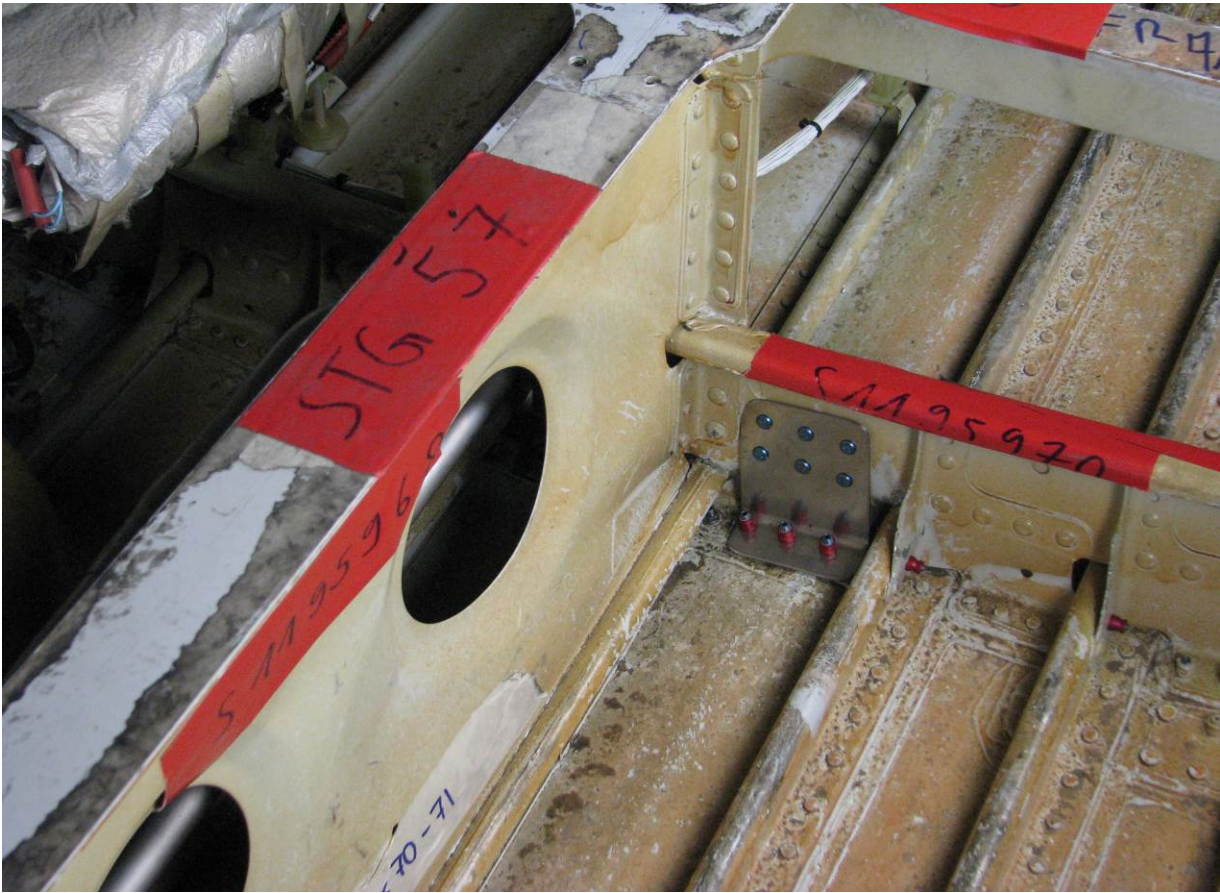
Deformed web plate of stringer 57 between frames 70/71, temporary connecting element right of stringer 57 Photo: BFU^
