Interim Report

Type of Occurrence:	Accident
Date:	10 August 2013
Location:	Bienenfarm
Aircraft:	Airplane
Manufacturer / Model:	PZL-MIELEC / Antonov AN-2
Injuries to Persons:	Five persons suffered minor injuries
Damage:	Aircraft severely damaged
Other Damage:	Minor crop damage
Information Source:	Investigation by BFU
State File Number:	BFU 3X102-13
Published:	November 2013

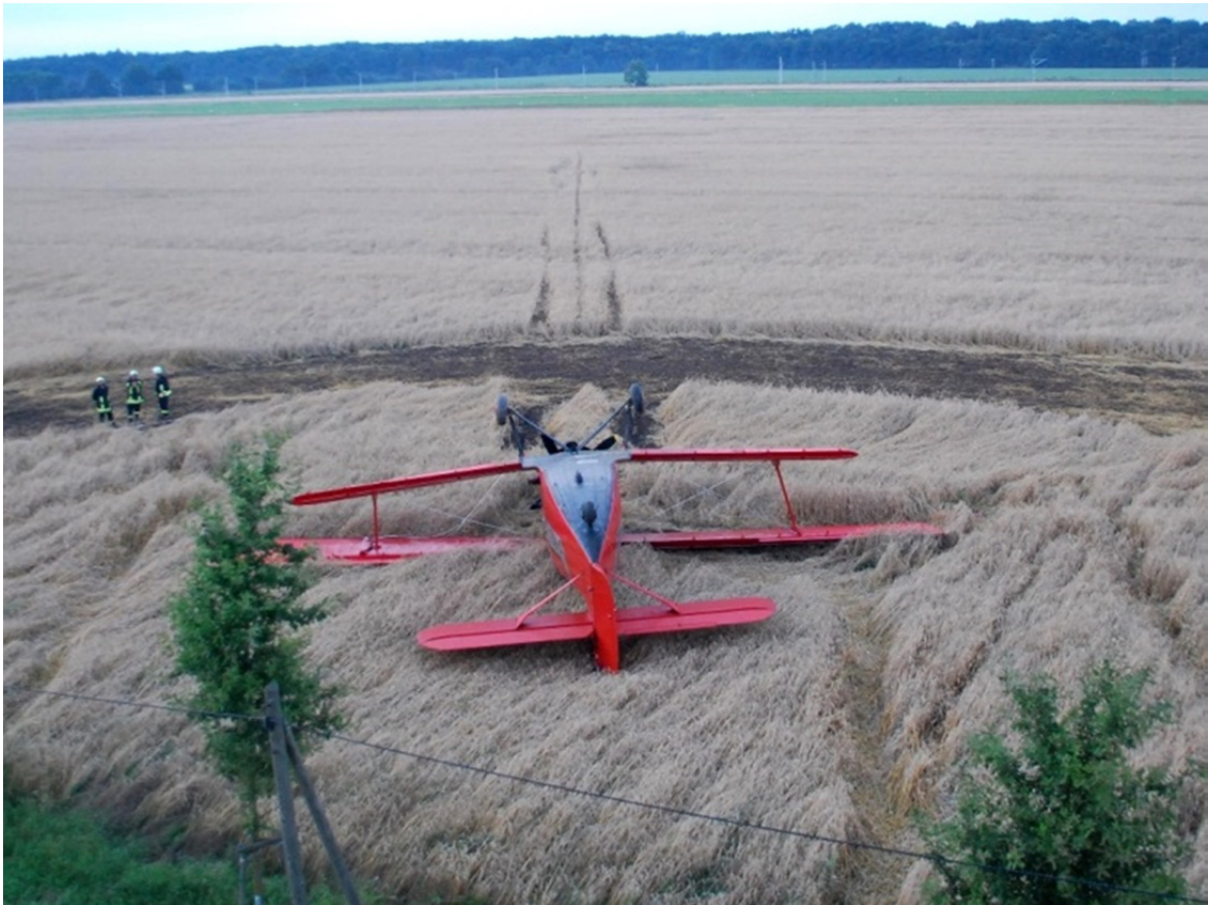
The aircraft was lying upside down in a grain field. The aircraft's longitudinal axis pointed towards 010°.

Accident site

Viewed from the airplane, tyre tracks were visible in the grain field which were 130 m long and pointing in about 010°. They matched the tail wheel and the main landing gear wheels.

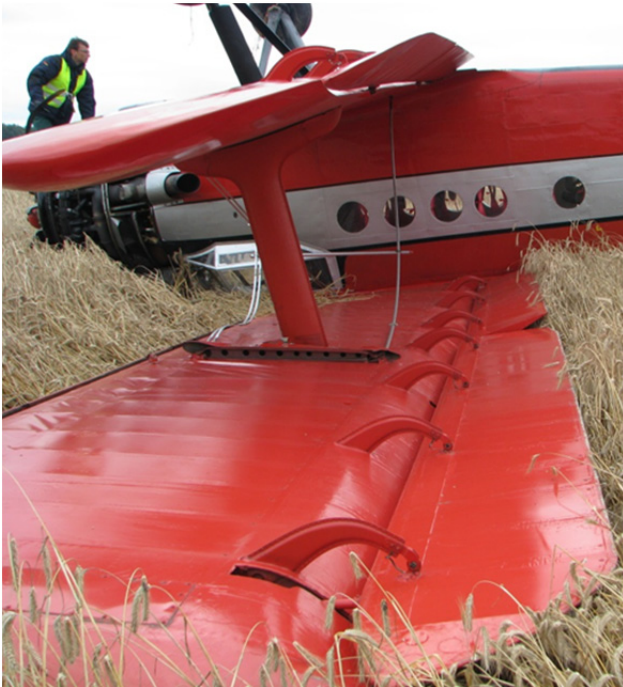
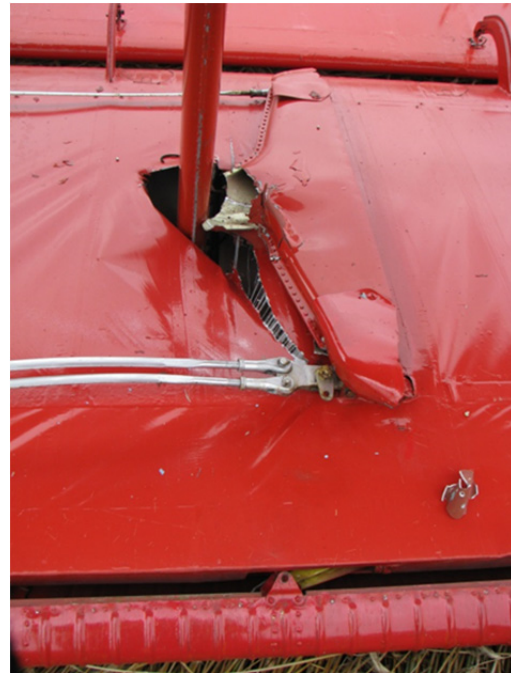
The upper part of the vertical tail was heavily deformed. The upper mounting of the right wing strut was damaged and the strut had perforated the upper wing.

Damages on the wing structure and position of the flaps

The flaps of the upper and lower wings were deflected by approximately 10°.

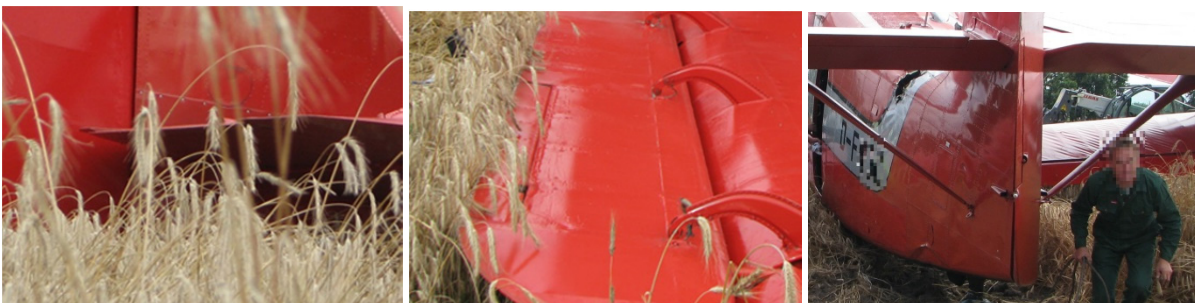
The trim tab of the elevator was deflected by approximately 5° in the nose-down direction.

The trim tab on the left upper aileron was in alignment with the aileron profile.

The trim tab of the rudder was in alignment with the rudder profile.

Positions of the trim tabs

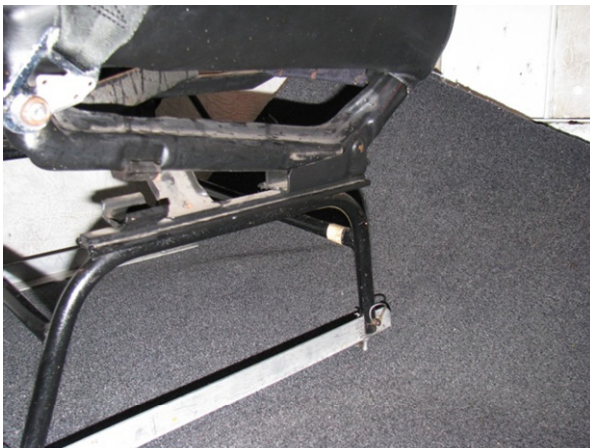
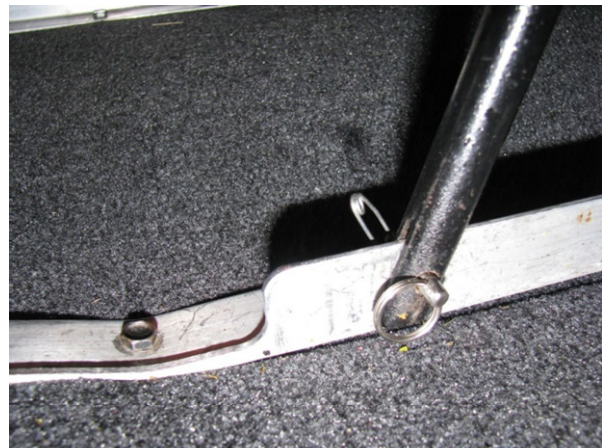
Each of the foremost mountings of the seat tracks of the left seats were torn from the fuselage structure and the seat tracks were bent upward.

Damages on the mounting of the first left seat

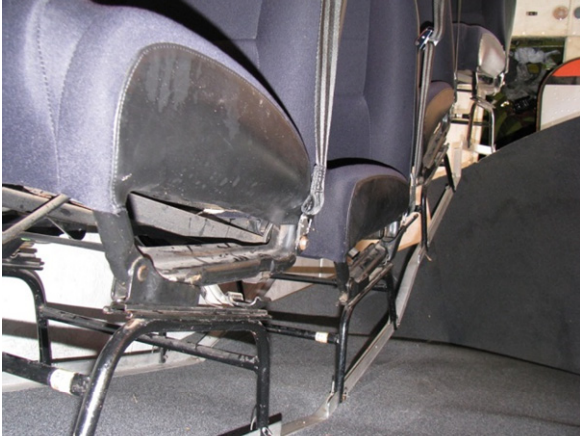
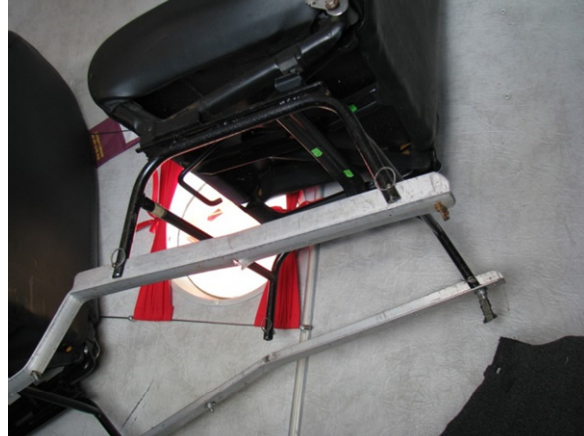
In the area of the aft three rows, the seat tracks of the right seats were torn from the fuselage structure and the seat tracks were bent upward. The front left mounting of the seat in the fifth row had been torn from the seat track.

Damages of the mountings of the third, fourth and fifth right seats
