Interim Report

| Date: | 15 February 2013 |
| Manufacturer / Model: | Embraer / EMB-500 |
| State File Number: | BFU CX001-13 |

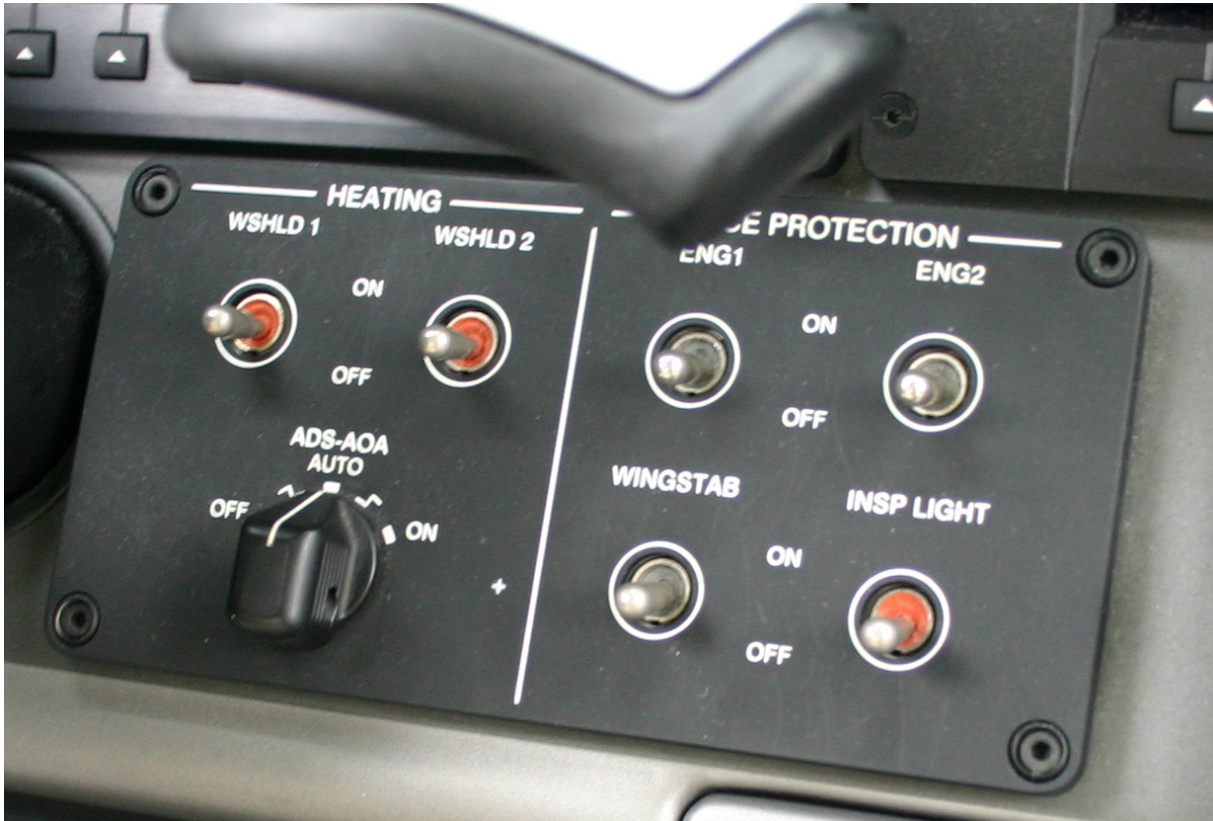
Panel of the ice and rain protection system

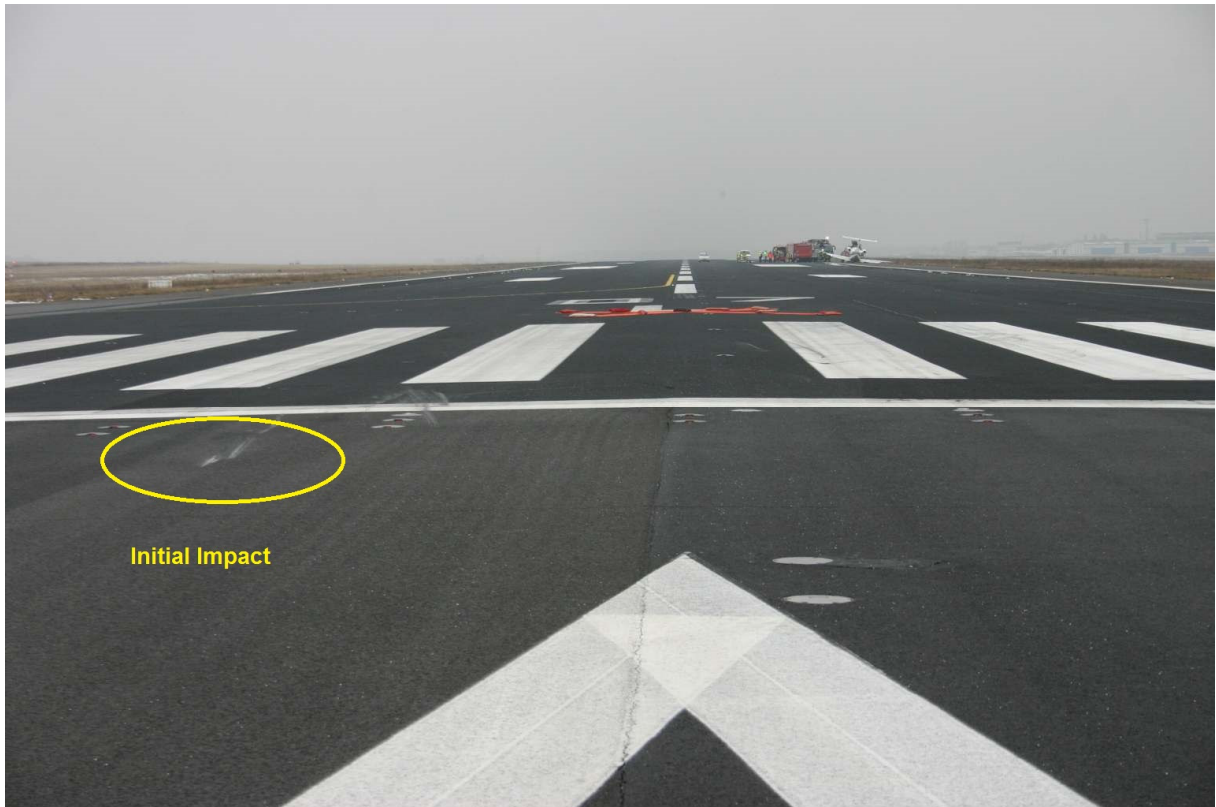
The airplane had initial ground contact with the left wing tip about 4 m left of the runway centre line of runway 07L and about 7 m prior to the displaced threshold which is marked with a white bar. About 4 m behind the threshold, rubber deposit from the nose landing gear was found. Further 6 m, along rubber deposit of the right main landing gear was found.

Initial ground contact

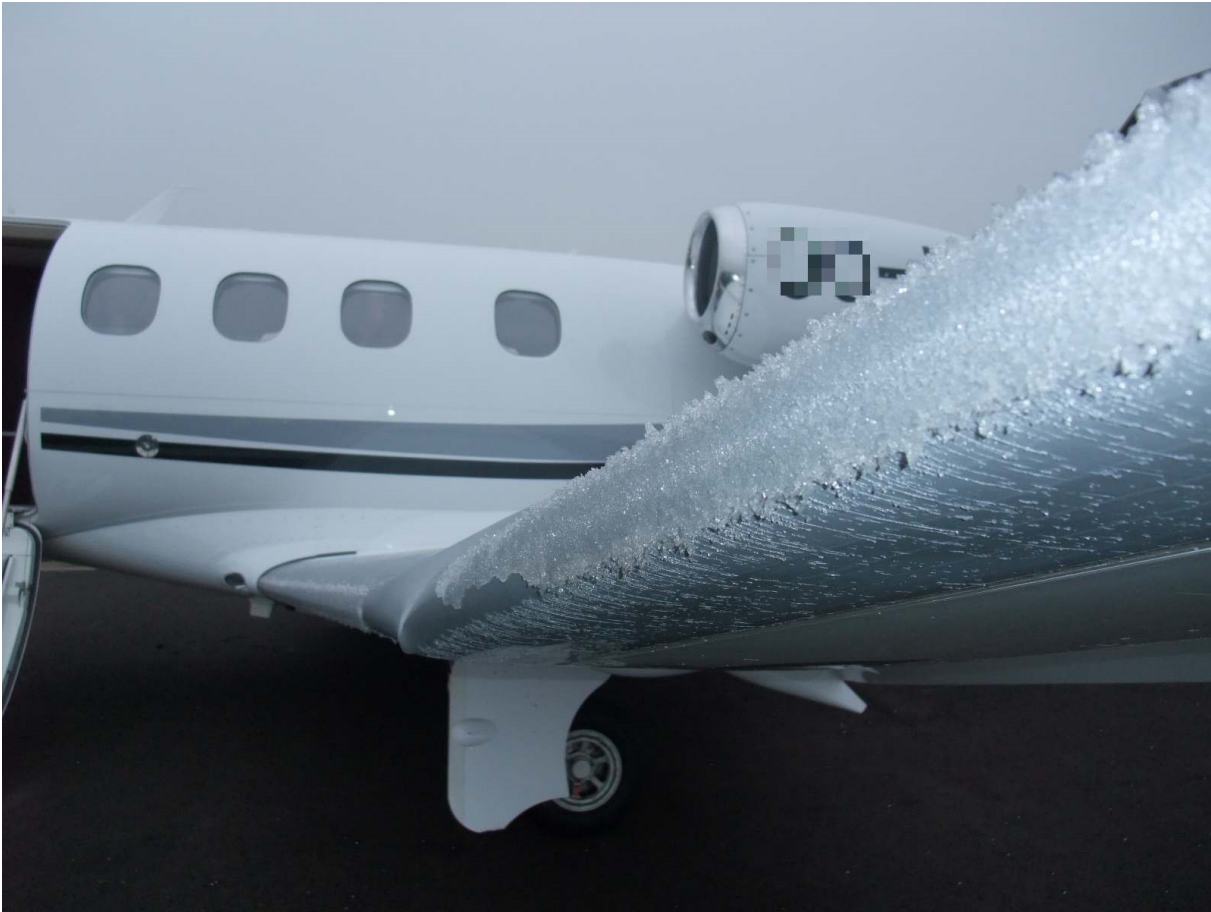
It was determined that the airplane carried ice of a thickness of up to 10 mm on the nose, the wing leading edges and the horizontal stabilizer.

Ice accretion on the left wing leading edge
