# Interim Report

| Type of Occurrence: | Serious incident |
| Location: | Berlin-Tegel Airport |
| Manufacturer / Model: | Dassault Aviation / Falcon 7X |

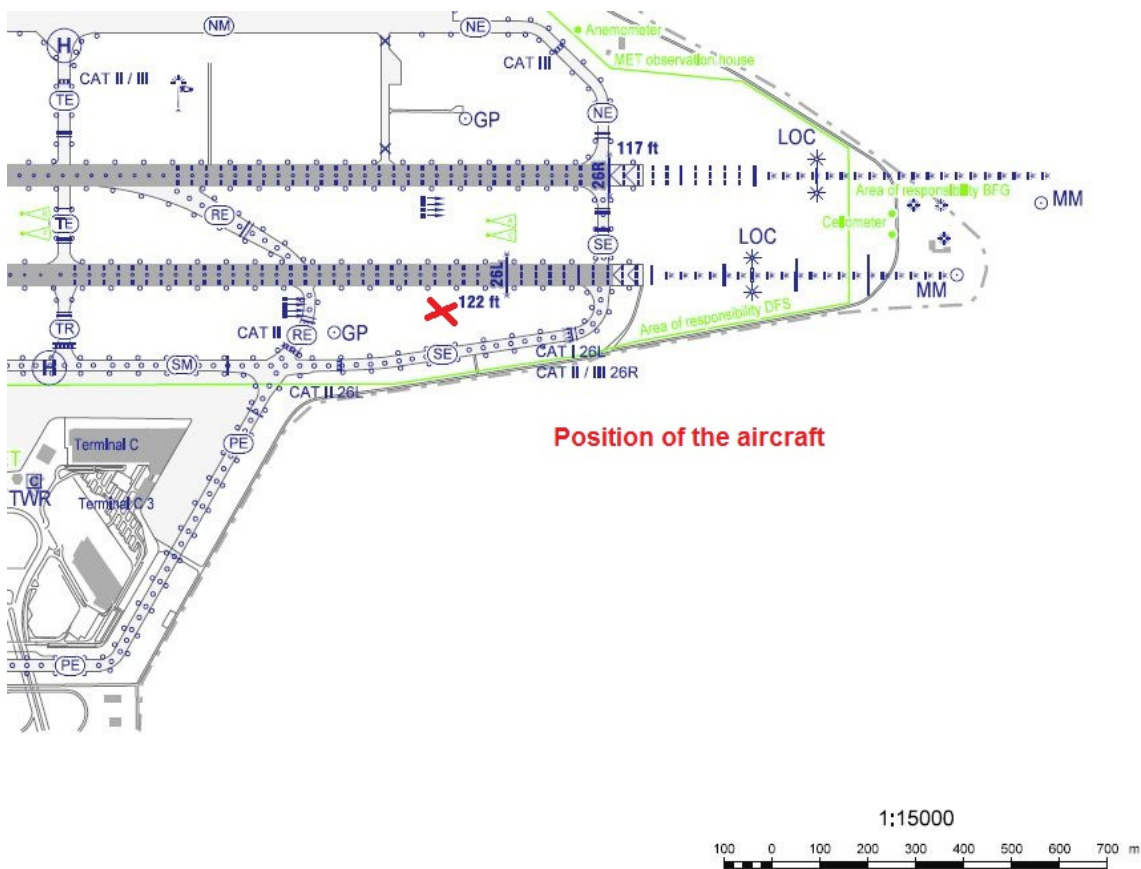
The airplane came to rest left of the runway in the grass.

Position of the airplane

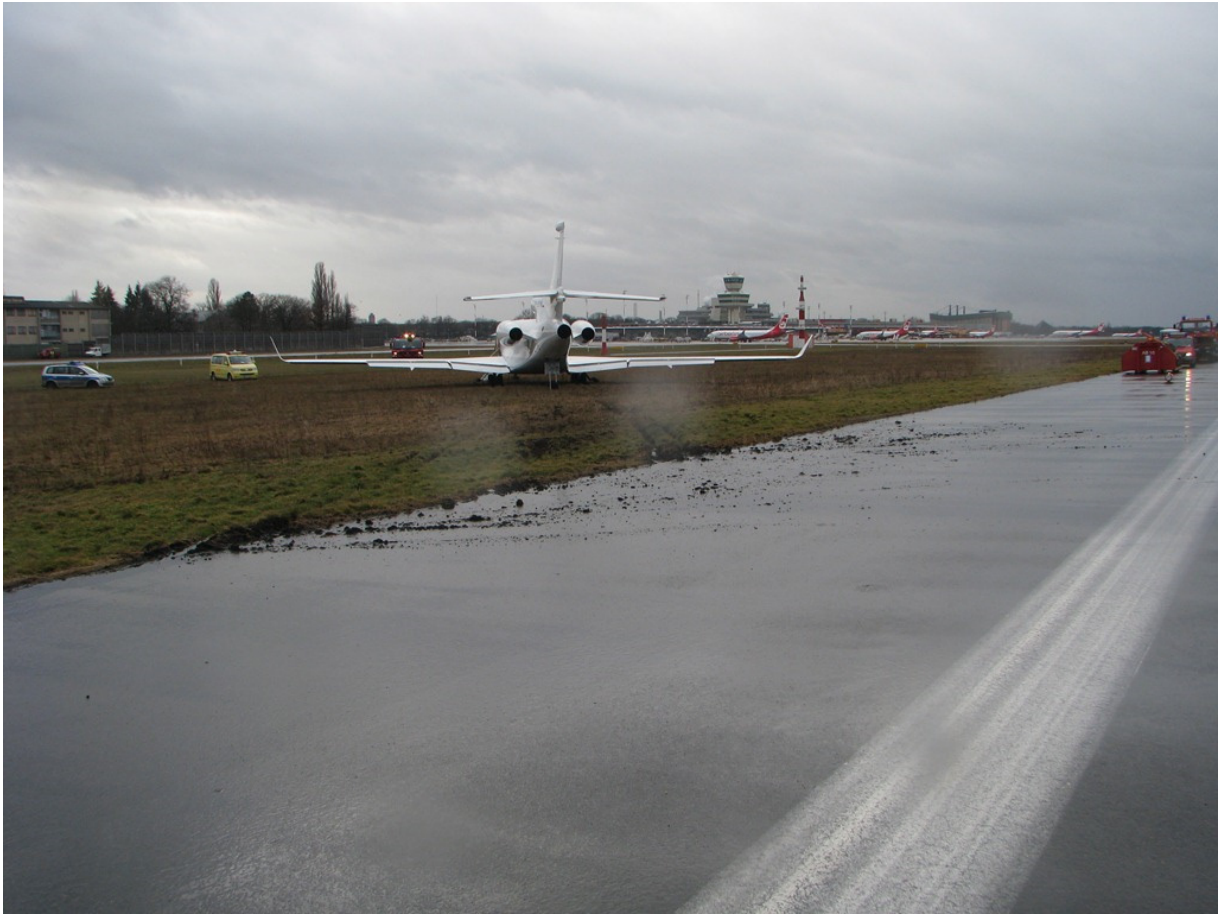
The airplane had come to a complete stop on a grassy, flat area about 140 m from the threshold and about 70 m south of the centre line of runway 26L. The nose was pointing into the direction of 218°. The right tire of the nose landing gear was damaged. Aileron and rudder were in neutral positions. The horizontal stabiliser was deflected down. Flaps and spoilers were extended.

Final position of the airplane south of runway 26L

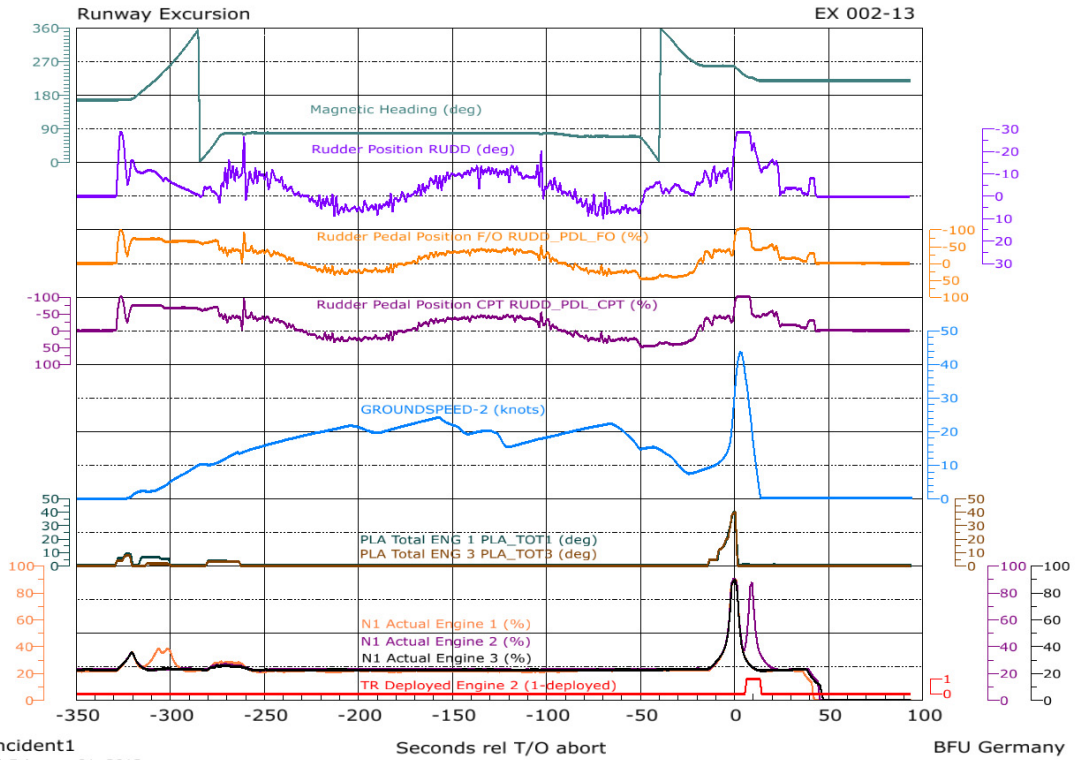
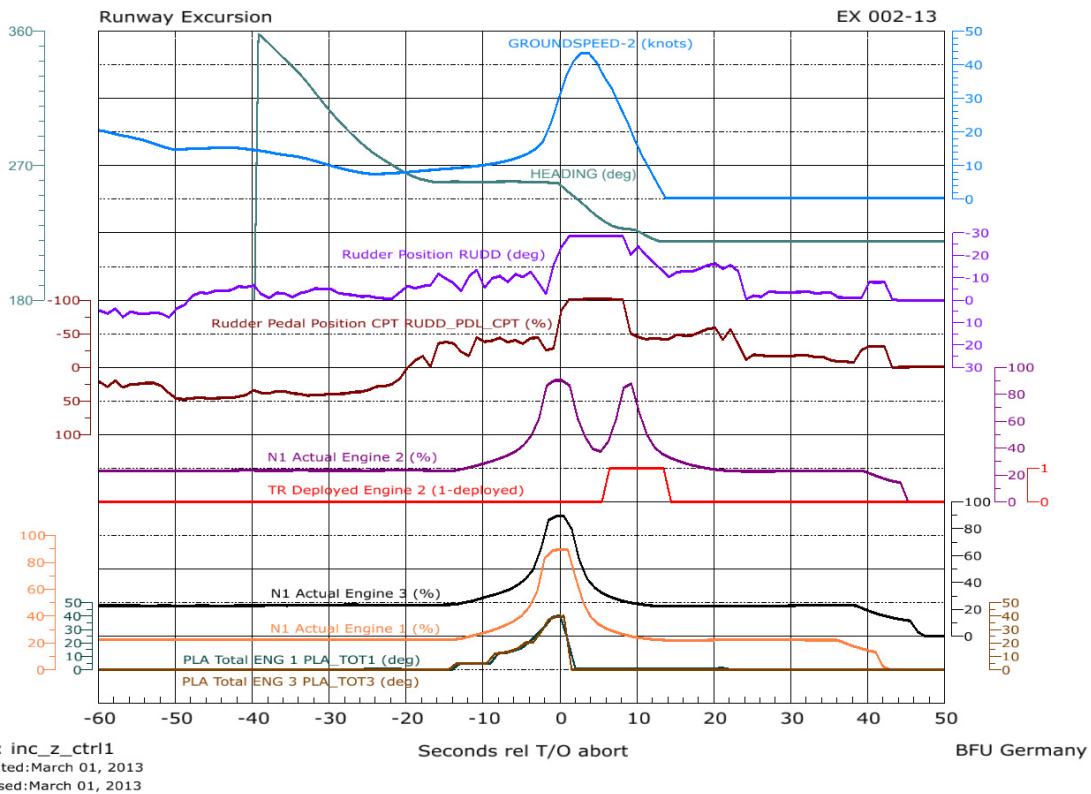
DFDR excerpts

The DFDR data shows that the airplane taxied with about 10 kt in take-off direction as engine speed N1 changed from about 25% to about 90% within 10 seconds. During this time the speed increased to 30 kt whereas the heading remained by constant 260°. The rudder deflection to the right increased and reached full deflection. The heading decreased in the following 7 seconds to approximately 220°. Engine speed N1 of the three engines decreased to about 30% and N1 of engine 2 increased as the thrust reverser was activated.
