# Interim Report

Type of Occurrence:	Accident
Date:	12 January 2014
Location:	Near Trier-Föhren
Aircraft:	Airplane
Manufacturer / Model:	Cessna / 501 Citation I /SP
Injuries to Persons:	Two pilots and two passengers fatally injured
Damage:	Aircraft destroyed
Other Damage:	Open wire, forest and crop damages
Information Source:	Investigation by BFU
State File Number:	BFU CX001-14
Published:	April 2014

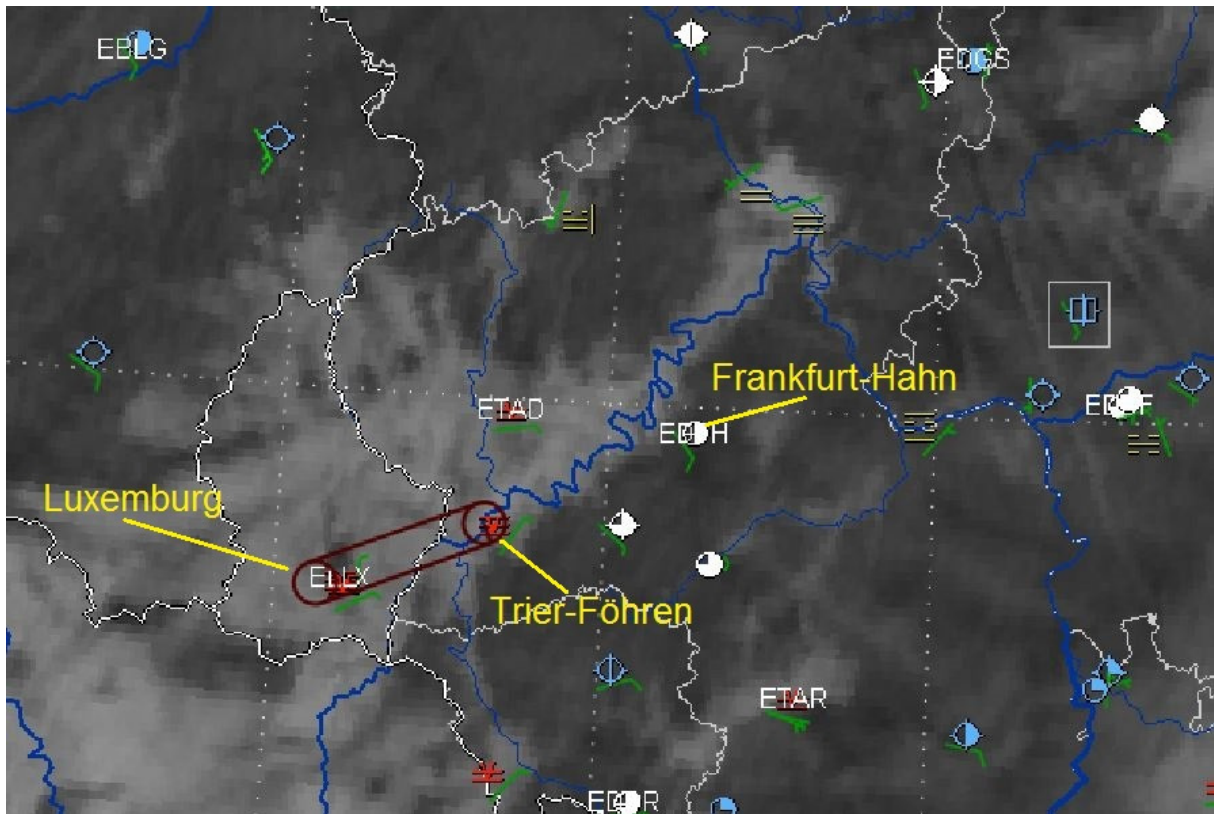
Satellite image of 1100 UTC

The area Trier - Luxembourg is marked on the satellite image. It shows a complete fog or high fog layer (white colour) in the entire area of the Mosel valley. The weather report of Trier of 1100 UTC shows freezing fog, the sky is not visible and visibility is below 100 m. The weather station Trier is located a few meters higher than Trier Airfield.

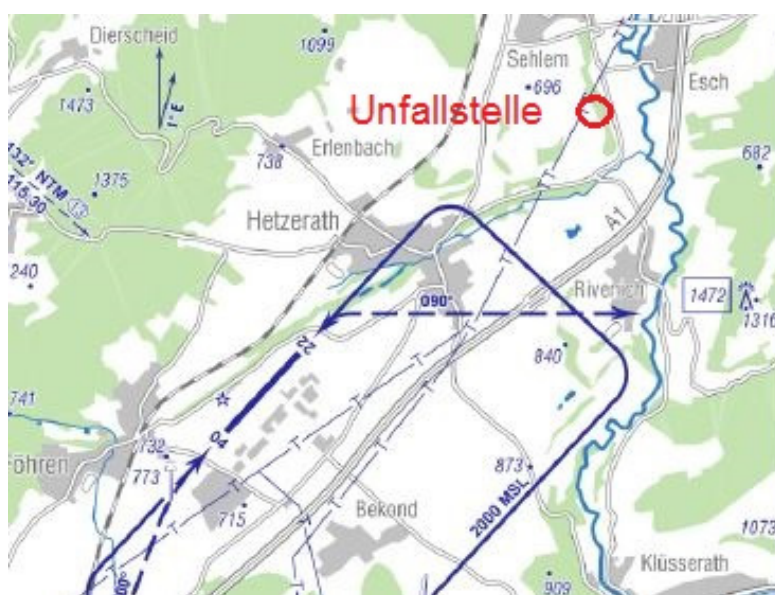
Accident site

The accident site was located about 2.5 NM from the threshold of runway 22 of Trier-Föhren Airfield.

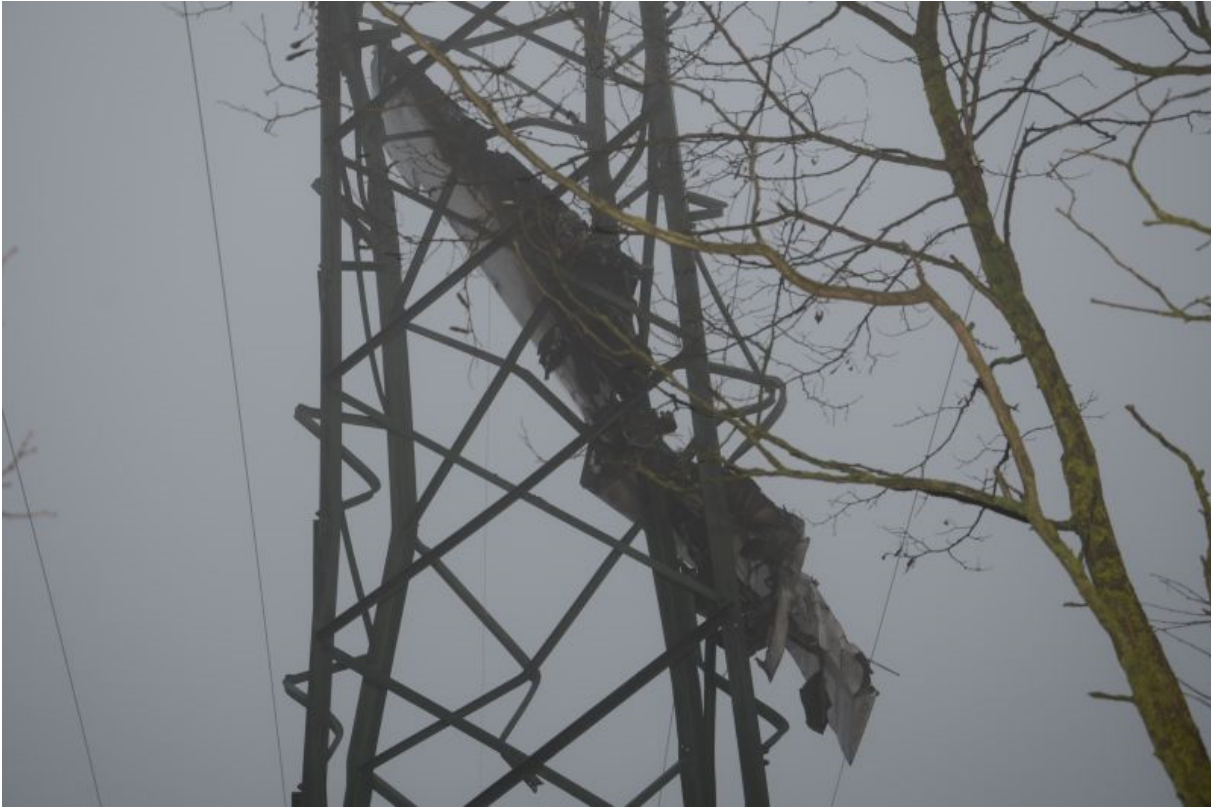
View toward the approach direction

Approximately 10 m below the plateau on the forested steep slope the aircraft had contact with tree. The traces in the tree show, that the airplane had had a bank angle to the left of about  $25^\circ$ .

Halfway up, the right wing of the airplane poked out of an approximately 20 m high pylon.

The angle the right wing had had when penetrating the pylon indicated a left bank angle of about 60°. The right wing showed traces of fire. At the foot of the pylon the right main landing gear, one speed brake, and the right elevator were found.

Between the initial contact with the trees below the plateau and the collision with the pylon the trajectory angle was about 20° upwards.

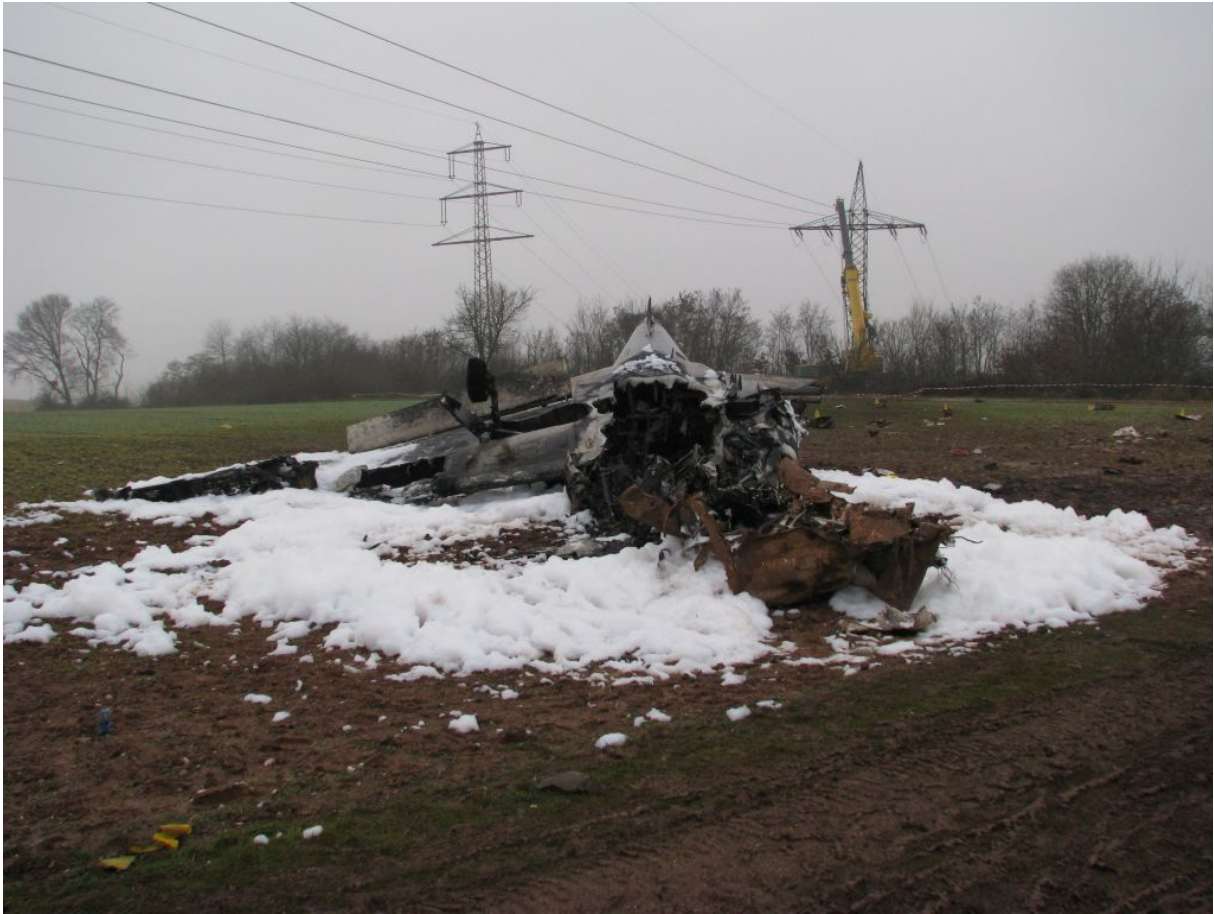
Main wreckage viewed toward the approach direction

The wreckage was laying on its back about 106 m from the pylon. The airplane fuselage pointed in the direction of 187°.

The left main landing gear and the flap were extended.

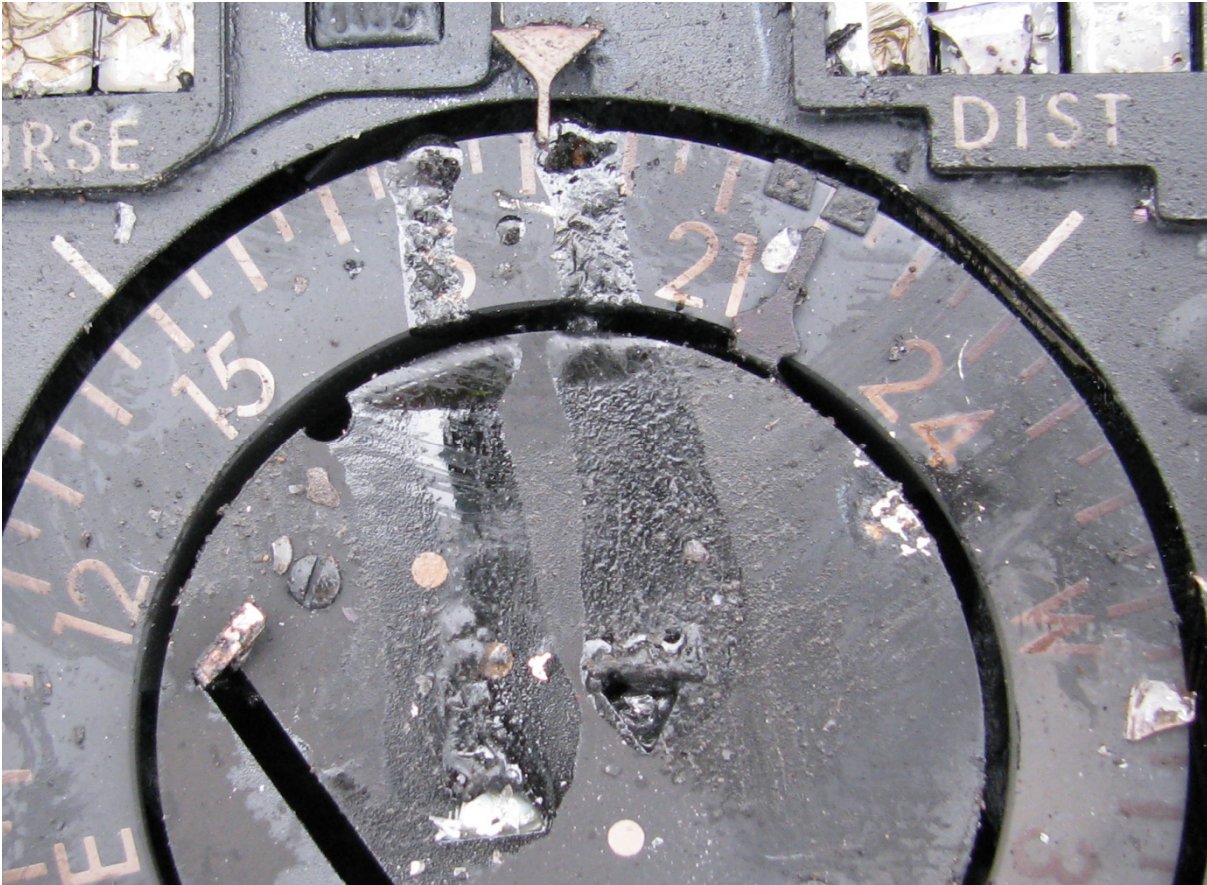
Horizontal Situation Indicator (HSI)

Heading and course of about 220° were selected on the Horizontal Situation Indicator (HSI); the indicated heading was 192°.
