Interim Report

Type of Occurrence:	Accident
Date:	14 December 2017
Location:	Near Waldburg
Aircraft:	Airplane
Manufacturer / Model:	Cessna Aircraft Company / C510
Injuries to Persons:	Three persons fatally injured
Damage:	Aircraft destroyed
Other Damage:	Damage to forests
State File Number:	BFU17-1604-CX
Published:	March 2018

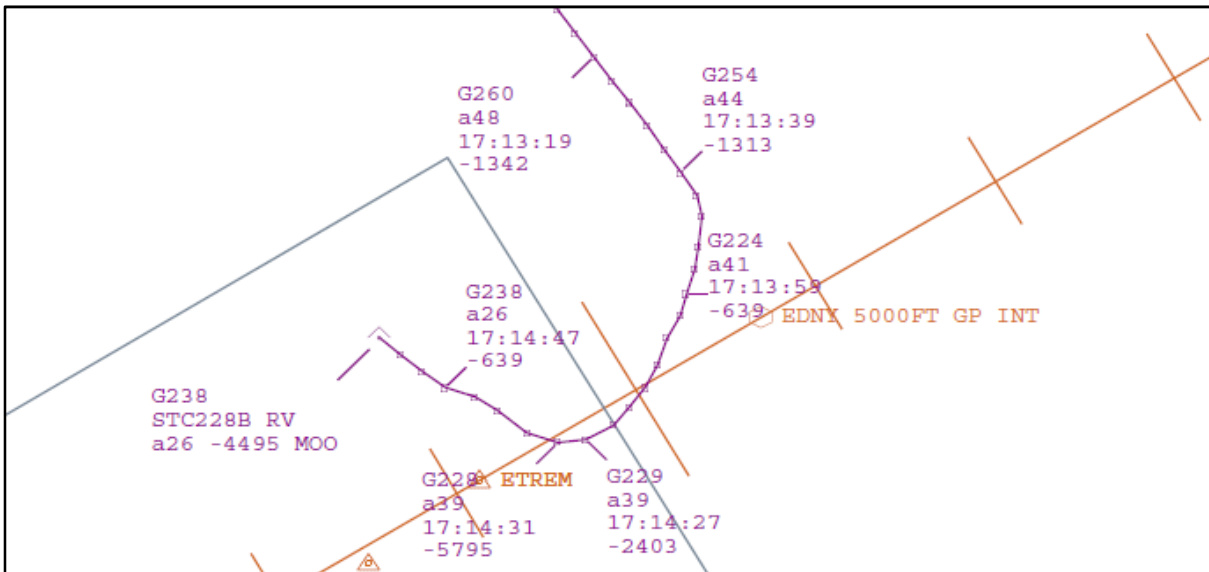
Approach to the extended runway centre line

Then the radar controller noticed that the aircraft, during interception with about 240 KIAS, slightly overshoot the extended runway centre line and entered a high rate of descent. He repeatedly called the aircraft, but the crew did not respond any more.

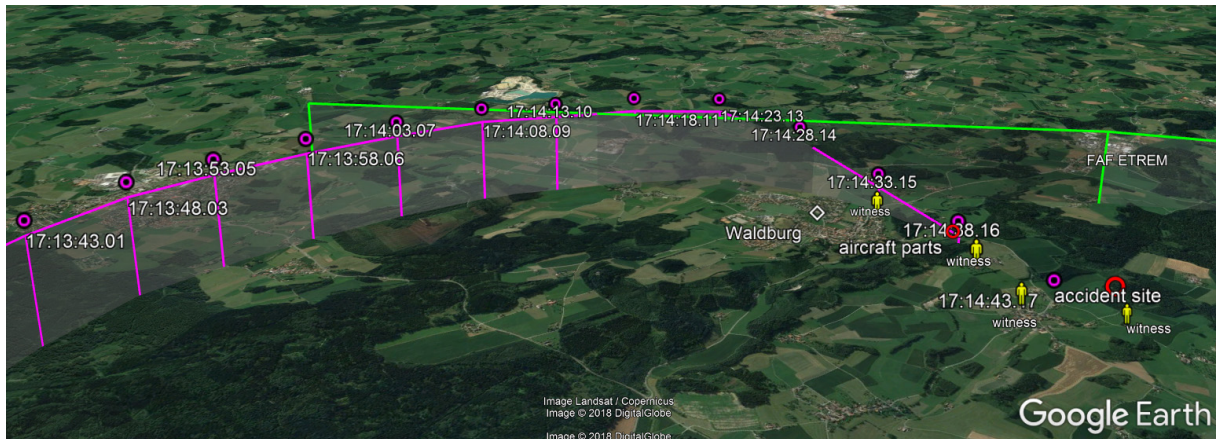
Witnesses near Waldburg saw and heard an airplane in low altitude. One witness heard the accident and saw a short but intense fire in a forest about 1.5 km west of Waldburg. He called the rescue personnel.

At about 1814 hrs the airplane had contact with trees in a forest west of Waldburg. Then it flew with high speed and a flat angle in another forest approximately 1,000 m away. The three occupants suffered fatal injuries and the aircraft was destroyed.

Overview: Witnesses' position, initial contact with trees, accident site

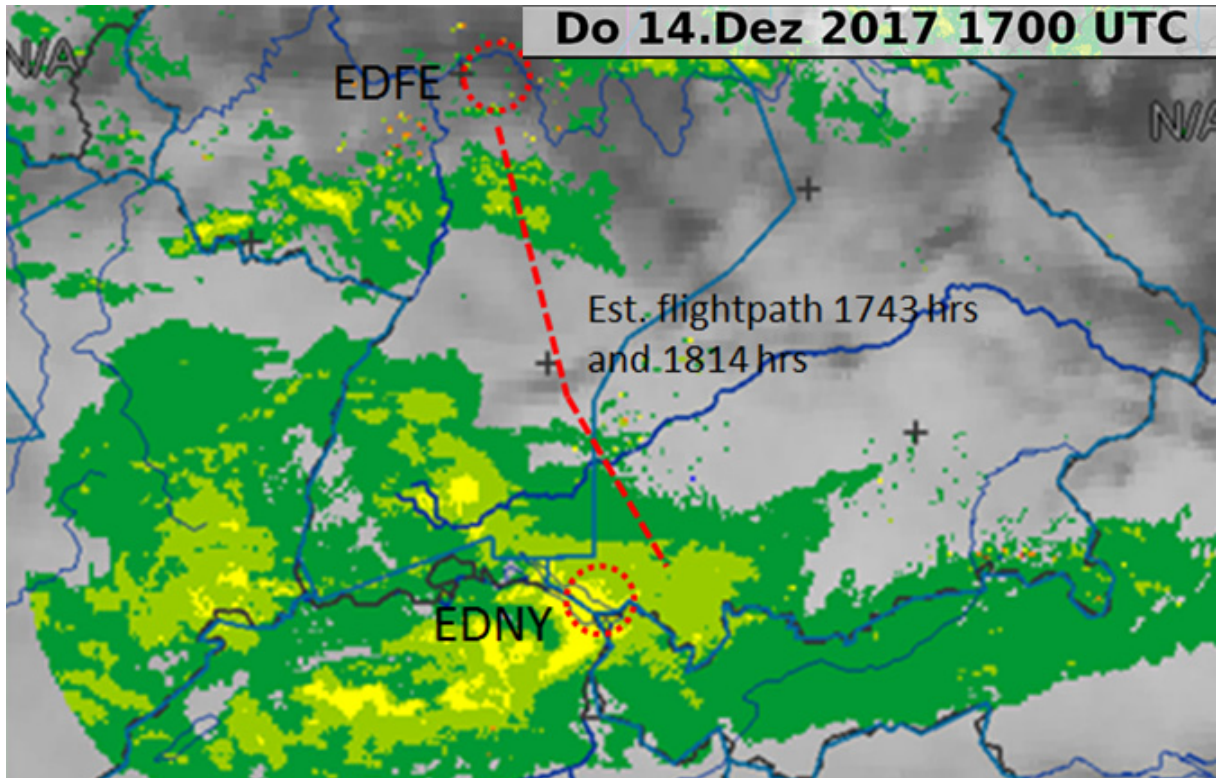
Precipitation radar image including the flight path

In general, icing conditions above the freezing level prevailed at the entire flight path, because mostly there were heavy layered clouds. Without precipitation there were probably only slight icing conditions up to FL140 - 150. Heavier and higher-reaching icing conditions prevailed in the northern part of the flight path due to convective clouds and in the south due to compact layered clouds with the gathering frontal precipitations. There regional moderate and/up to heavy icing conditions between freezing level and maximum FL100 occurred. The accident site was affected too.

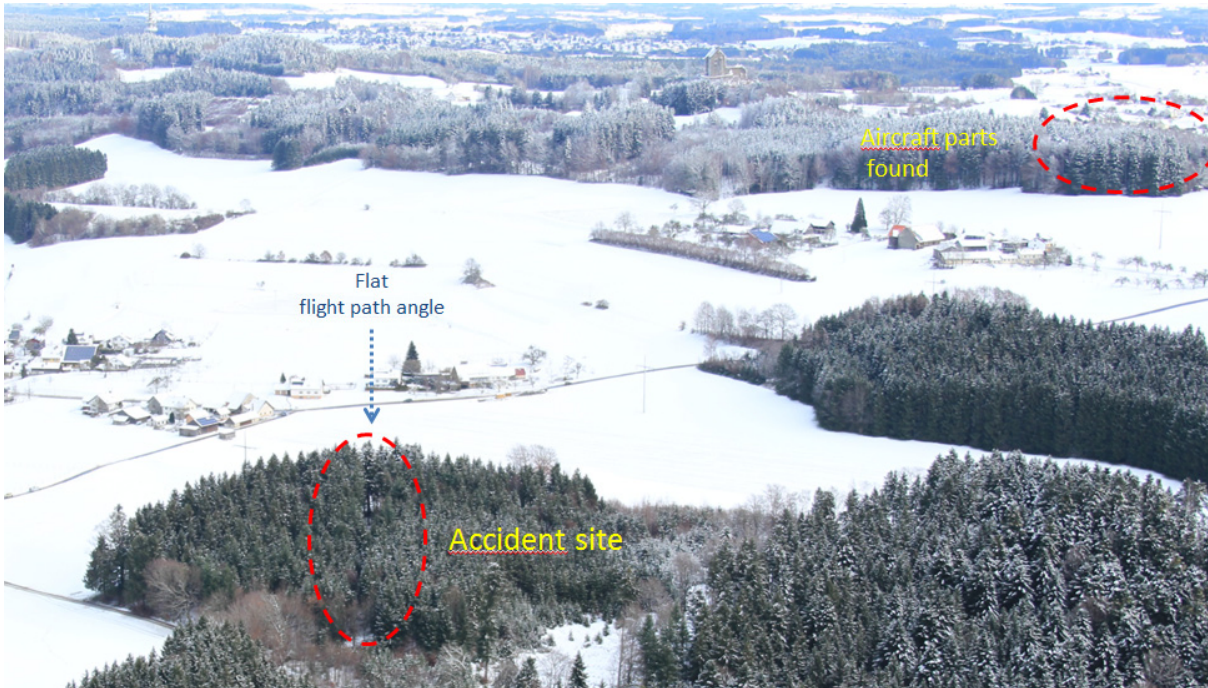
The airplane had contact with trees in the area west of Waldburg, in a forest called Frankenberg. The left wing tip and parts of the rudder were found in this forest.

Then the airplane entered a forest, near Sieberatsreute, approximately 1,000 m away in a flat angle. The airplane caused a crash aisle of about 130 m which had the direction of about 240°. Several trees had been cut off and uprooted along this crash aisle. The terrain in the area of the accident site had an elevation of approximately 2,300 ft AMSL.

Overview initial contact with objects and accident site

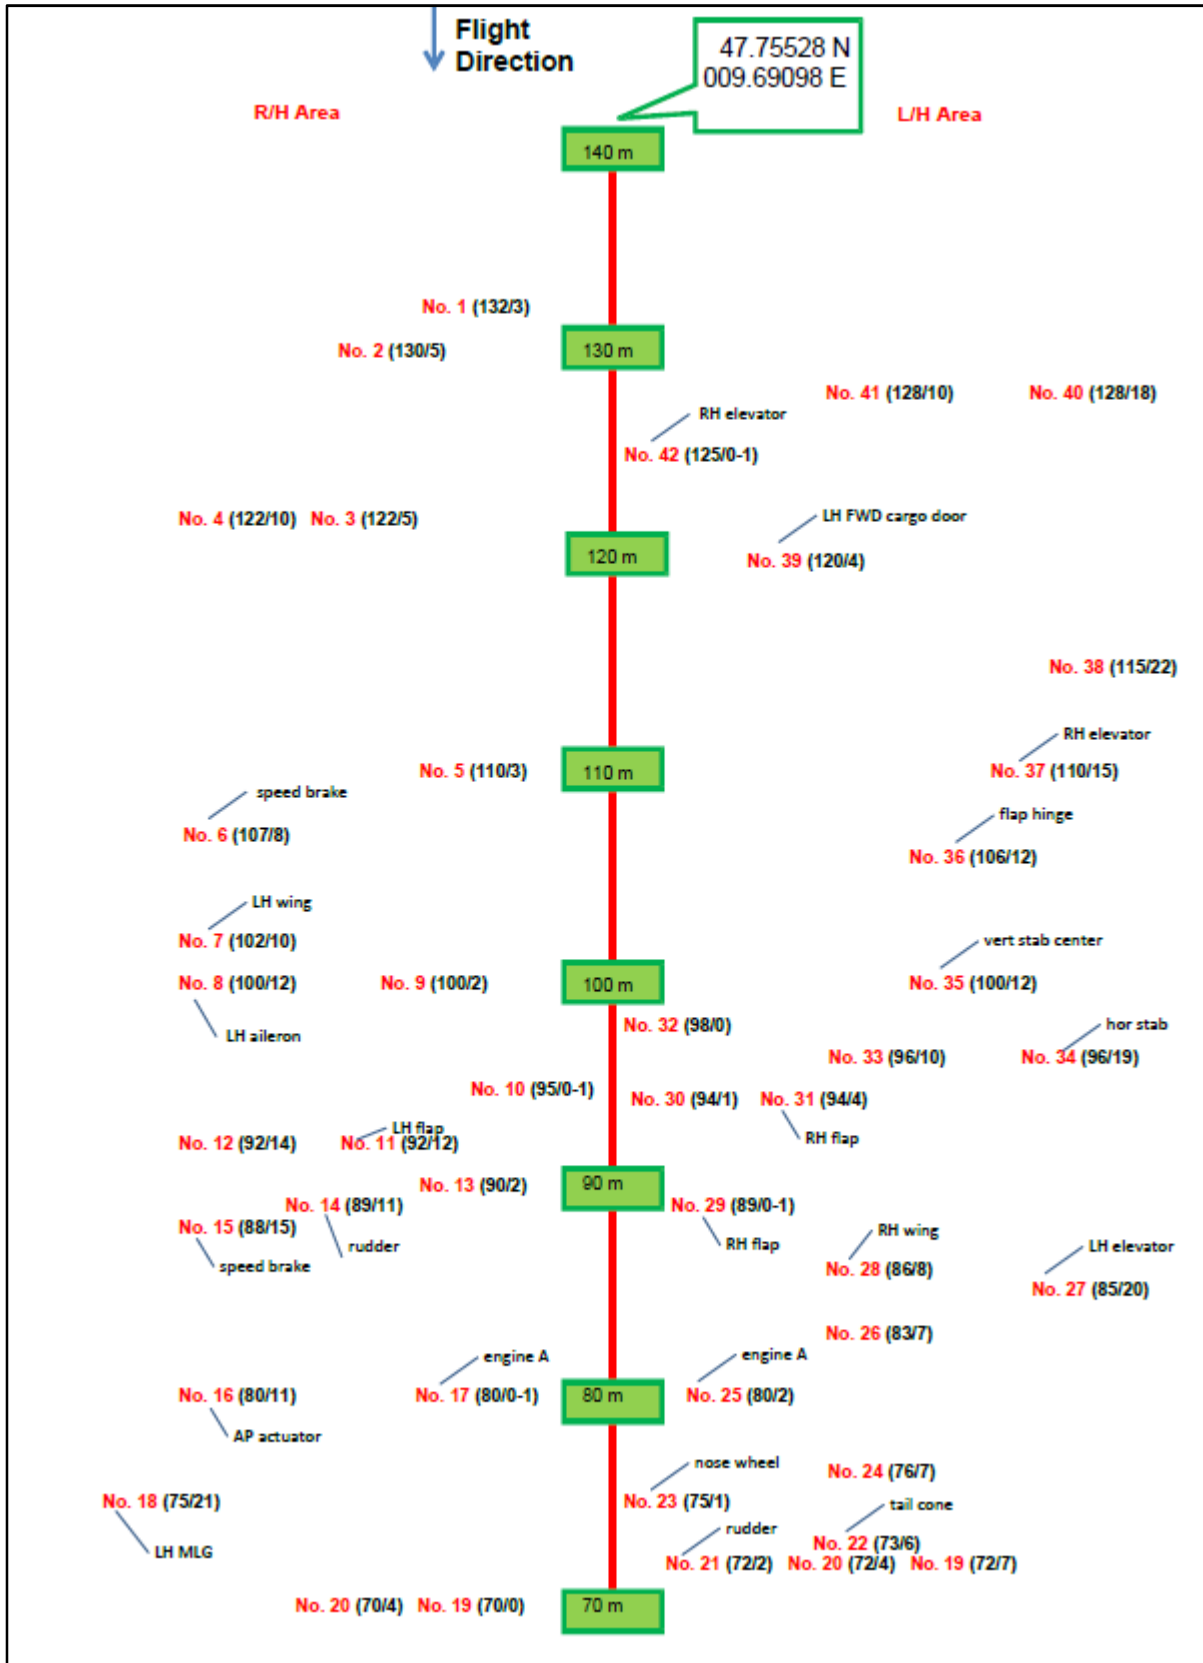
Wreckage distribution at the accident site

The airplane was destroyed during the path through the forest. Wreckage parts were distributed over an area of approximately 130 m by 50 m. Remarkable was that numerous wreckage parts lay reversed left to right, i.e. parts of the right aircraft side were found left of the accident trace and vice versa (see Appendix: Wreckage Distribution)
