Final Report

CX002-0/01
Mai 2003

Type of Occurrence: Accident
Date: 08. February 2001
Location: Nürnberg / Germany
Aircraft: Airplane
Manufacturer, Model: Learjet LR35A
Injuries to Persons: Fatal
Damage: destroyed
Other Damage: minor

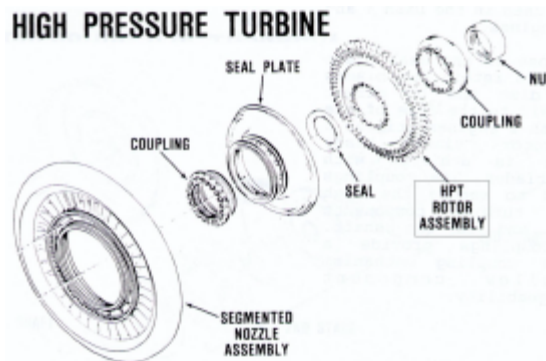
left engine	right engine
fan speed (%N1)	00.0	91.4
turbine speed (%N2)	00.0	96.4
ITT (C°)	967	824

From these values indicated for the time of the impact it is to be concluded that the left engine was not running, and the right engine was running at a high power.

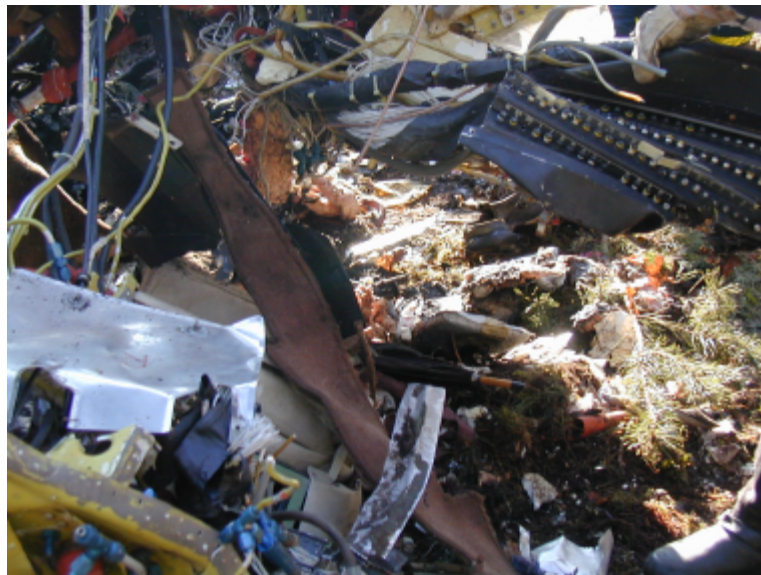
Cockpit Area

The cockpit and the entire front section of the airplane were destroyed. The second pilot and the passenger were found to the left in front of the wreckage, partially still in the airplane wreckage. In the center section of the wreckage, in the wing attachment area, distinct traces of a fire were to be seen. The tail was lying on the right side. The airplane documents from a flight case were scattered in the direction of impact over approx. 8 meters on the ground. The pilot's seat was found approximately two meters further on. The seat belts had been torn off their attachment points at the seat. The position of the pilot in command was four meters further on.

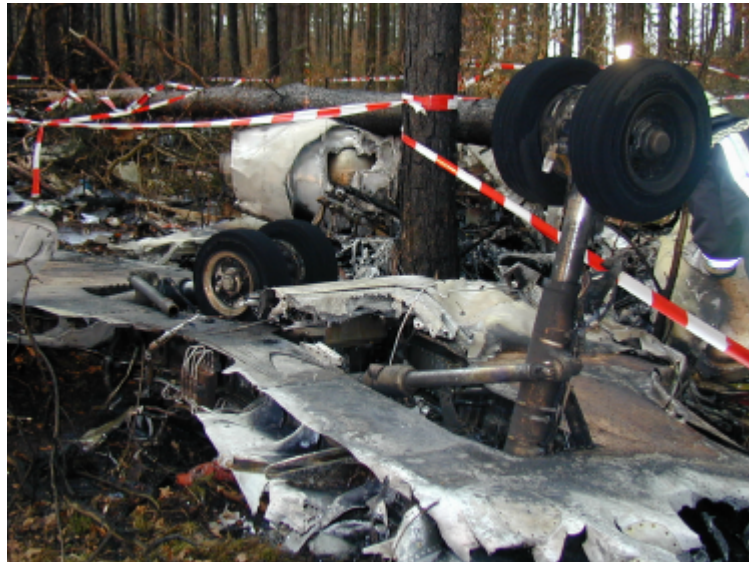
Left Wing and Landing Gear

The left main landing gear was down and locked. The right main landing gear and nose wheel assembly were torn off their attachment points. The gear lever was in the down position.

The left-hand engine was found at a distance of several meters from the main wreckage. The right engine was lying on the wreckage. The left wing had separated from the fuselage. The fan blades of the left-hand engine did not show any traces of rotation. The right jet engine had obviously been rotating with high power. The indications of the engine instruments, which were discovered later on, were in conformity with the traces found on the engines. Caused by the impact, both thrust levers were in the neutral position.

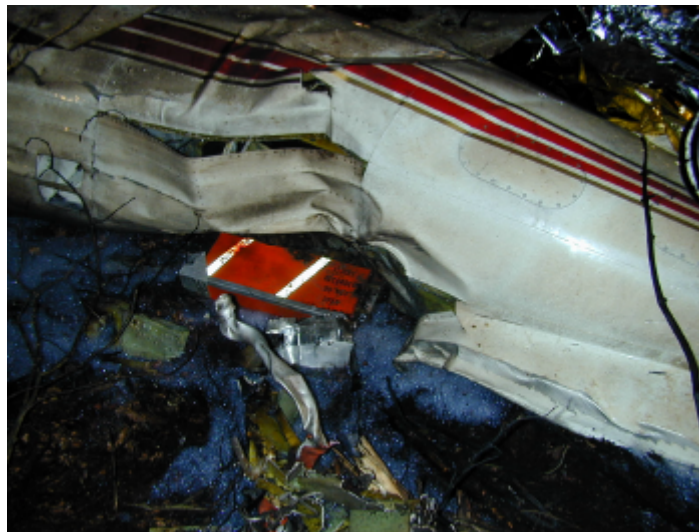
Tail Section and Flight Data Recorder

The fuselage of the airplane had been destroyed by the ground impact and the subsequent fire. The tail section was heavily damaged. The horizontal tail had been torn off and was found under the left-hand wing. These parts, however, were not damaged by the fire. For the most part the rudder and trim positions could be determined. The rudder trim was observed to be in a centered position. The flaps were in a position between sixteen and twenty degrees. The flap lever in the cockpit was set to 20 degrees.

The flight data recorder was found in front of the tail section. The cockpit voice recorder was still in the wreckage. Both recorders were recovered and brought to Braunschweig for evaluation. On the second day it was stated that a signal of the ELT (Electronic Locator Transmitter) was still received in Toulouse. The transmitter could be located in the airplane and switched off.

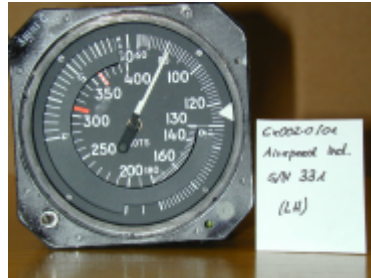
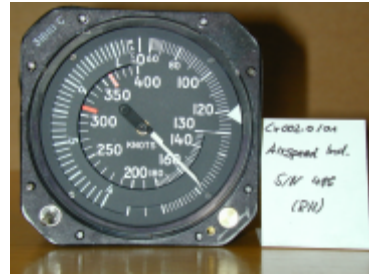
(Speed/Mach Meters)

The flight guidance and engine instruments brought from the accident site for further investigations were inspected and evaluated as far as possible. Most instruments were found to be destroyed or damaged too severely as to allow a safe evaluation of the indications. Since the cockpit crashed on the ground and the trees obliquely and in an inverted flight attitude, hardly any shock marks were detectable on the instrument scales. The pointers were

in part freely movable, heavily bent or the control bars were not in their bearings anymore. Thus the displays were not representative. The findings made on the instruments directly at the accident site must be classified as more valid than the result of the evaluation later on at Braunschweig.

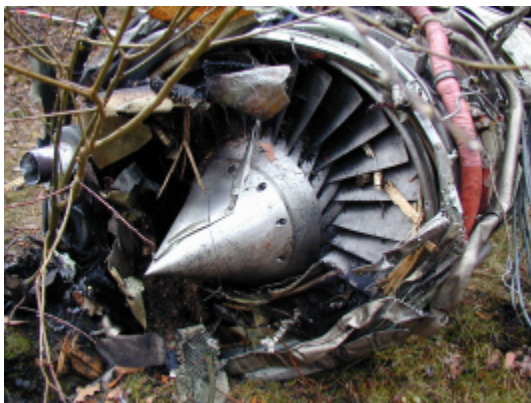
Left engine had stopped before the impact

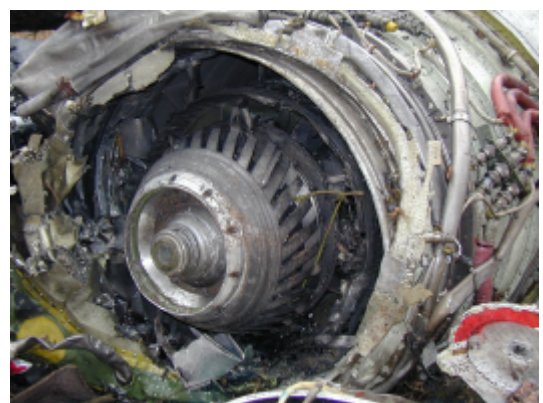
Right engine had been running at high speed

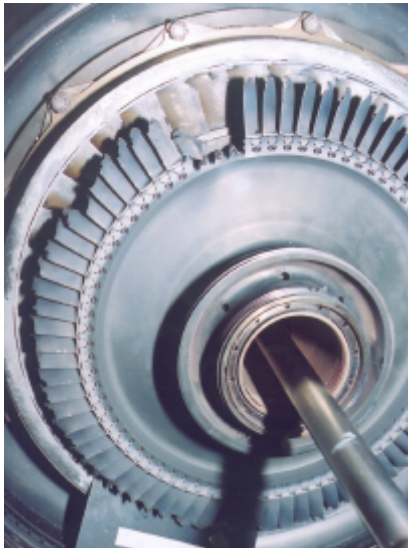
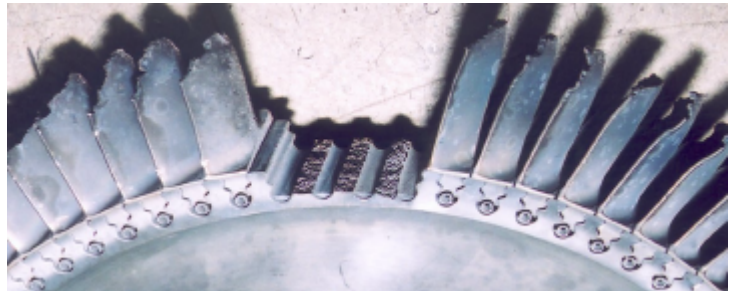
The investigation of the jet engines had shown that 3 mounts for the attachment of the tree post blade roots and 4 blades of the high pressure turbine (HPT) of the left power plant were missing. All other blades of the turbine were damaged on their leading edges and tips. The turbine blades which had separated were found within the turbine section. The shroud housing of the high pressure turbine was partially damaged. The broken mounts and turbine blades, however, had been contained in the housing.

*left engine: High Pressure Turbine Disk(HPT)
Missing Tree Posts and Blades*

The technical material investigation revealed that intergranular cracking on the turbine disc had led to the loss of three mounts. In the cracking area there were further cracks proceeding from outside as well as fractured carbides with starting cracks in the within the material. The mounts adjacent to the cracking area also showed starting cracks in both waists. The material resistance (service life) against the combination of cyclical stress by speeding up and speeding down (cycles), creep stress and hot gas corrosions during the operation obviously had deteriorated.

During the evaluation of the technical documentation of the engine SN 89244 it was found that the maximum of 5200 Cycles (CSN) prescribed in the service bulletin TFE731-72-3001, had been exceeded by 157 cycles.

- The uncommanded in-flight shutdown of the left engine was a result of intergranular fractures on the high pressure turbine disk having led to the loss of three blade retention posts with four turbine blades.
