Aircraft Accident Report

CX003-0/01
March 2002

Occurrence: accident
Date of the occurrence: 08. March 2001
Location: Hamburg
Aircraft: aeroplane
Manufacturer/type: Cessna / C 525 Citation Jet
Injuries to persons: none
Damage to the aircraft: Aircraft severely damaged
Other damage: one runway edge light destroyed

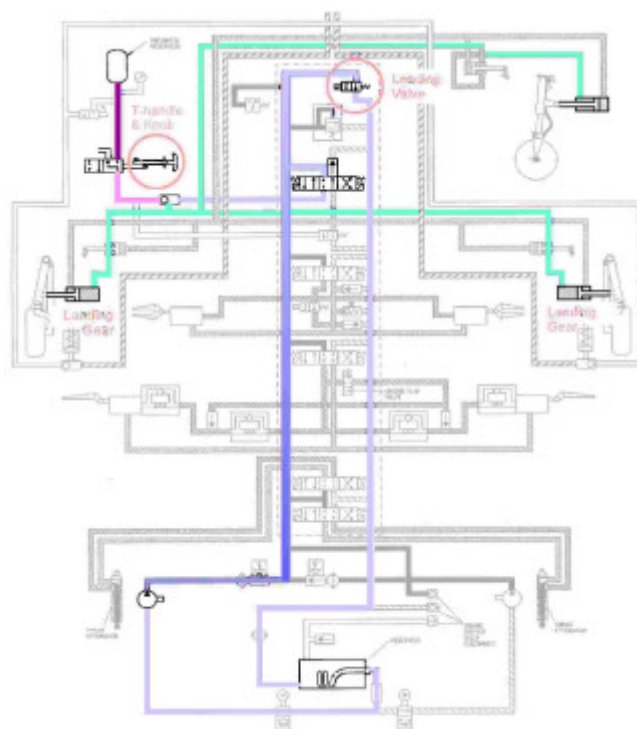
The fault isolation procedure revealed a failure of the valve P/N 9912423-22, S/N 262 (*hydraulic power – solenoid loading valve*). This valve shuts the return line to the hydraulic fluid tank and thus produces the working pressure required by the systems landing gear, flaps and speed brakes.

In the cylinder of the defective valve a loose metallic filter screen was found to be stuck between the front edge of the piston and the internal flange of the cylinder.

The filter screen, which had separated from its fit, had blocked the solenoid loading valve P/N 9912423-22 in the opened position. This explains the total failure of the hydraulic system.

After the valve S/N 262 had been replaced by a new one (of the same model) the hydraulic system worked properly.

The aeroplane manufacturer submitted a Service Bulletin SB 525-29-10 dated February 9th, 2001, which on the day of the accident had not been known yet to the German maintenance company. This S.B. recommends the replacement of all valves P/N 9912423-22 by a new version –39.

The new version of the valve is not provided with the metallic filter screen; the coil and the return spring have been reinforced.
