Investigation Report

5x011-0/02
August 2004

Type of Occurrence: Serious Incident
Date: 3 December 2002
Location: near Munich
Aircraft: Transport Aircraft
Manufacturer / Model: Airbus Industry / A300-600
Injuries to Persons: 1 crew member slightly injured
Damage: Aircraft not damaged
Other Damage: None
Source of Information: Investigation by BFU

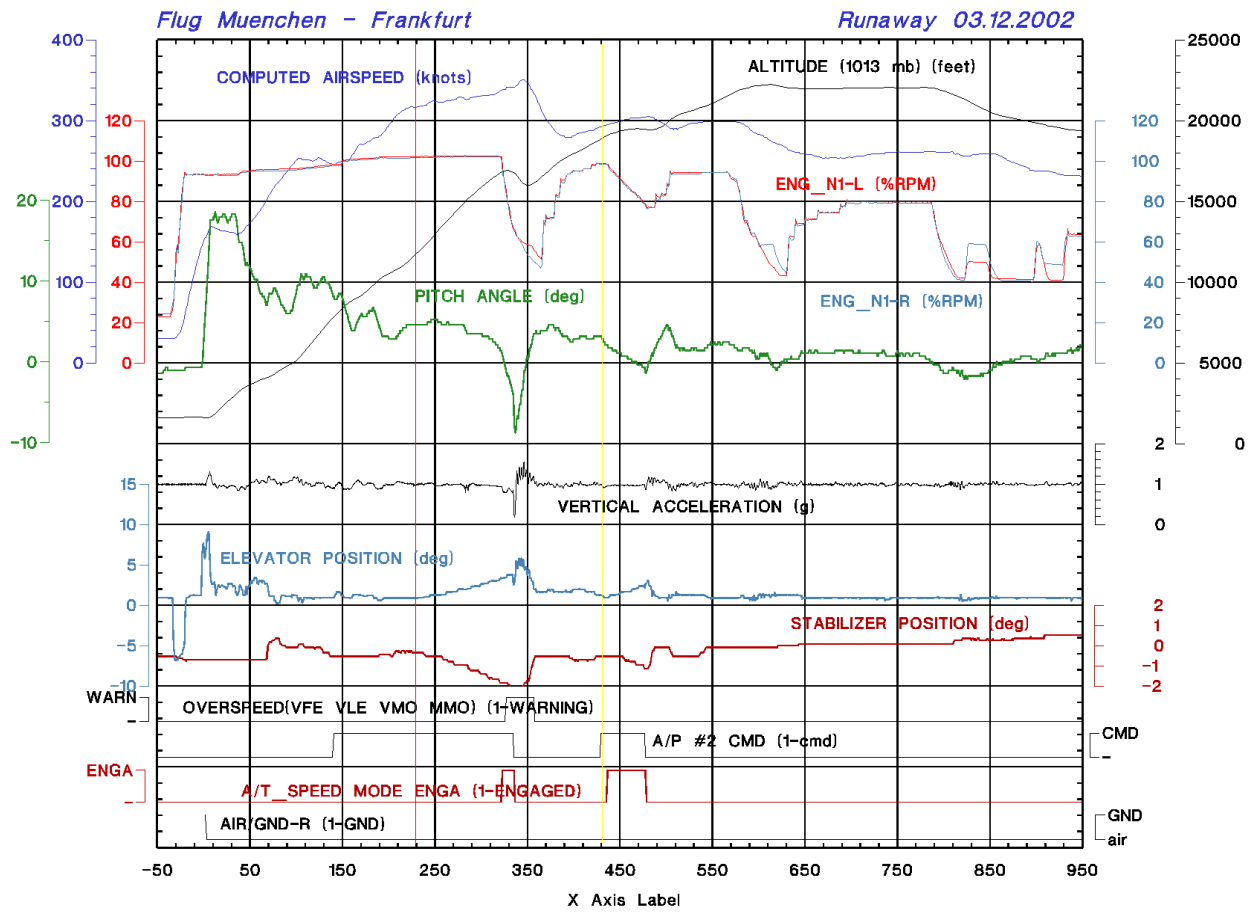
FDR Readout

The recording dated 3 December 2002 showed that with engaged AP 1 the flight from Frankfurt to Munich occurred without incident. On the flight back with AP 2 engaged and during climb a position change of the THS occurred at an altitude of about 17 000 ft. The THS continuously turned with a rate of 0,01 °/s in the direction of "nose down". At the same time the horizontal stabilizer deflected into the contrary position.

60 seconds after the beginning of the position change the nose dropped, climb rate decreased and airspeed increased. After 20 more seconds the power of both engines decreased and the nose dropped further. After another 20 seconds the AP 2 was disengaged and the nose dropped once more. The deflection of the elevator decreased for a short time whereas the reached position of the THS of 2.5° remained.

10 seconds after the disengagement of the AP the THS had almost reached its neutral position again. By the time the airplane was back into climb it had undergone an altitude loss of 1 000 ft, the airspeed had reached a maximum of 351 KIAS and vertical acceleration had been between 0.2 g and 1.5 g.
