Investigation Report

3X164-0/03
April 2006

Type of occurrence:	Accident
Date:	25 July 2003
Location:	Heppenheim
Aircraft:	Sailplane
Manufacturer / Type:	Schempp-Hirth / Duo-Discus
Injuries to persons:	No injuries
Damage:	Aircraft severely damaged
Other damage:	Minor damage to forest
Information Source:	Investigation by BFU

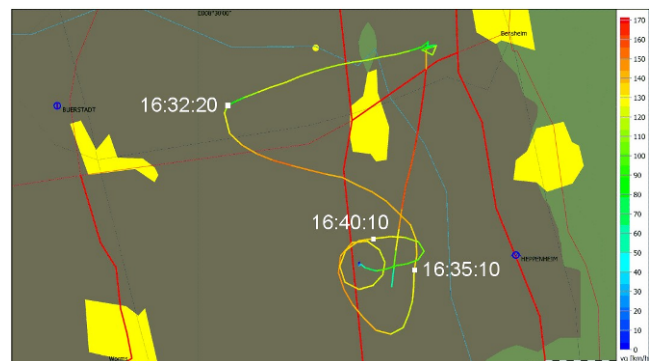
On the day of the accident at 16:30 hrs¹, the Duo-Discus with two persons aboard was on a thermal flight in the surroundings of Heppenheim. According to the pilot's statement and analysis of the GPS logger recording, the sailplane was heading west at a height of approximately 2,000 m AGL after circling in a thermal. This flight phase was characterized by a straight flight path (picture 1) and a ground speed of not more than 150 km/h.

Picture 1: Abrupt end of straight flight at 16:32:20 hrs

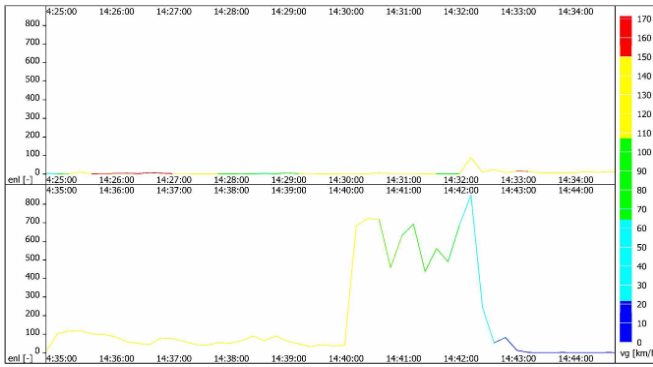
From 16:32:20 hrs, the graph of the sound parameters shows sudden rises and different levels (picture 2).

Picture 2: Sudden high sound level in the sonogram

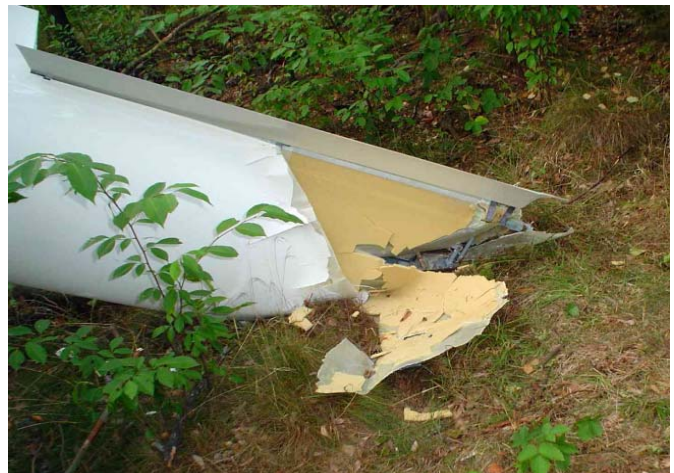
The sailplane was found in the town forest of Lampertheim. The right wing had come to rest in the branches of trees and the stub of the left wing on the ground (picture 3). The fuselage nose pointed downwards and the fuselage tube upwards. The empennage, which had broken off and the canopy were also found in this area. The fragment of the left wing and the left aileron were recovered some distance from the main wreckage.

Picture 3: Left wing's point of rupture

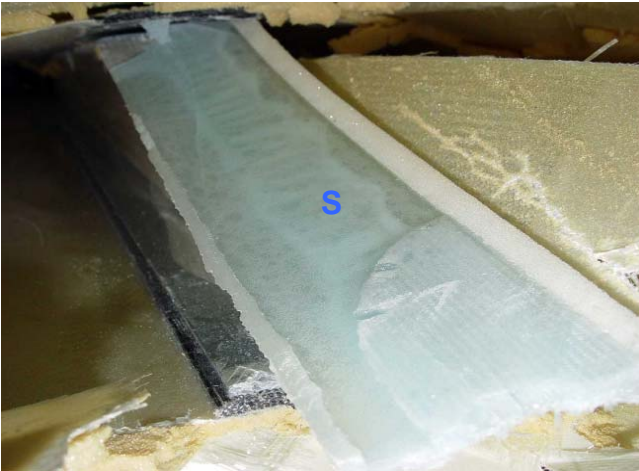
The left wing's fracture is characterized mainly by the fracture of the main spar 10 cm to 30 cm beyond the aileron drive. The fracture face of the lower spar cap of CFRP sticking to the sandwich shell is somewhat fibrous and the fracture face of the upper spar cap is edgeless. The upper flange of the spar web made of GFRP (I-profile) is detached from the upper spar cap made of CFRP and bent downwards. The shear web is destroyed.

The uncovered surface of the adhesive on the bent part of the flange is extremely smooth and lower as the area showing a fibrous texture (picture 4).

Picture 4: Defective bonding between the spar web (S) and the upper spar cap

Quite obviously there was a flawed bonding of almost 20 cm in length in the bonding between the flange of the spar web made of GFRP and the upper spar cap made of CFRP. The interrupted bonding between the web and the upper cap of the main spar led to a stability failure of the upper spar cap. This occurs as soon as the wing is subject to a sufficiently high upward bending load. The Duo-Discus concerned was almost new.

The accident is to be attributed to deficiencies in the production of the wing and to an insufficient inspection.

The Luftfahrt-Bundesamt should restrict operation of the aircraft type Duo-Discus until the sailplanes which may have defective bondings also are identified and inspected.

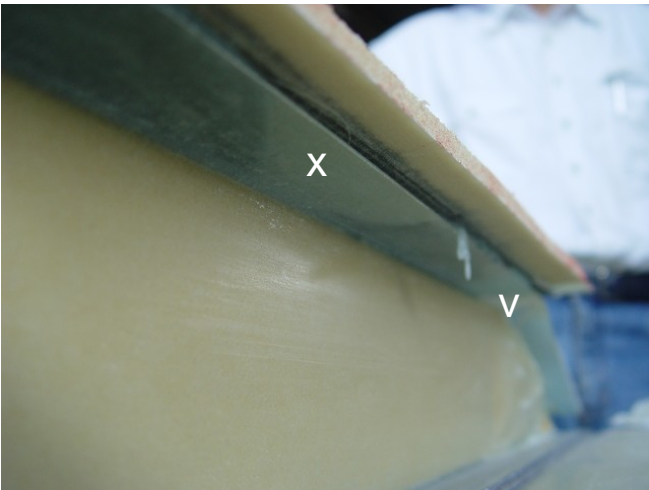
For the bonding surfaces between spar web and upper spar cap, the engineers had calculated with the full value of the components' bonding surface. The thickening of the resin through flakes and a surplus of adhesive were to ensure full bonding of the glued joints during manufacture.

The mixing ratio resin and hardener was observed precisely. The content of filler in the resin could vary depending on the room temperature. A viscosity value of the adhesive for checking purposes was not provided. The surplus of adhesive was to appear on a plastic film placed within the wing box and pulled out later through the wing root. This verification was not documented in detail by actual and target values.

Picture 5: Flawed bonding (x) and excessive (v) adhesive
