# Investigation Report

3X221-0/03  
October 2009

Type of Occurrence: Accident  
Date: 30 September 2003  
Location: Büchig Soaring Site  
Aircraft: Sailplane with auxiliary motor  
Manufacturer / Model: Walter Binder Motorenbau GmbH / Eta  
Injuries to Persons: None  
Damage: Aircraft badly damaged  
Other Damage: Slight damage to forest trees  
Source of Information: Investigation by BFU

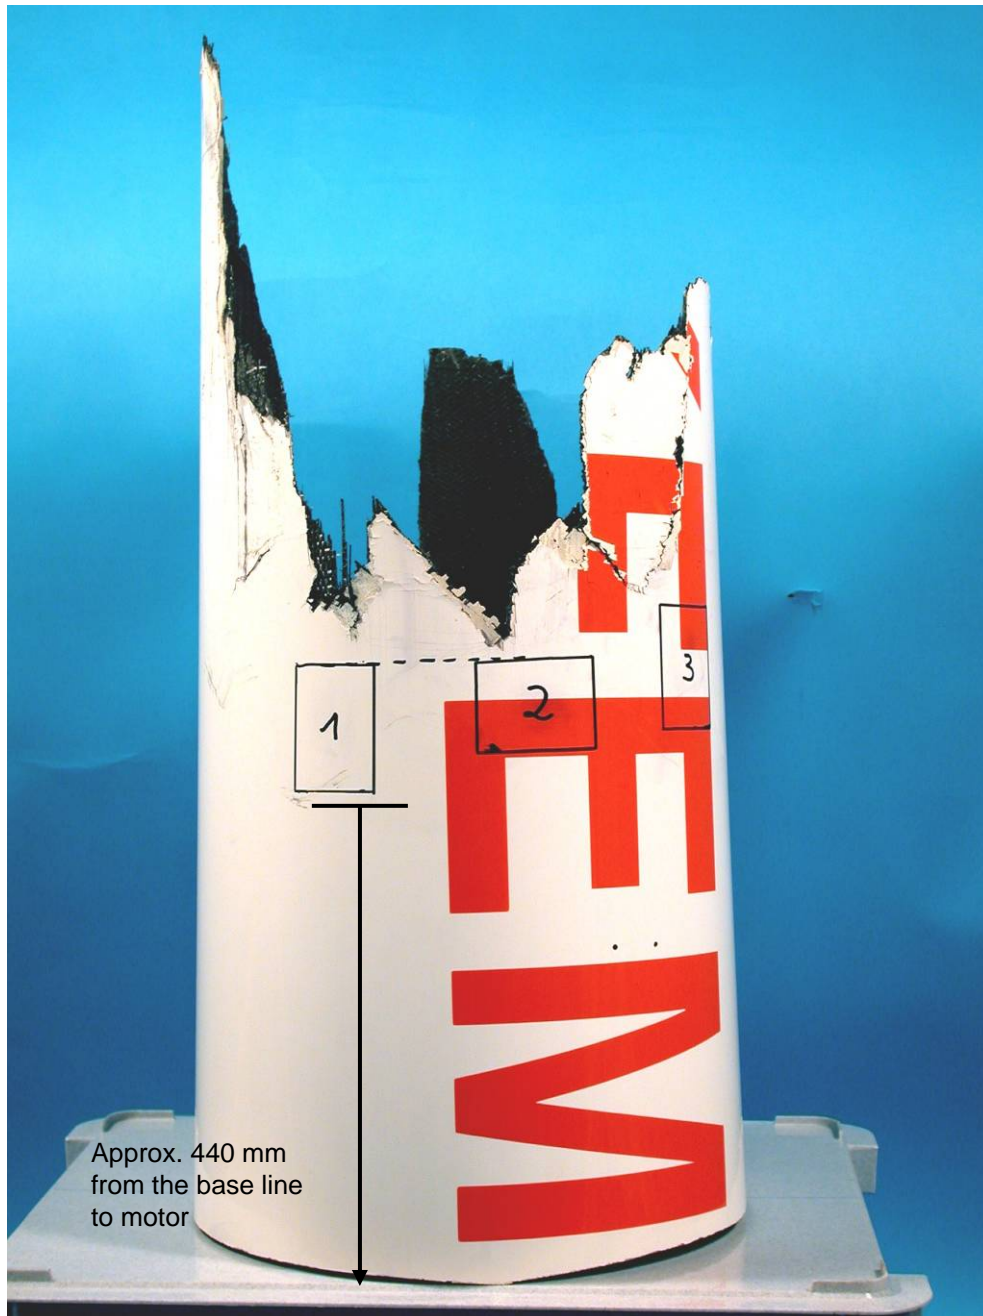
Appendix 1

Samples were taken from the rear fuselage structure in the vicinity of the primary fracture line for examination by the DLR (see Appendix 1). Examination revealed an irregular distribution of resin and parts of the fibre volume, also air bubbles and irregularities on the outer surface of the composite structure. There was also an absence of the solely envisaged 0°-layer at several points in the structure over a width of several centimetres. No

investigation was made to determine whether the rovings were completely absent, or had only been shifted. In both cases, the fuselage did not have the strength assumed from calculation.

The fractured section of the rear fuselage with three of the four quadrants marked (Number four is on the upper side).

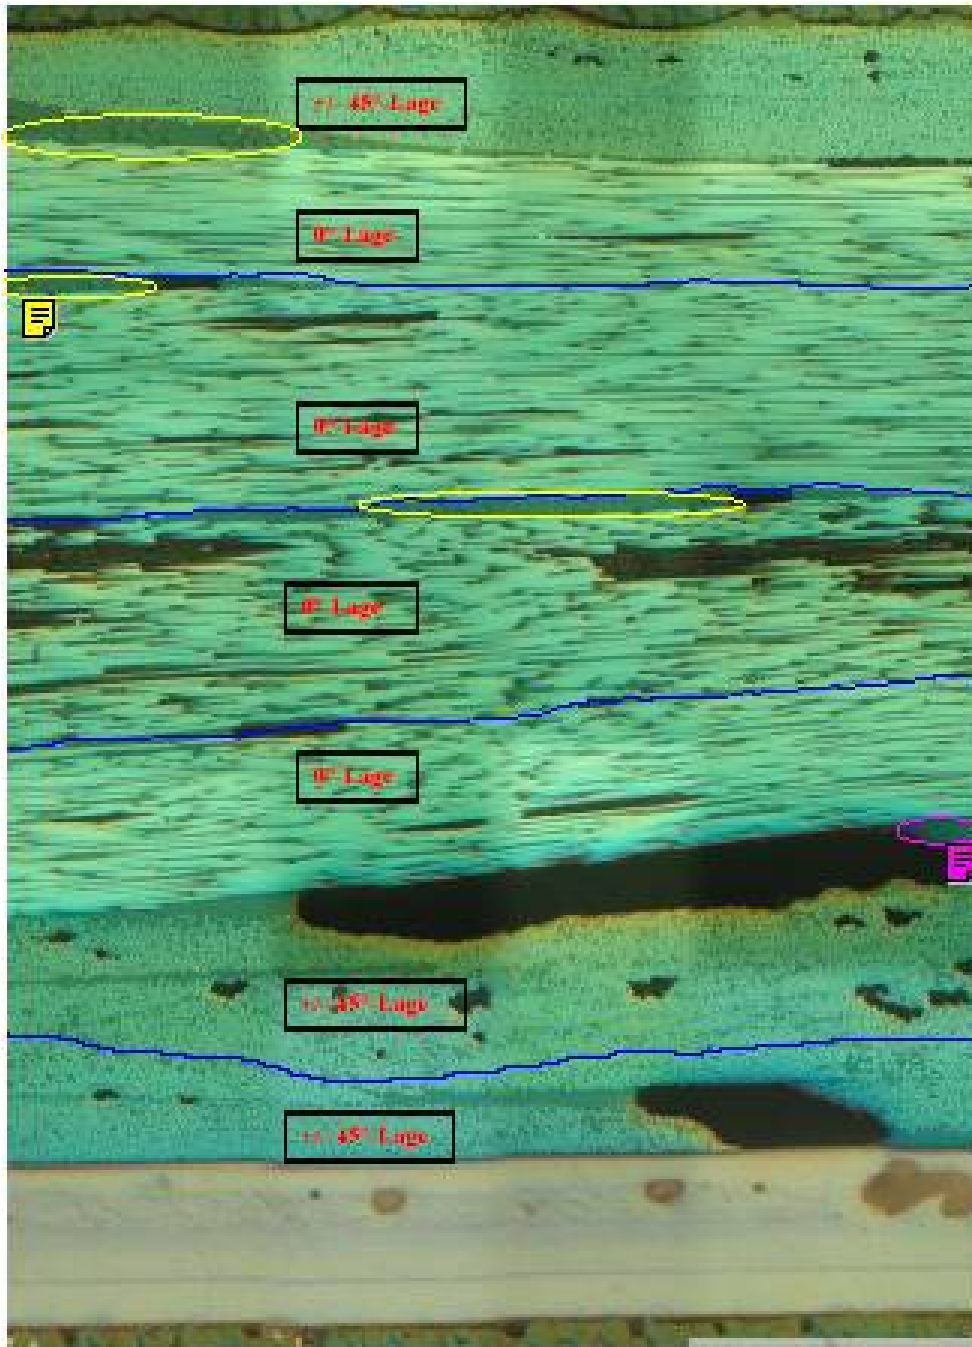
Appendix 2

All the enlarged cross-sectional photographs revealed large trapped air bubbles, resin pools and some slightly warped roving layers. It can be demonstrated that there were differences between the layup sequence as described in the plans and those actually present in the structure (Appendix 4). In Quadrant 1 the number of woven threads in the photomicrograph indicates four 0°-layers instead of three 0°-layers (see Appendix 2), while the 0°-layer is completely absent in Quadrant 2 (see Appendix 3). Another indication is that no 0°-fibres could be found in the residual carbon fibres within Quadrant 2; inspection also revealed that this strip, which is only a few centimetres wide, has a very thin wall. In Quadrants 3 and 4, the layup is identical to that of the planned layup sequence."

Photomicrograph of Quadrant 1 (ground in the 0°-direction)

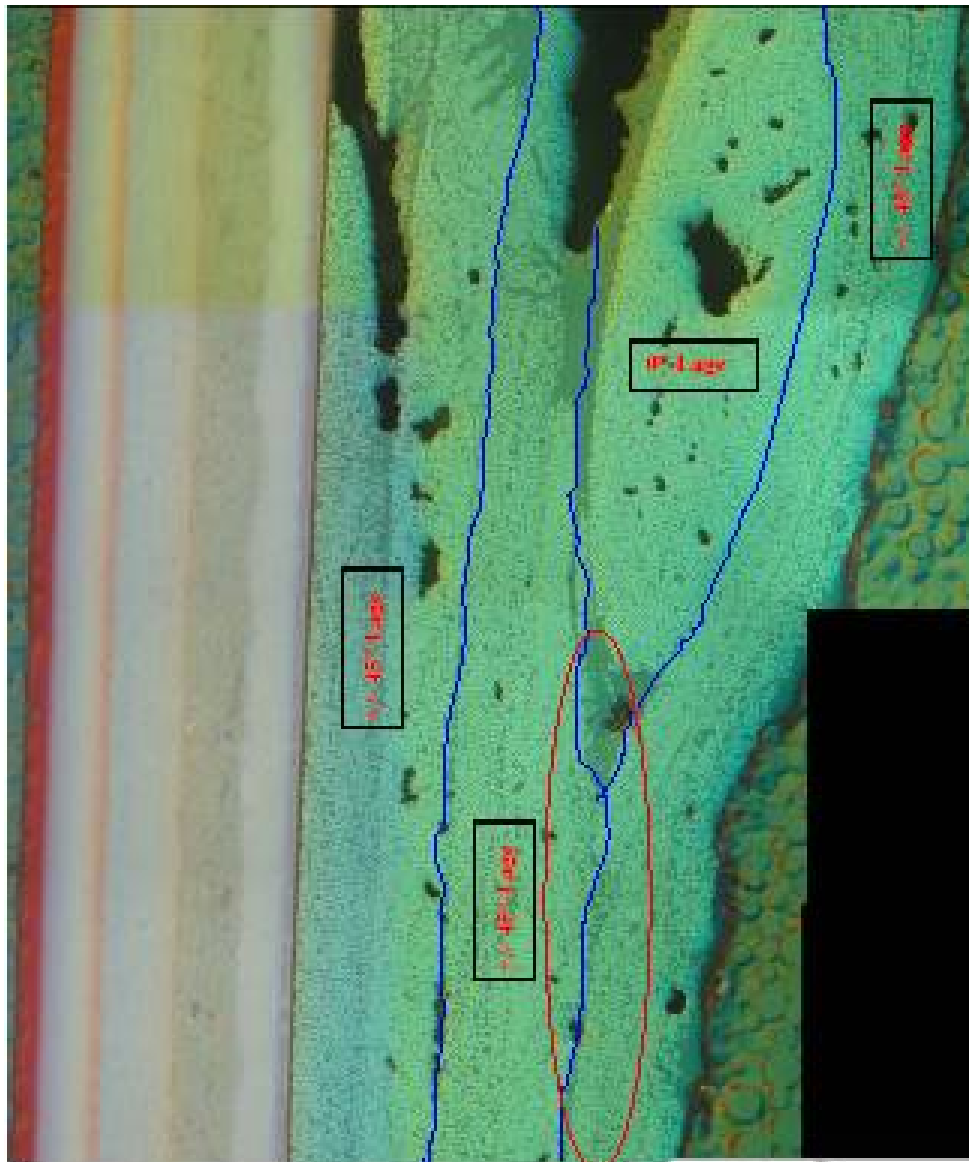
Appendix 3

Photomicrograph of Quadrant 2 (ground in the 90°-direction)

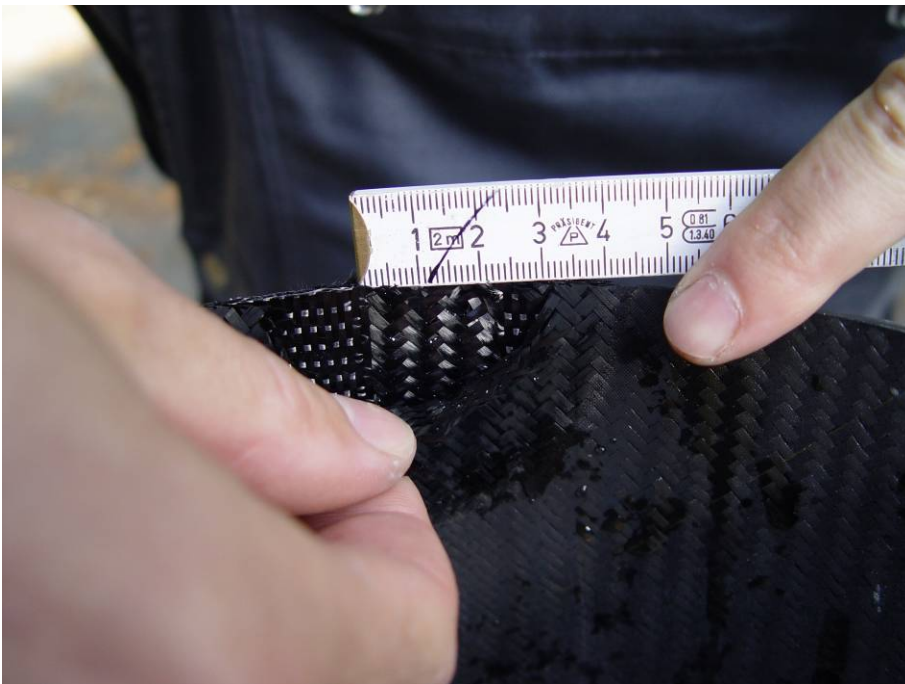
Appendix 5

Physical inspection of the wreck identified two further parts of the broken rear fuselage that appeared to be very thin (approx. 1800 mm before transition to the fin leading edge). Inspection revealed that the unidirectional (UD) layer was interrupted over a width of 45 mm at the middle of the left fuselage half, and over a width of about

20 mm in middle of the right fuselage half. (See Appendix)

Left Fuselage half: Approx. 20 mm gap in the unidirectional layer UD-Layer

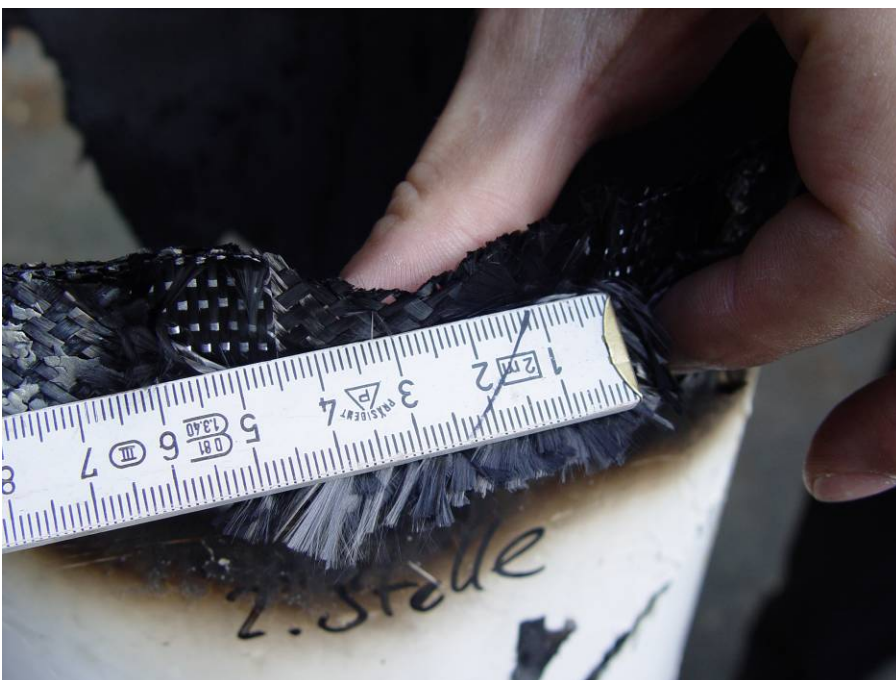
Right Fuselage Half: Approx. 45 mm gap in the unidirectional layer
