# Investigation Report

Type of Occurrence:	Serious incident
Date:	6 March 2003
Location:	Near Sharja / United Arab Emirates
Aircraft:	Airplane
Manufacturer / Model:	Boeing B747-230B
Injuries to Persons:	None
Damage:	Minor damage to aircraft
Other Damage:	None
Information Source:	Investigation by BFU
State File Number:	BFU 6X001-03

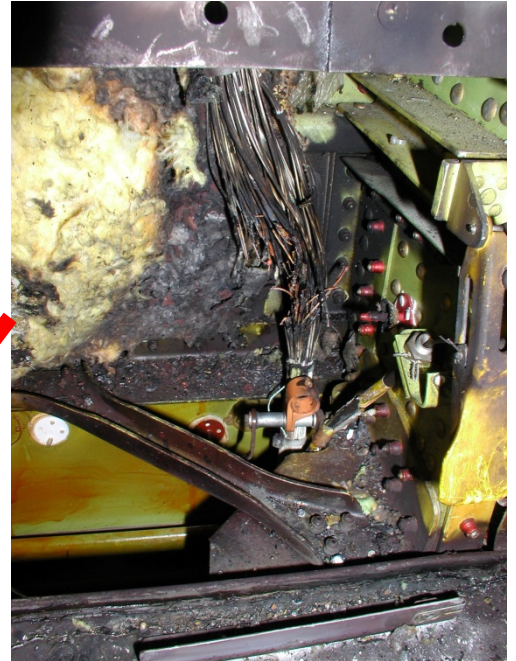
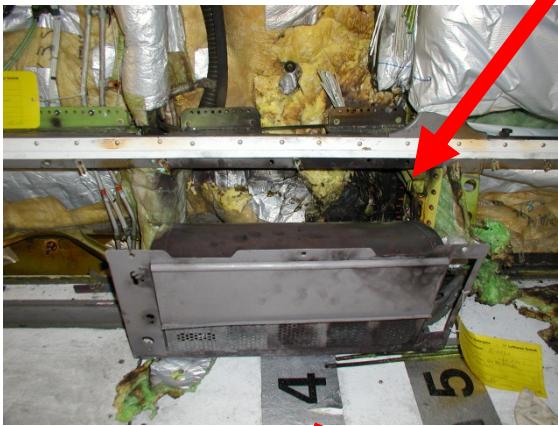
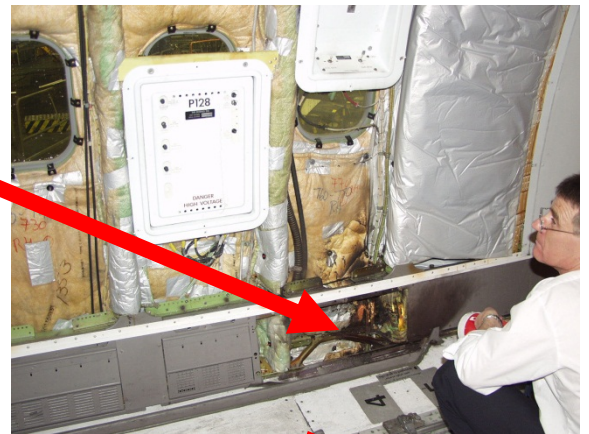
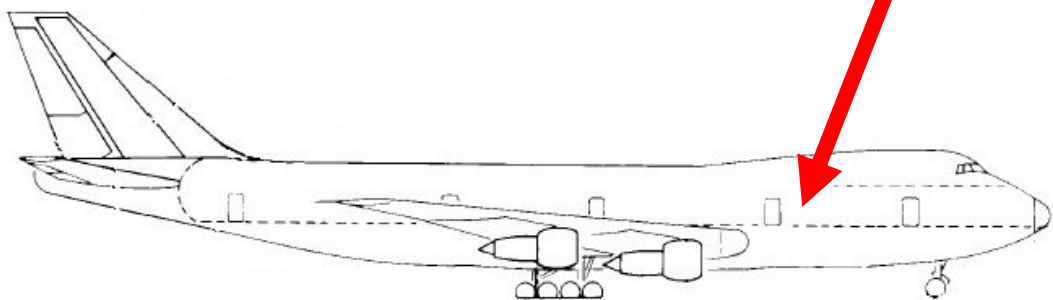
Appendix 1: Damages to the upper cargo compartment

The power supply lines for the upper galley were scorched in the area of the cockpit oxygen supply in the lower cargo compartment. The oxygen supply itself was not damaged. A wire bundle with 80 cables for the galley power supply was severely damaged. The insulation behind the wall panels of the lower cargo compartment was partially scorched. The dado vent box at STA 780 showed a hole the size of the palm of a hand.

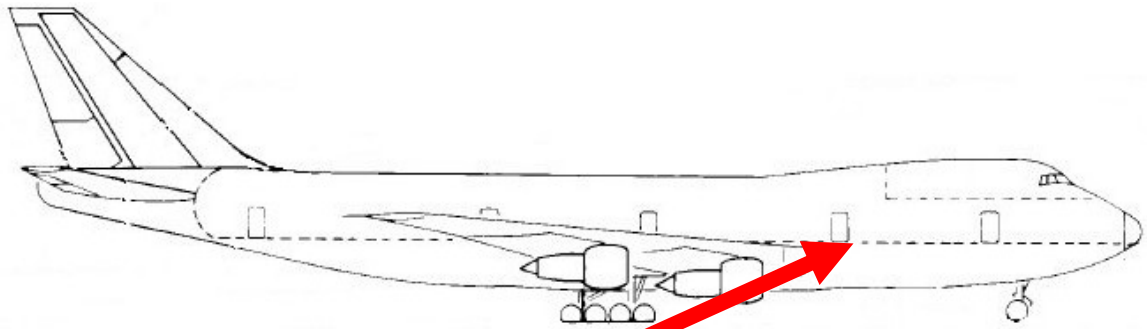
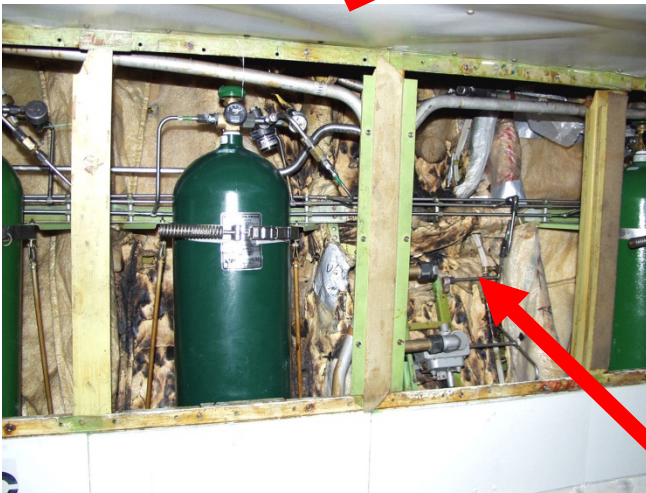
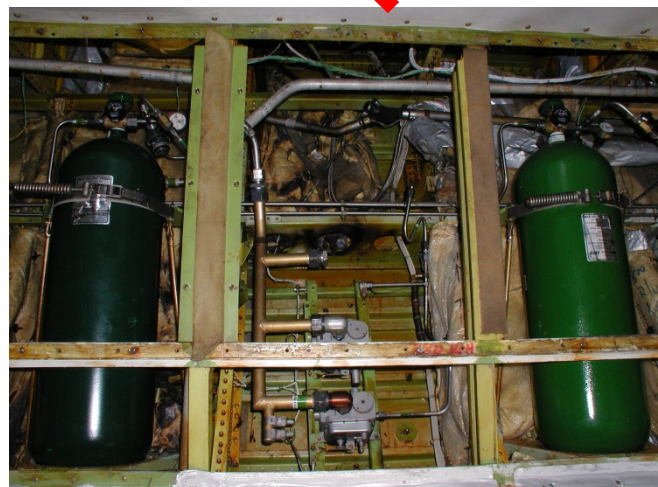
Appendix 2: Damages to the lower cargo compartment

After the cargo had been unloaded in Frankfurt the wall panels in the lower cargo compartment were removed. The whole area of the oxygen bottles up to the main cargo deck showed partially scorched insulation. Further removal work showed an about 5 cm x 10 cm big hole in the aluminium structure of the dado vent box at station (STA) 780 close to the main cargo deck caused by fire. Two wire bundles running behind the dado vent box and the insulation in this area showed severe fire damage. Smoke and heat traces were found on parts of the pressurised fuselage structure. There were also smoke and heat traces behind the wall panels of the lower cargo compartment underneath the damaged dado vent box. In this area about one square metre of insulation was scorched.
