Investigation Report

CX008-0/04
January 2009

Type of Event:	Accident
Date:	24 September 2004
Location:	near Nordhorn-Lingen
Aircraft:	Fixed-Wing Single Engine Power
Manufacturer / Type:	Piper / PA 28-181
Injuries/Fatalities:	Fatal injuries to flying instructor, student pilot and passenger
Material Damage:	Aircraft destroyed
Third party damage:	Damage to forest
Information source:	Investigation by BFU

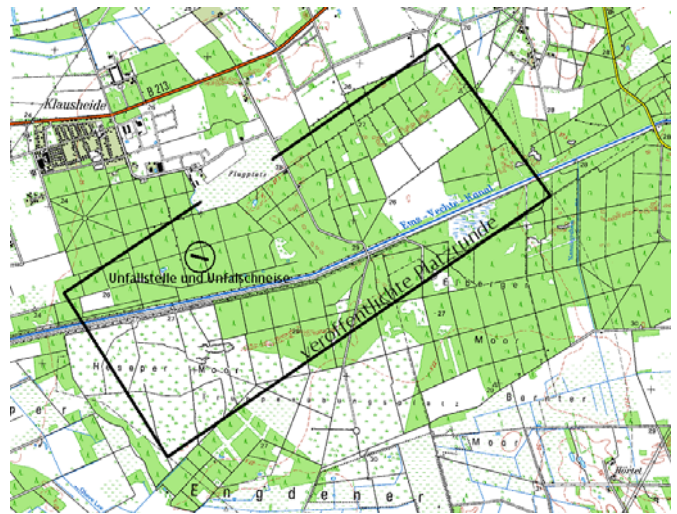
The impact took place within a large area of woodland about 700 m southwest from the threshold of runway 24.

The aircraft right outer wing section made first contact with the trees, following which wreckage was scattered on a track of 150°. About 50 metres further forward the aircraft hit a large tree. The right wing and the right landing gear were arrested by the tree at a height of 8 - 10 m; the remaining wreckage then changed the scatter path track to 100°. The fuselage and nose gear came to rest about 75 m from the point of first tree contact.
