# **Final Report No. 1926**

**concerning the serious incident (Airprox)**

involving Tupolev 154M

and Airbus 319

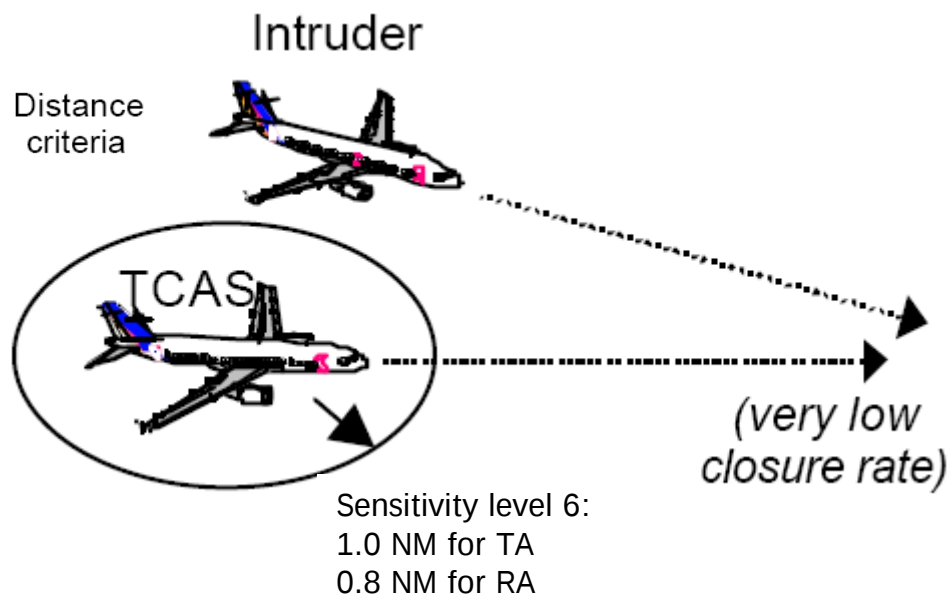
The A319 was in level flight at FL 130, whereas the Tu-154M was descending. At the time of the closest lateral convergence of the two aircraft at 06:58:52 UTC, the altitude difference was some 1,600 ft. The A319 was at this time already at FL 130 in level flight, and the rate of descent of the Tu-154M was approximately 1,500 ft/min. These values did not yet fulfil the requirements for triggering a traffic advisory. From this point in time, the lateral separation between the two aircraft began to increase again, until about 06:59:04 UTC, but at such a slow rate that an extrapolation of the flight path would have resulted in a convergence of less than 1.0 NM by the time they reached the same altitude (co-altitude). As the lateral separation between the aircraft was continuing to increase from 06:58:52 UTC, a special function of the TCAS logic was triggered. This function is provided for situations in which the horizontal closure rate is very low or the aircraft are even diverging, but the TCAS computer indicates that at the time when they reach the same altitude (co-altitude), a set lateral separation minima will be violated.

For the altitude band between 10,000 and 20,000 ft (sensitivity level 6) in which the incident took place this set lateral separation minima corresponds to 1.0 NM for the triggering of a TA (traffic advisory) and 0.8 NM for the triggering of an RA (resolution advisory).

Because of the geometry of this serious incident, these conditions were fulfilled at the time at which the Tu-154M was executing a left turn onto a heading of 150°. Shortly thereafter, the flight paths of the two aircraft were again diverging as a result of this turn, which prevented further intensification of the conflict and the issuing of a resolution advisory.
