# Investigation Report

Type of Occurrence:	Accident
Date:	15 February 2006
Location:	Kiel-Holtenau
Aircraft:	Airplane
Manufacturer / Model:	Dassault Aviation / Falcon 20-C5
Injuries to Persons:	One person seriously injured, five persons slightly injured
Damage:	Aircraft severely damaged
Other Damage:	Crop damage
Information Source:	Investigation by BFU
State File Number:	BFU AX001-06

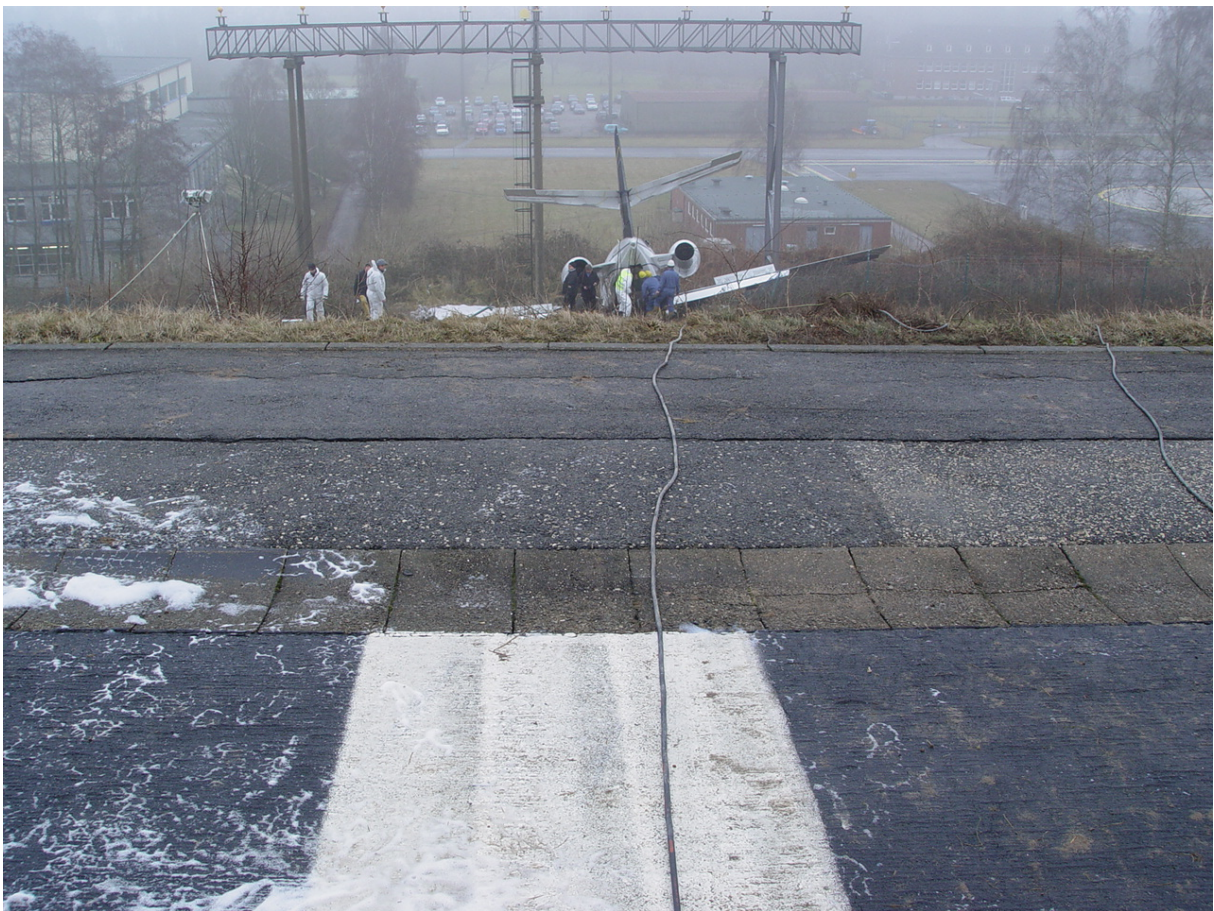
The airplane had overshoot the end of runway 08. In the process it had destroyed a concrete lamp post in the adjacent sloping ground, had burst through the airport fence and had come to rest about 30 m behind the asphalt area, about 140 m behind the threshold of runway 26 in extension of the centre line and about 5 m below the airport level. The distance between the threshold of runway 08 and the final resting point of the airplane was about 1,174 m.

Final position of the airplane

The left main landing gear had been torn off; the left wing was severely damaged. On the left wing the outer flap was extended, the inner flap was lying on the left main landing gear and was bent upward. The slat had been torn off and was found about 8 m from the aircraft. On the right wing outer and inner flaps were extended. The slat was extended.

The airbrakes on both wings were in the extended position.

As the airplane was over-shooting the end of the runway it still had a speed of about 55 kt; when it left the asphalt strip it still had a speed of about 50 kt. The decrease of the vertical acceleration to 0 g shows that above the sloping ground the aircraft followed a ballistic trajectory before it crashed to the ground with about 4 g.

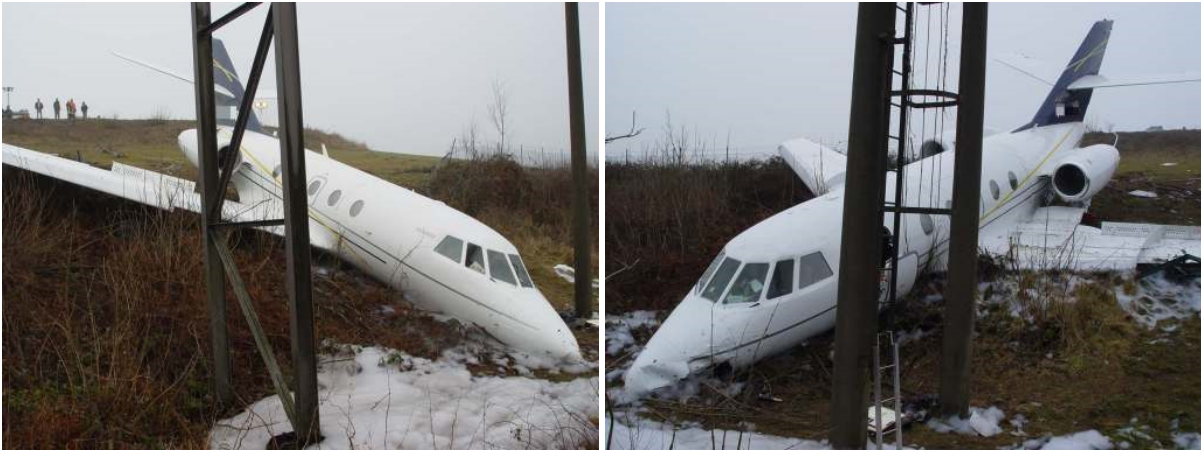
Locked emergency exits

The fuselage was torn open and deformed in the area of the fuselage nose. The entire extent of the fuselage in front of and behind the wings showed folds. The main door hinged at the bottom and located on the aft left fuselage side was open by about a third. The door could be opened without much force. The two overwing emergency exits were closed.

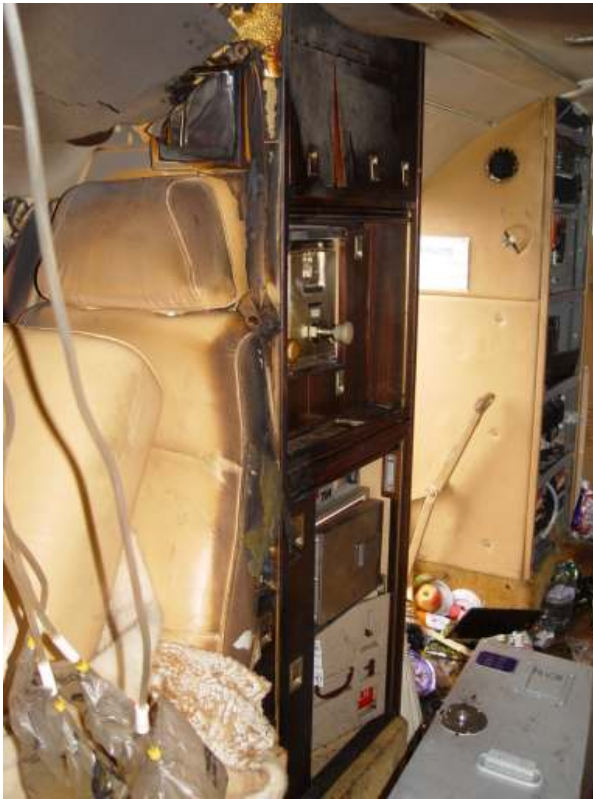
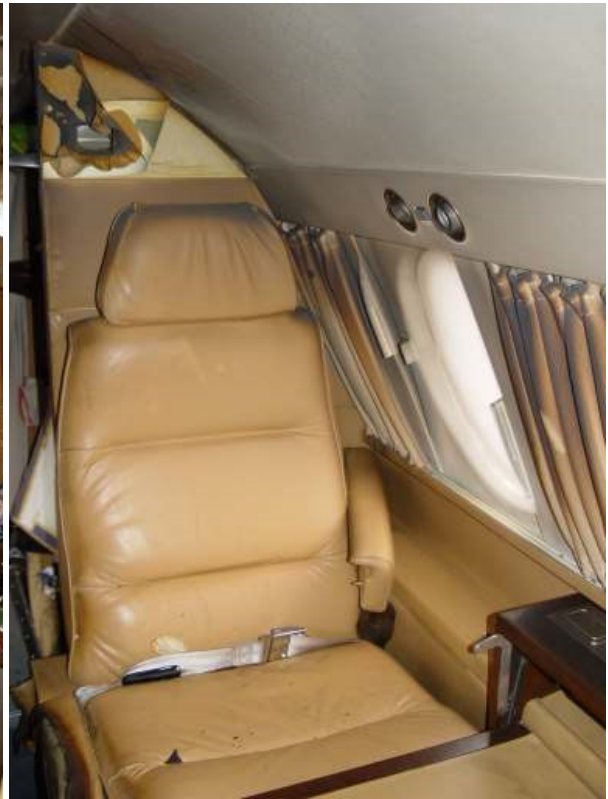
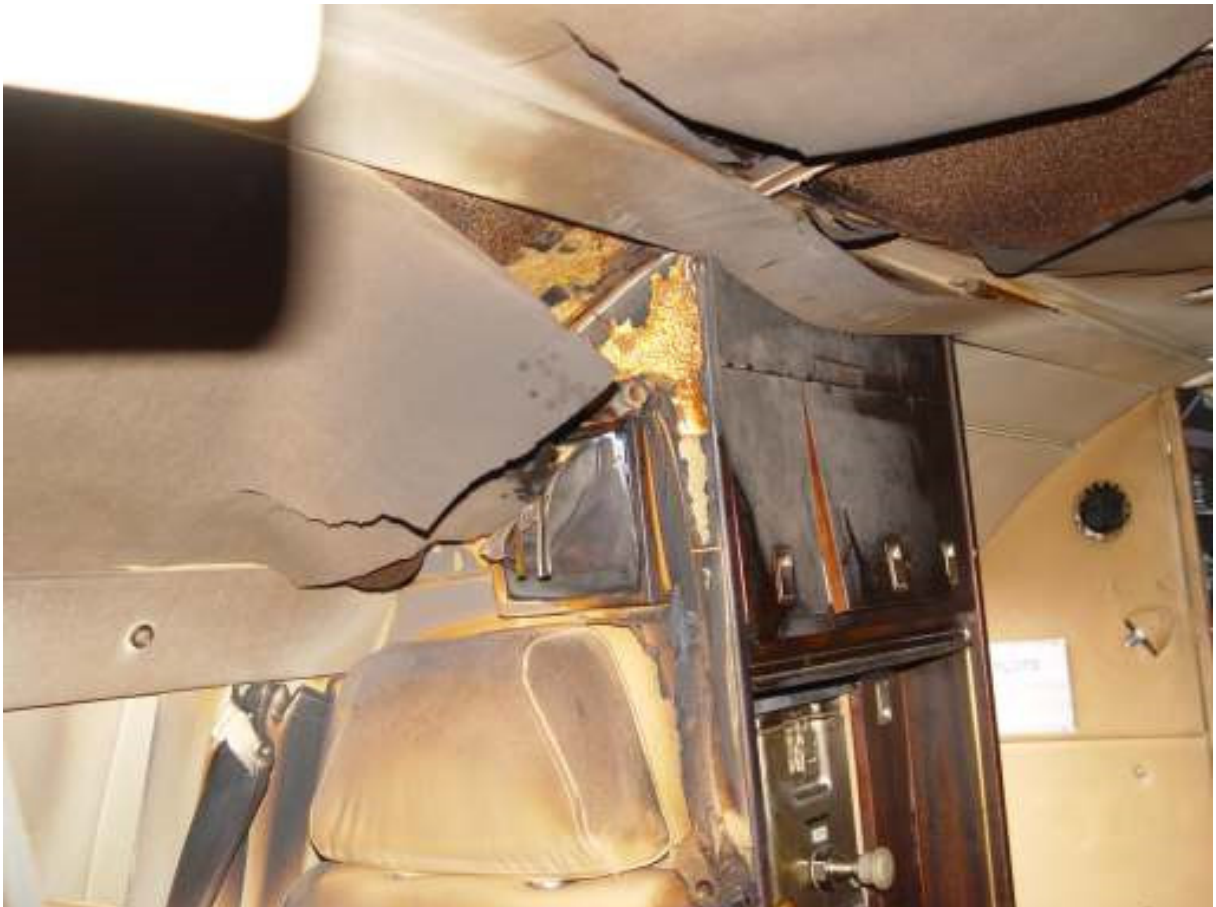
The entire interior of the cabin showed a layer of soot.

Traces in the cabin; line of vision is flight direction

Once the pyrotechnical device was triggered the rocket was activated. The CVR recordings showed a time span of 4.19 seconds during which the sizzling sound was recorded. The manufacturer stated the burning time of the flare was at least 40 seconds. The distinct traces of heat and soot of about 2 m<sup>2</sup> found in the area of the galley and the left front passenger seat on the cabin ceiling showed clearly that the pyrotechnical device burned out in this area.

The BFU is of the opinion that the traces showed the fire did not set the whole interior on fire. The main reason is the short burning life of the pyrotechnical signal of not more than one minute (rocket and flare). The entire cabin and the cockpit showed clear traces of soot. This means the entire fuselage must have been filled with smoke. The statement of the flight attendant indicates that during the approach to land at least the fire of the curtain was not fully extinguished.

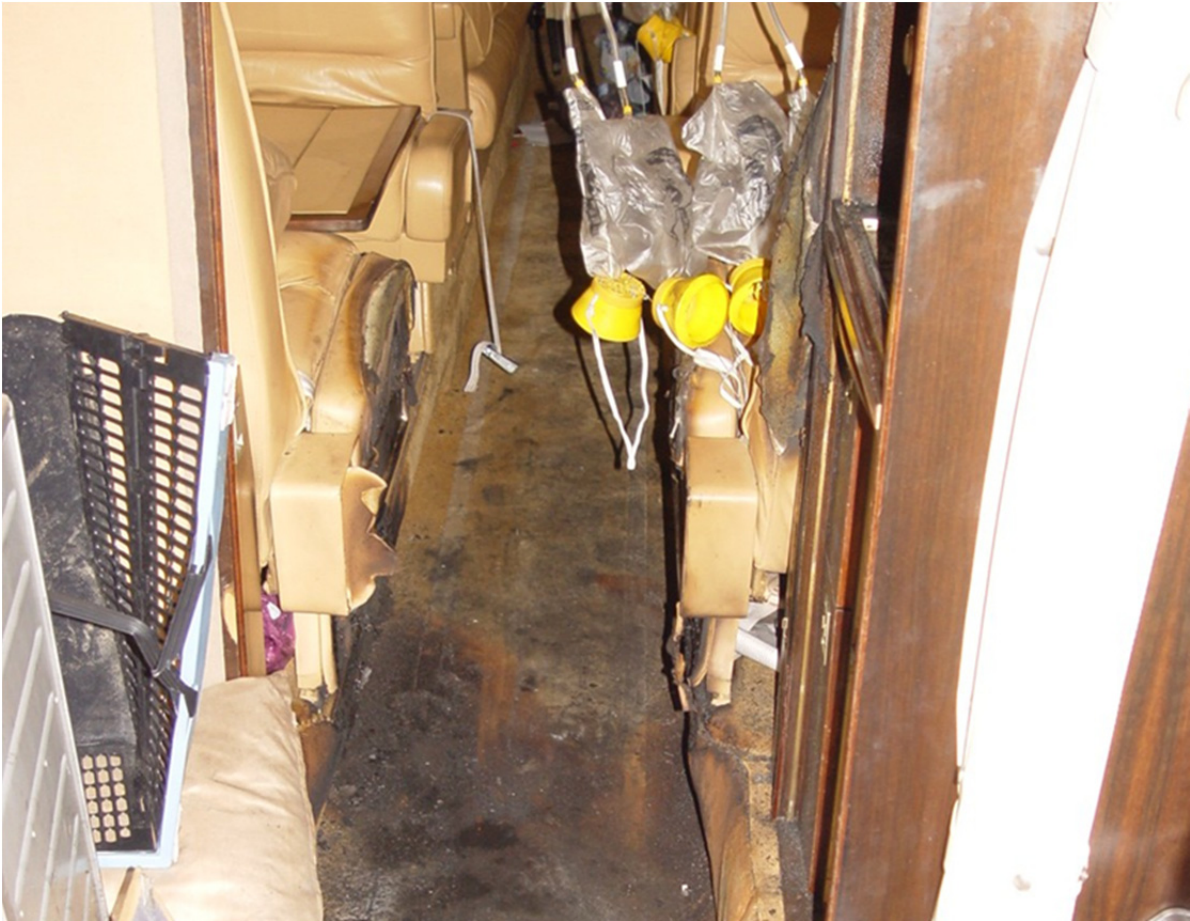
Fire damage on the cabin floor opposite the galley

The signal flare had caused a fire in the aft part of the cabin. Especially the interior between cockpit and first seating area showed traces of fire.

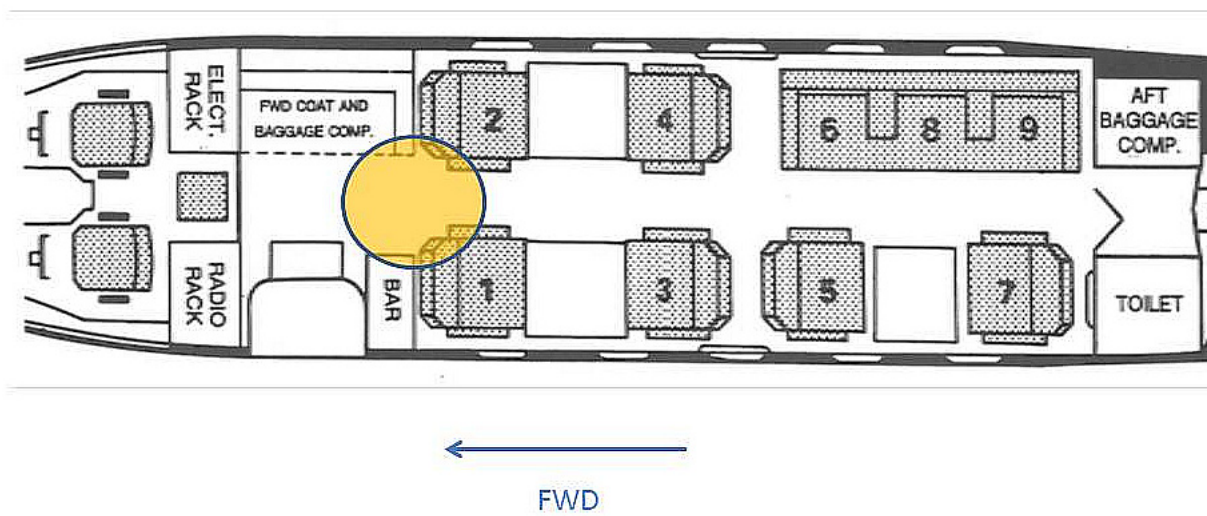
Cabin layout and fire damage

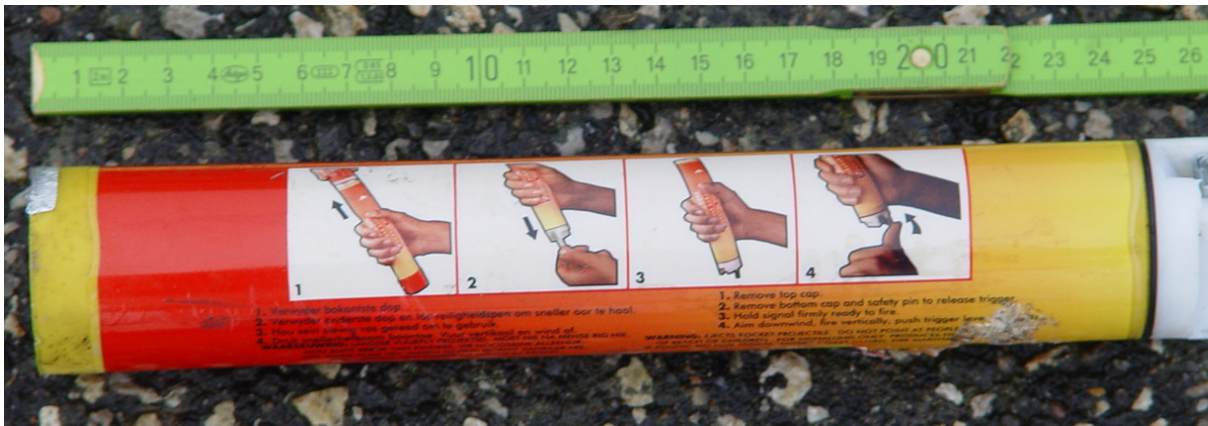
The pyrotechnical device was a *Handheld Flare*. Powered by a solid fuel rocket it was meant to reach about 300 m and let a red flare sink to the ground on a parachute for at least 40 seconds. The device was meant to be used outdoors for the purpose of signalling an emergency. The manufacturer stated that the activated pyrotechnical device could be extinguished by water. According to the manufacturer the device has to be treated in accordance with the regulations for Dangerous Goods and it is not permitted to transport it in passenger aircraft.

Handheld flare with imprinted operating instructions and warnings

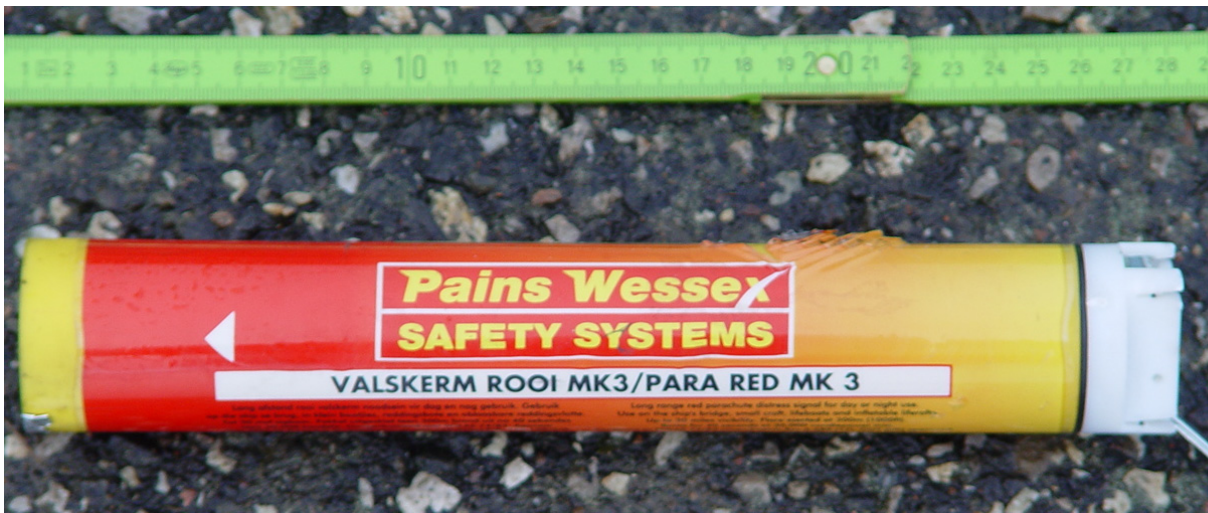
Pyrotechnical device with classification and description

The BFU is of the opinion that the statement of the flight attendant the distress signal was laying unsecured in the galley area is plausible. The unsecured storage made the improper use of the pyrotechnical device possible in the first place. The BFU is also of the opinion that the fact that it was dark when the event happened has contributed to the fact that the flight attendant had mistaken the pyrotechnical device for a roll of plastic wrap.
