# Investigation Report

EX003-0/06  
April 2008

Type of occurrence: Serious incident  
Date: 4 March 2006  
Location: Munich  
Aircraft: Transport aircraft  
Manufacturer / Type: Airbus Industrie / A310-300  
Injuries to persons: No injuries  
Damage: Aircraft not damaged  
Other damage: Crop damage  
Information Source: Investigation by BFU

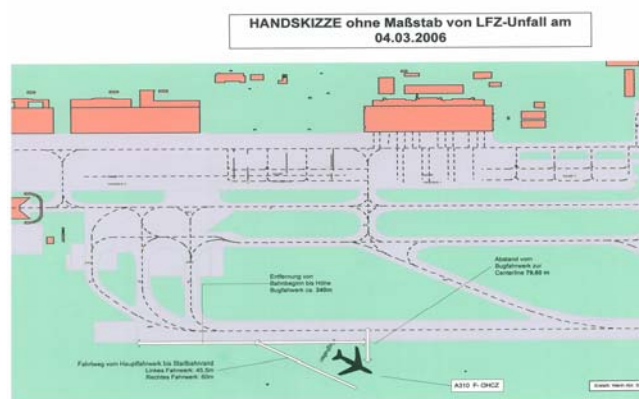
keep the airplane on the runway. The Airbus veered off the runway at an angle of approximately 45°, about 250 m after the beginning of the take off run and at a speed of approximately 30 kt. The airplane came to a stop on unpaved terrain about 60 m to the right of the runway. Nobody was injured and the airplane remained undamaged.

The airplane stood on unpaved terrain about 250 m beyond the intersection B3 and perpendicular to the runway. The terrain was covered with approximately 40 cm of snow and the ground was frozen solid. During the runway excursion the RH engine had ingested a larger amount of snow. Soil stuck to the landing gears. The airplane was not damaged.

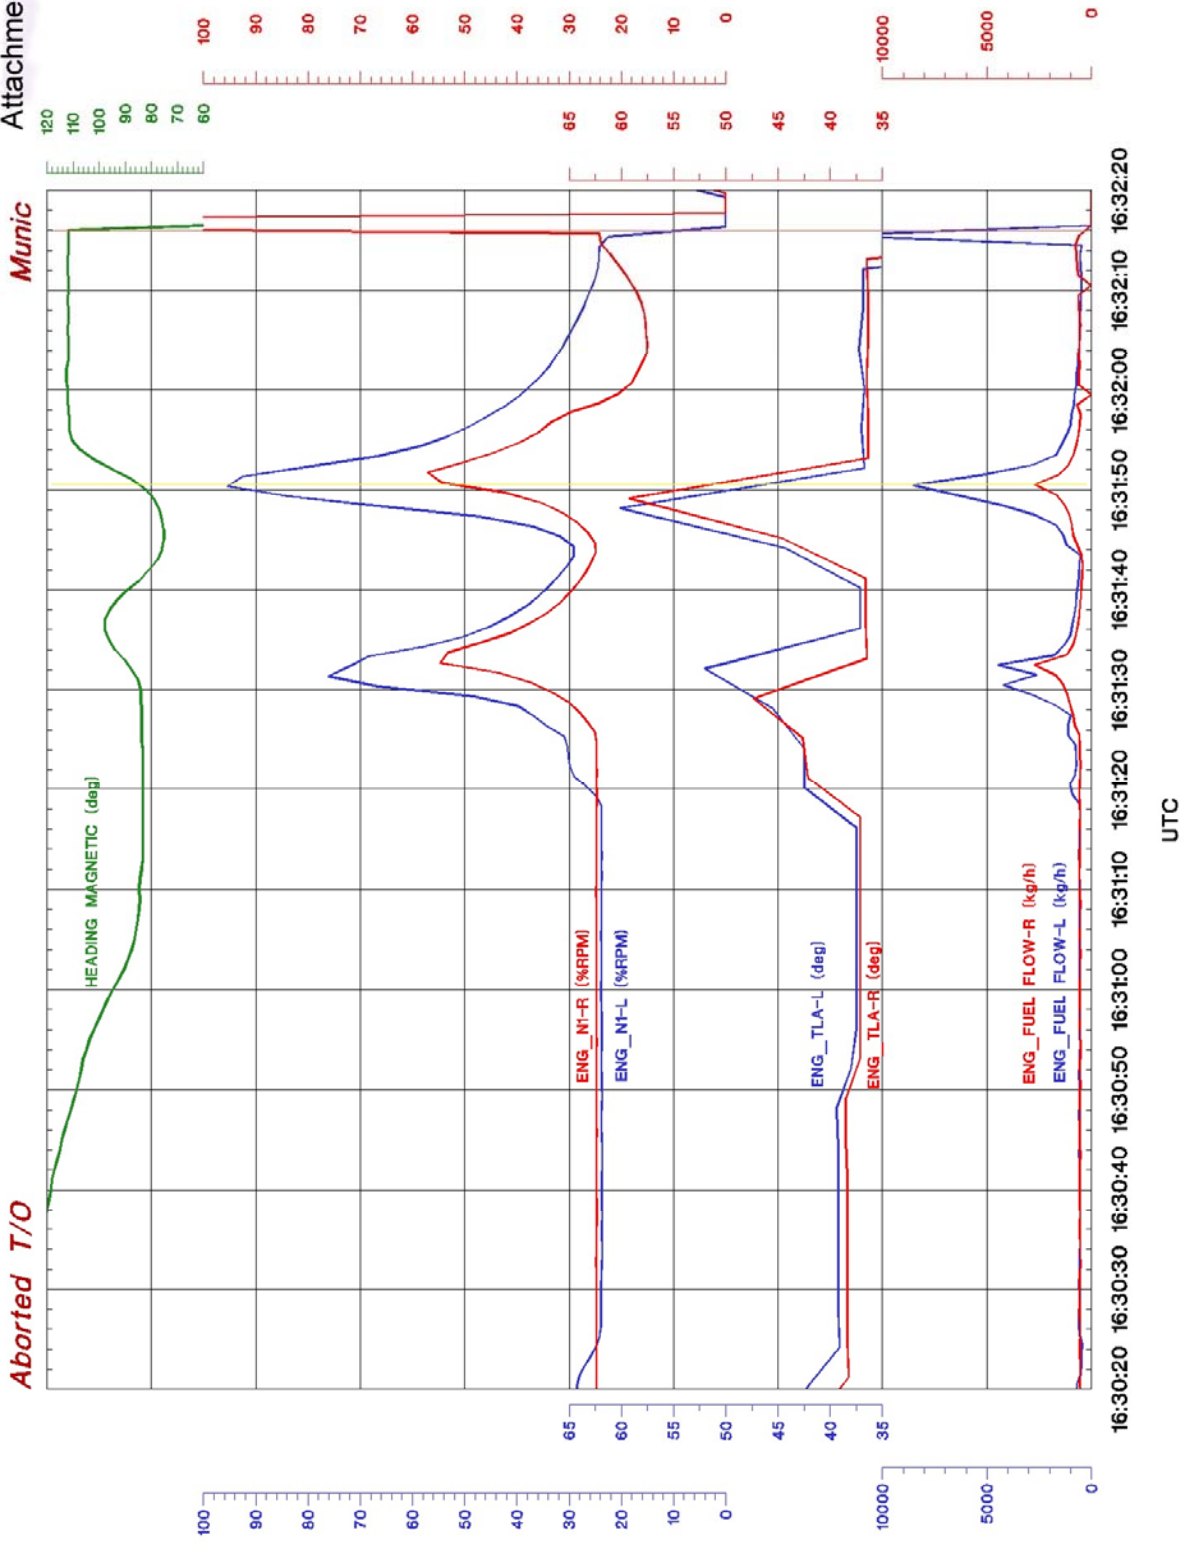
Attachment 1

After line up with runway 08R the thrust levers were positioned at 43° for two seconds and then moved continuously forward. The RH thrust lever was moved to 47° and the LH to 52°. The RH engine reached an N1 of 54% and the LH of 76%. Afterwards both thrust levers were pulled back into idle for a short period of time. The RH thrust lever for four seconds and the LH for two seconds.

During the second acceleration phase both thrust levers were continuously moved to 59° and 60°, respectively, within six seconds. The RH engine reached an N1 of 56% and the LH of 96%. Without delay both thrust levers were moved back to idle.

In both phases the fuel consumption of the RH engine never exceeded 2,700 kg/h whereas the LH engine consumed a fuel quantity of 4,300 kg/h at the first acceleration phase and 8,500 kg/h at the second.

Analysis of the FDR data showed that the fuel consumption of the RH engine never exceeded 2,700 kg/h independently of the position of the thrust levers. Also N1 of the RH engine was with 54% and 56%, respectively, very close in both phases.
