Investigation Report

Type of Occurrence:	Accident
Date:	4 October 2007
Location:	Düsseldorf
Aircraft:	Airplane
Manufacturer / Model:	Airbus / A330-322
Injuries to Persons:	None
Damage:	Aircraft severely damaged
Other Damage:	Minor damage to buildings and outdoor facilities
Information Source:	Investigation by BFU
State File Number:	BFU 1X002-07

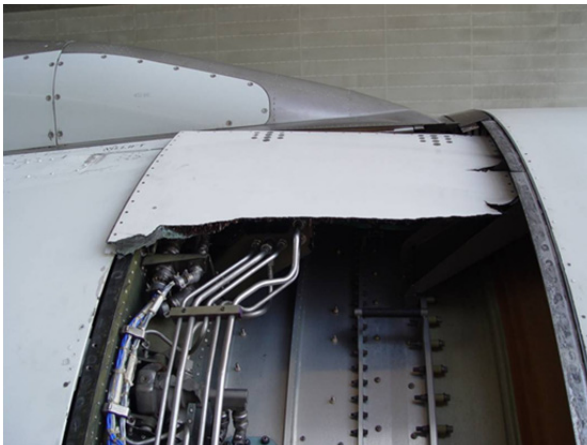
Each of the two cowling doors had fractured directly below the hinges. The fragment of the right (inner) cowling door got jammed below the cowling. On the left (outer) door a front and an aft fragment were found. The aft fragment was jammed below the fixed cowling part. The front fragment was movable.

Residual fracture, right and left side

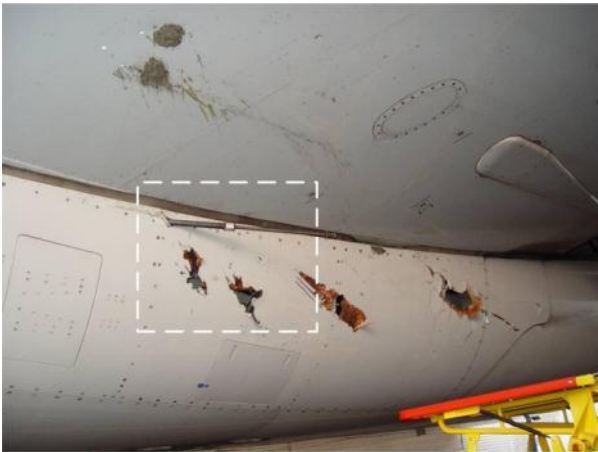
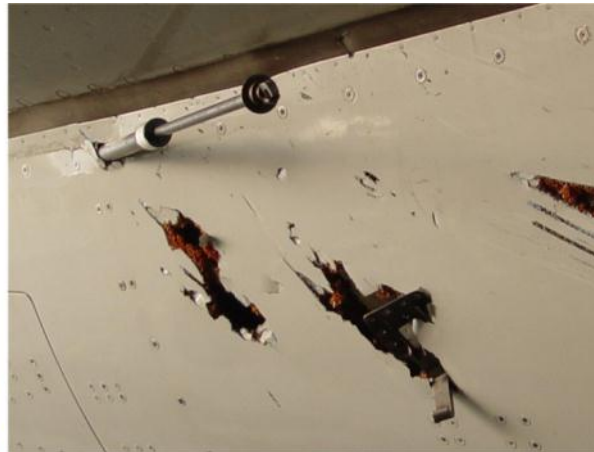
8 mm. Other parts of the cowling had damaged the belly fairing. One of the telescope bars had penetrated the fairing. Once the belly fairing was removed, damages to the structure and hydraulic pipes were determined. Only lines of the blue system were affected which had the following functions:

- Blue system reservoir air pressurisation
- Return line engine #1 thrust reverser
- Engine Driven Pump (EDP) case drain line
- EDP suction line (blue system),

Furthermore, parts of the cowling latches were found in this zone.

Damages to the belly fairing

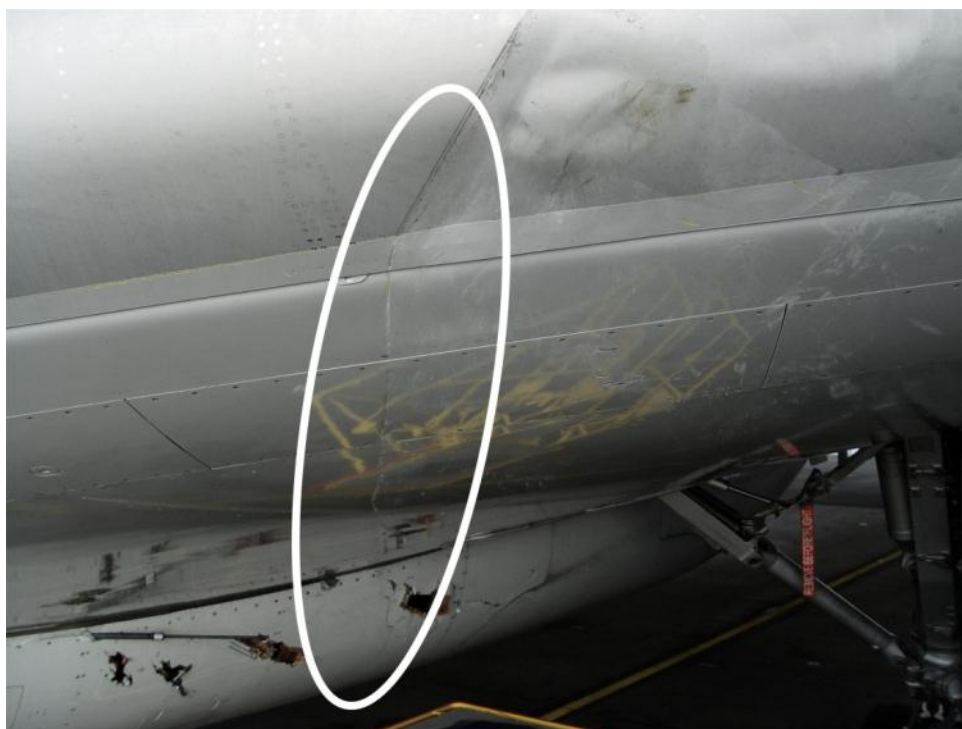
Additional damages were found on the slats, the flap fairing and on two passenger windows. A continuous scratch mark ran from the initial impact mark on the slats to the belly fairing.

Continuous scratch mark on the lower surface of the wing

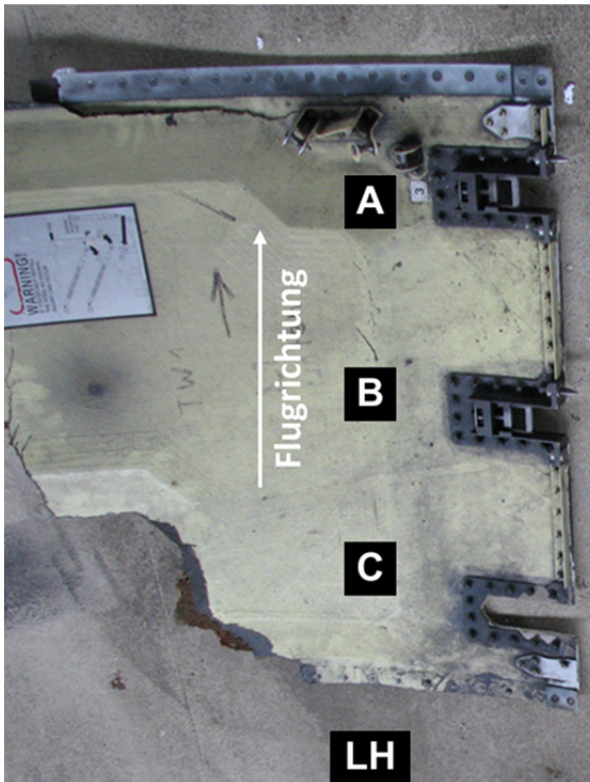
The lower section of the cowling doors showed different damages. On the left door the front two keeper housings (A and B) did not show any damages or impact marks, the aft clevis (C) was torn out. On the left door the front hook (A) was severely damaged, the centre hook (B) was torn out and the aft hook was damaged. The pieces found on the ground and in the belly fairing, respectively, could be matched with latches A and B, respectively (Appendix 1). The outer edge (in the area of the engine centre line) of the left cowling door was straight and did not show any damages. The outer edge of the right cowling door, however, showed an arch-shaped deformation.

Damages to the latches

The latches showed the damages described in Appendix 2. The engine manufacturer, who was also responsible for the cowling, examined all latch parts as well. It was determined, among other things, that on the front hooks of latches A and B white paint residue was present which matched the paint of the cowling.

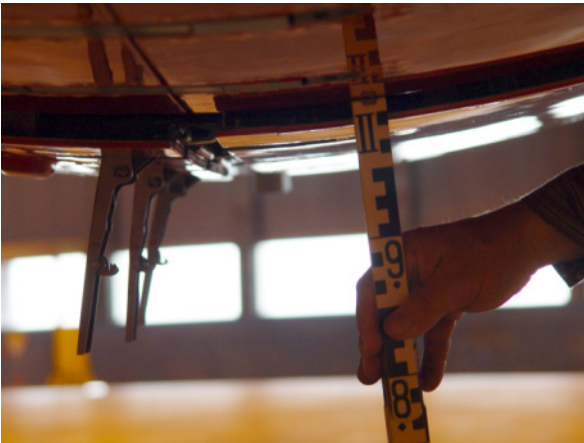
Closed and clasped cowling.

Closed cowling with one clasped latch (aft)
Photos (2): BFU

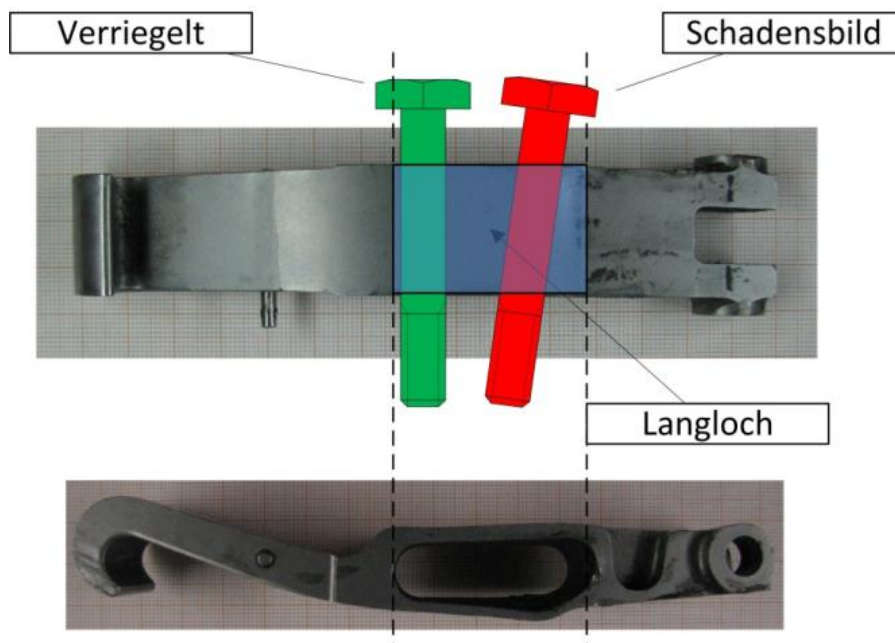
The deformation of the latch pin slots of latches A and B are about in the centre. Therefore, the deformation occurred with the hooks not in the locked position (red bolt); in the locked position the bolt would be at the outer end of the hook (green bolt). Since the deformation line does not run perpendicular to the longitudinal axis of the hook, the damage must have occurred when the hook was not locked otherwise the clevis and the bolt would have caused a perpendicular deformation.

Position of the bolt in a locked latch versus the damage (latch A)

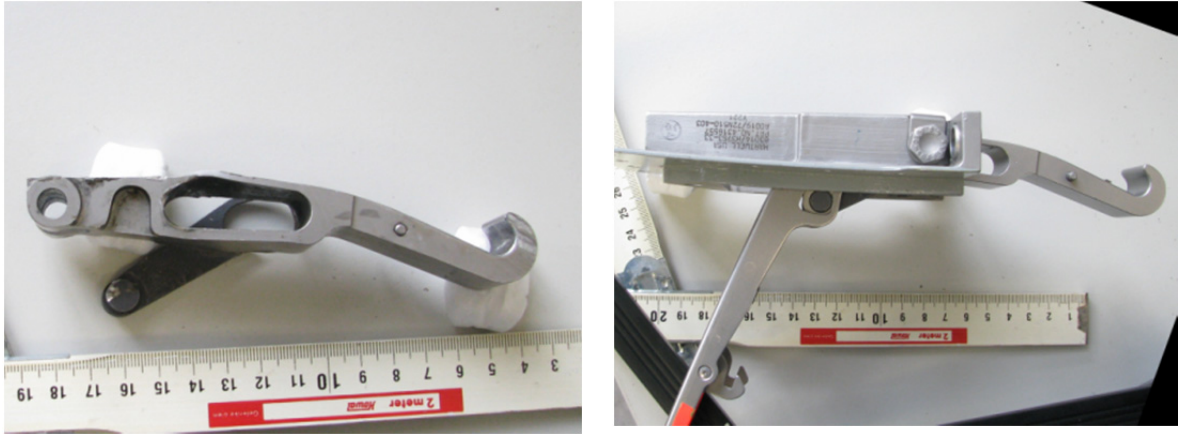
The position of the impact mark on the link (#3) also indicates that the hook and the handle of latch B were not closed when the damage occurred.

The approximate position of the link versus an undamaged latch

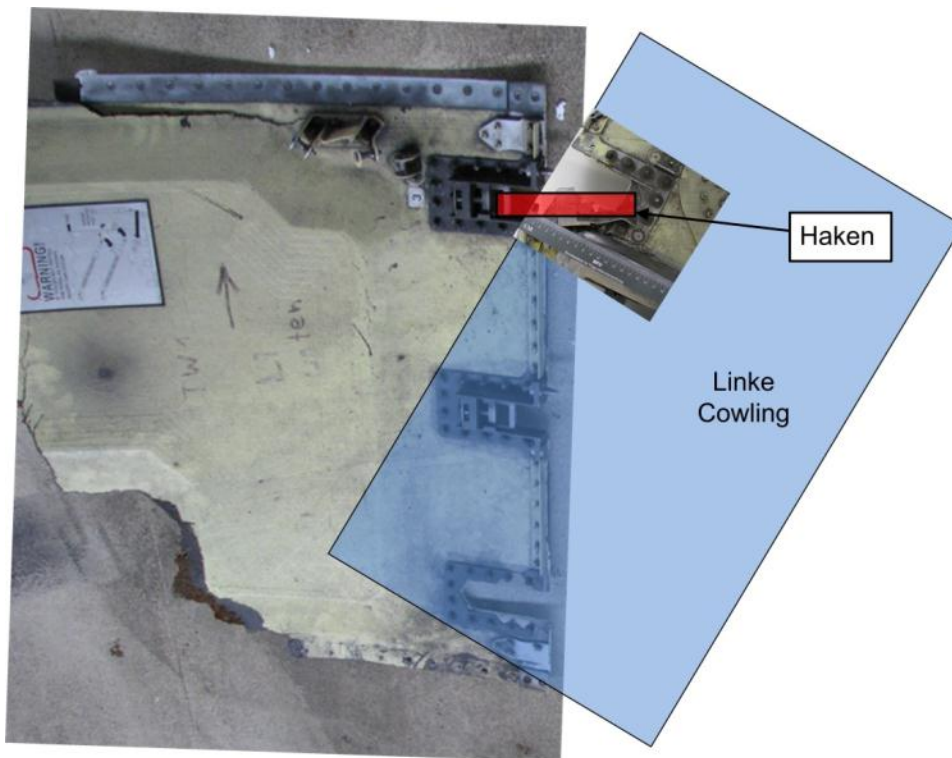
The deformation of the aft flank of latch housing A, the indentation of the latch hook (#4) and the deflection of the bolt (#2) show that the hook was deflected by about 30° at the time. Geometrically it is not possible that at that time all latches were aligned because the left aft part of the cowling door would have overlapped with the right. Therefore, the conclusion can be drawn that the aft flanks of the latches were unlocked when the deflection occurred.

Position of the left cowling (if latch A was locked)

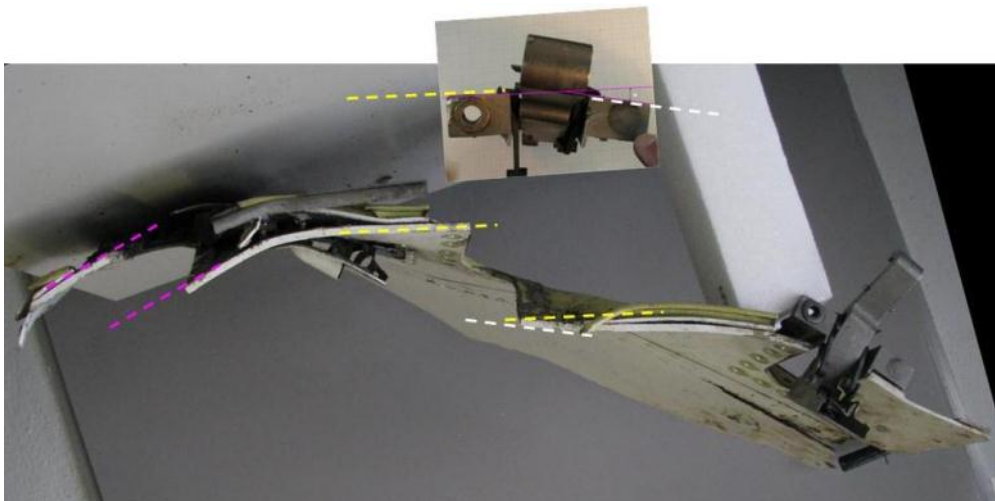
The arch-shaped deformation on the outer edge of the right cowling door could not have occurred with a properly locked cowling latch otherwise a similar damage could be found on the left door. The left door, however, is mainly undamaged and straight. Due to this fact, the deformation has occurred as individual latches were not properly connected with the opposing part of the right cowling. The arch-shaped bends match the deformation of the cowling latches. Therefore, it is highly likely that the latches were peeled from the cowling one by one.

Arch-shaped deformation on the outer edge of the right cowling door

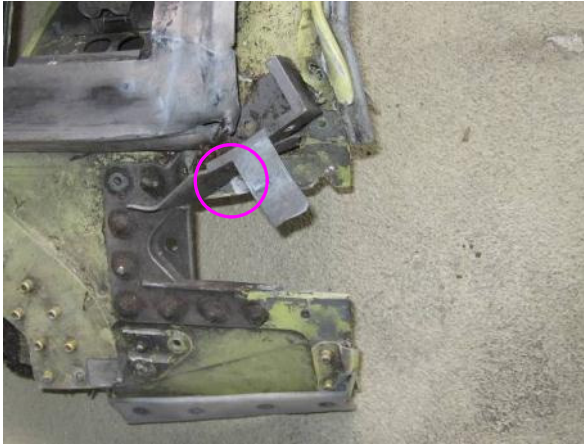
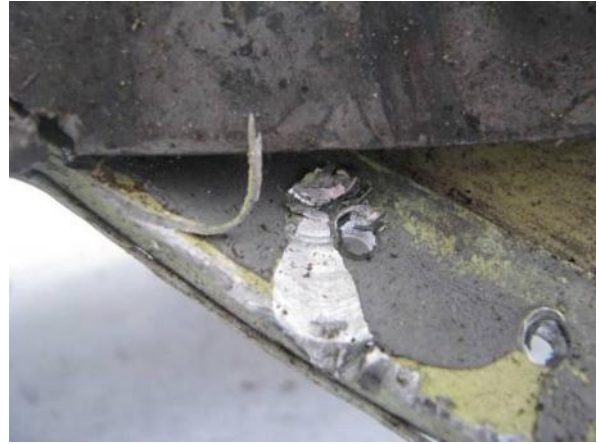
Latch A:

The aft flange of the housing was torn out and bent backward by about 30°. A dent was found (about 70 mm from the outer end).

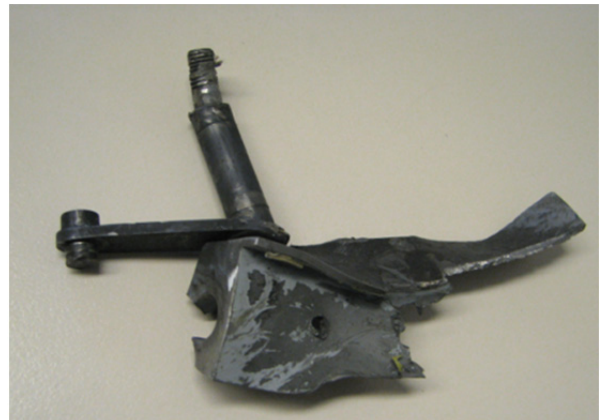
Latch housing part #2 (part of latch A):

The bolt was bent by about 30°. The thread end was twisted by about 30° (about parallel to the screw head). The receiving hole of the bushing was torn and showed an oval-shaped deformation.

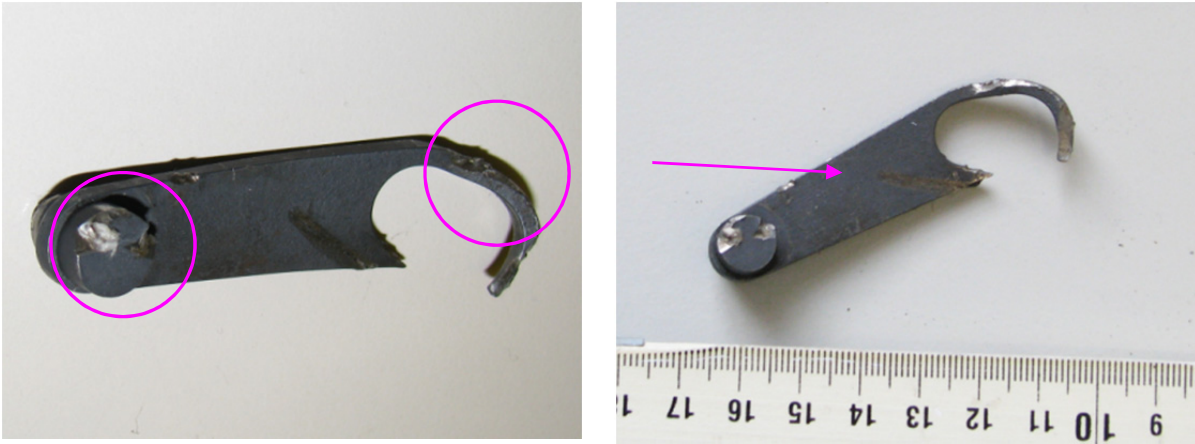
Link #3

The link showed a line-shaped impact mark which was slanted by about 30° in relation to the longitudinal axis

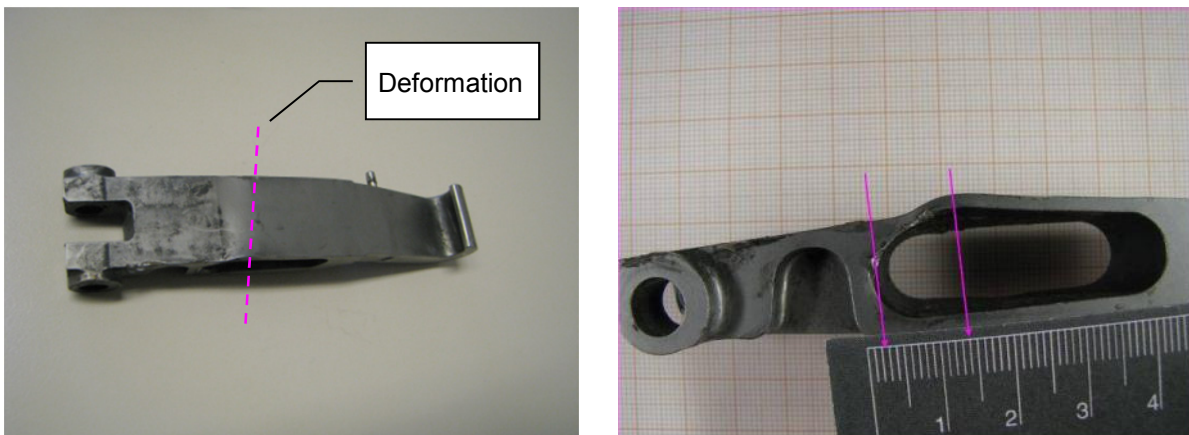
Hook #4 (part of latch A):

The hook showed a line-shaped deformation which was more pronounced at the front end. The line did not run perpendicular to the longitudinal axis of the hook (deviation about 7°). The housing of the hook was twisted. White paint residue was found on the front end.

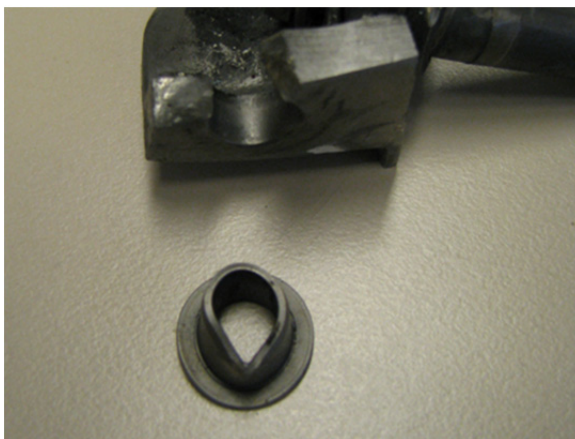
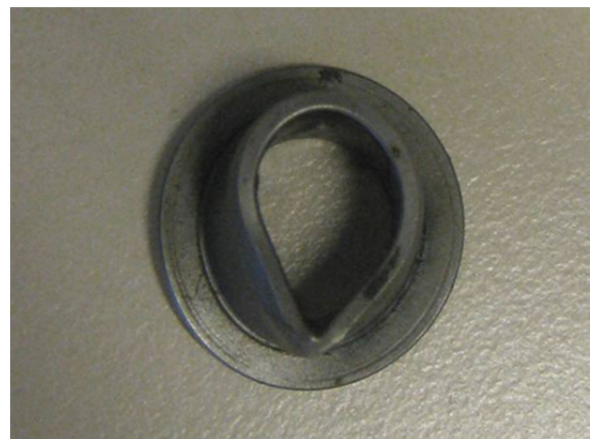
Shear Pin Receiving Bushing #6 (part of latch A):

The bushing showed an oval-shaped deformation and fit into the similar shaped receiving hole of housing #2.

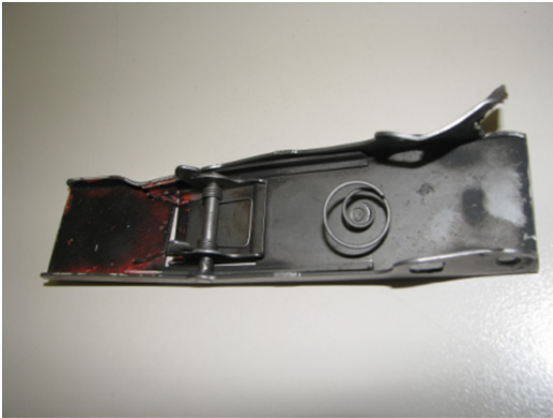
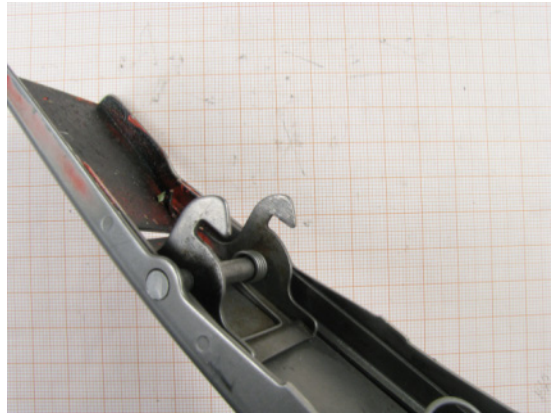
Handle #5:

The handle was slightly twisted and one of the aft receiving holes was torn. The two locking hooks were undamaged. The orange alarm colour was worn and covered by grime. It could not be unambiguously matched with latch A or B.

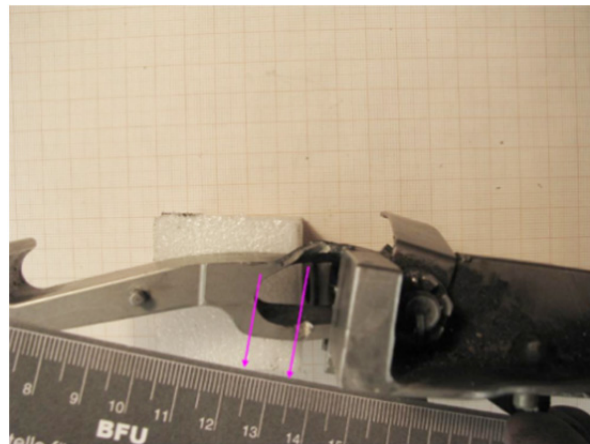
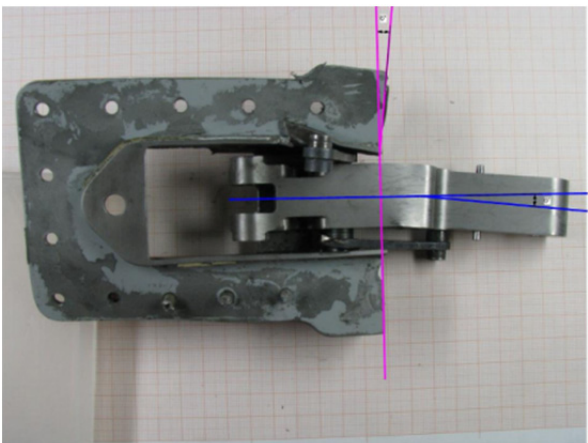
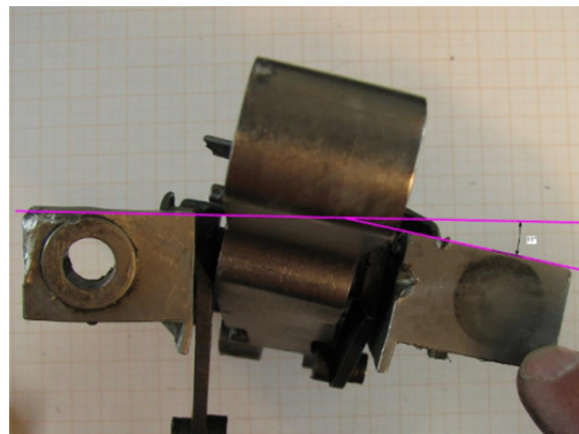
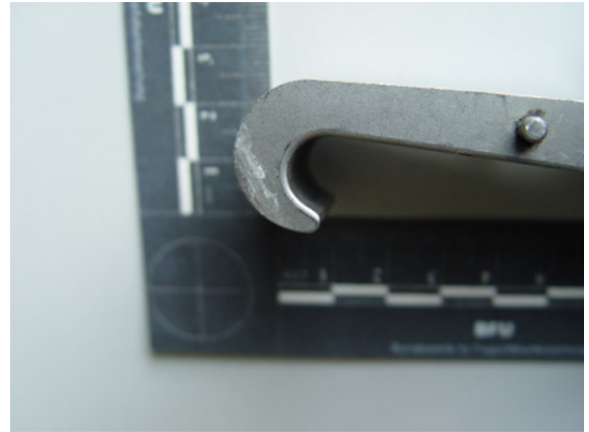
Latch B

The housing was twisted. The hook showed a line-shaped deformation which was more pronounced at the front end. The line did not run perpendicular to the longitudinal axis of the hook. The bushing showed an oval deformation on its inner end.

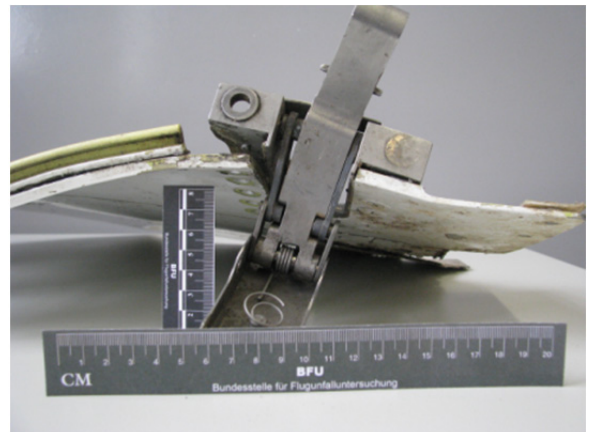
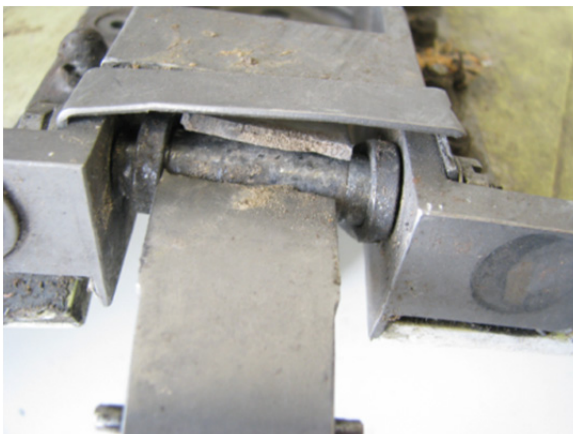
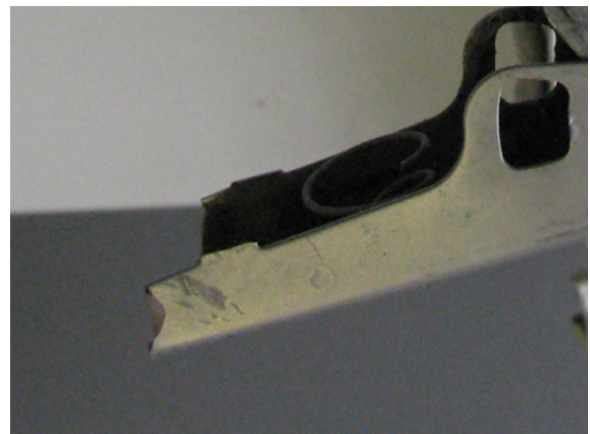
Latch C

The housing was not twisted. The hook of the latch was bent backward and had fractured in a straight line. The handle was fractured and both locking hooks were torn off.

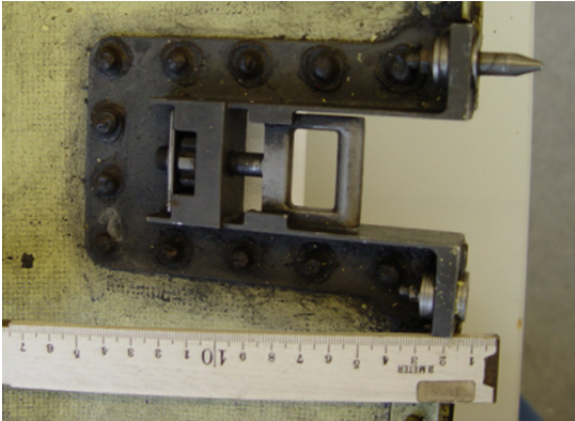
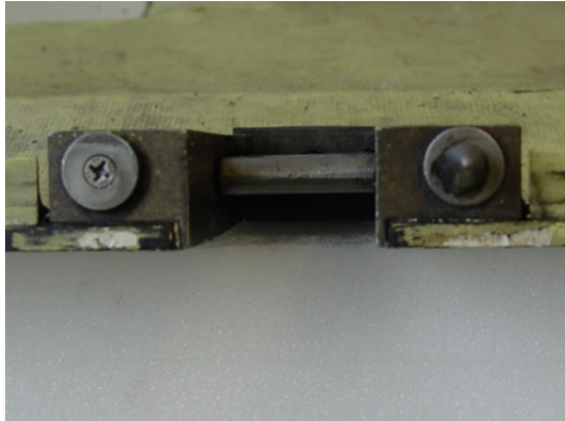
The keeper housing assembly did not show any visible damage.

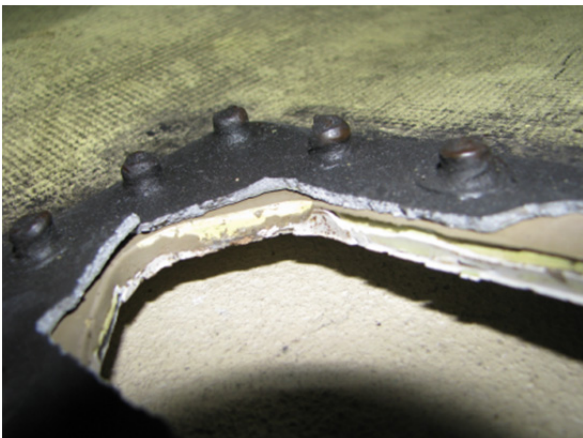
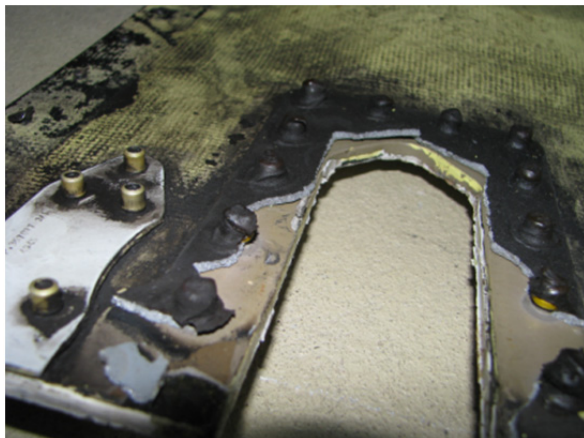
Keeper housing assembly C

The keeper housing assembly in the area of the mounting flange was destroyed.
