Factual Report

CX008-0/07
September 2007

Type of Occurrence: Accident
Date: 16 June 2007
Location: Seedorf airfield
Aircraft: Aeroplane
Manufacturer / Model: Avions Pierre Robin / DR 400-160
Injuries to Persons: Pilot and two passengers fatally injured
Damage: Aircraft destroyed
Other Damage: Forest damage
Source of Information: Investigation by BFU

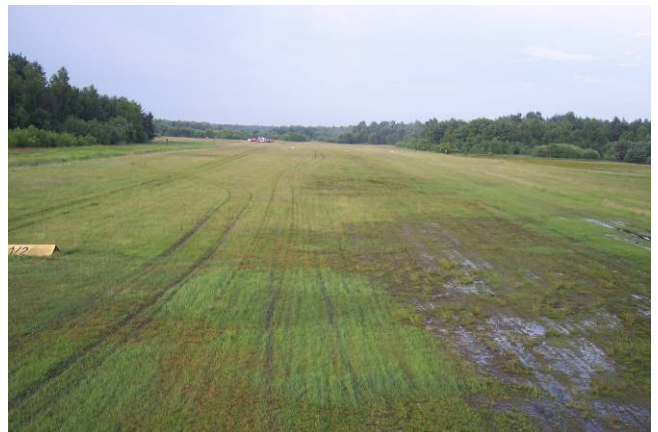
Seedorf special airfield is situated within a military area and is operated by a Dutch flying club. It has a grass strip 450 m long in 06/24 direction with grass areas of approx. 250 m on both ends of the strip. The grass had not been mown for a longer period of time. Due to the rain on the days before, the strip was wet and the soil was soft. The airfield is surrounded by forests. Its elevation is 72 ft MSL.

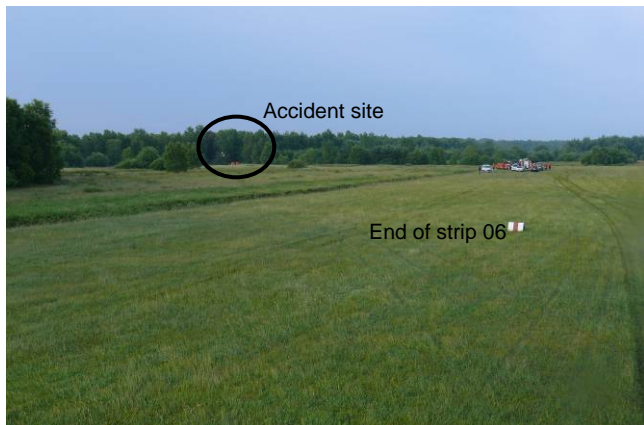
The site of the accident was situated approx. 150 m to the north-east of the end of grass strip 06, with an offset of approx. 30°, at Seedorf special airfield at the beginning of a forest.

The trees were first touched with the right wing at an altitude of approx. 5 m. The right wing was torn off between aileron and landing flap and stayed hanging in the tree. As a result, the aircraft hit the ground head-on 13 m away and caught fire in an explosion.

All components of the aircraft were found close to the site of the accident. However, some of them were completely burnt. Remnants of the steering and control-surface fittings were found, they did not show any signs of technical defects.
