Investigation Report

Type of Occurrence:	Serious incident
Date:	17 August 2007
Location:	Munich Airport
Aircraft:	Transport aircraft
Manufacturer / Model:	Airbus / A 330-200
Injuries to Persons:	None
Damage:	Minor damage to aircraft
Other Damage:	Taxiway surface
State File Number:	BFU EX007-0/07

While initiating a turn during taxiing to the runway the bogie beam of the right main landing gear fractured behind the shock absorber.

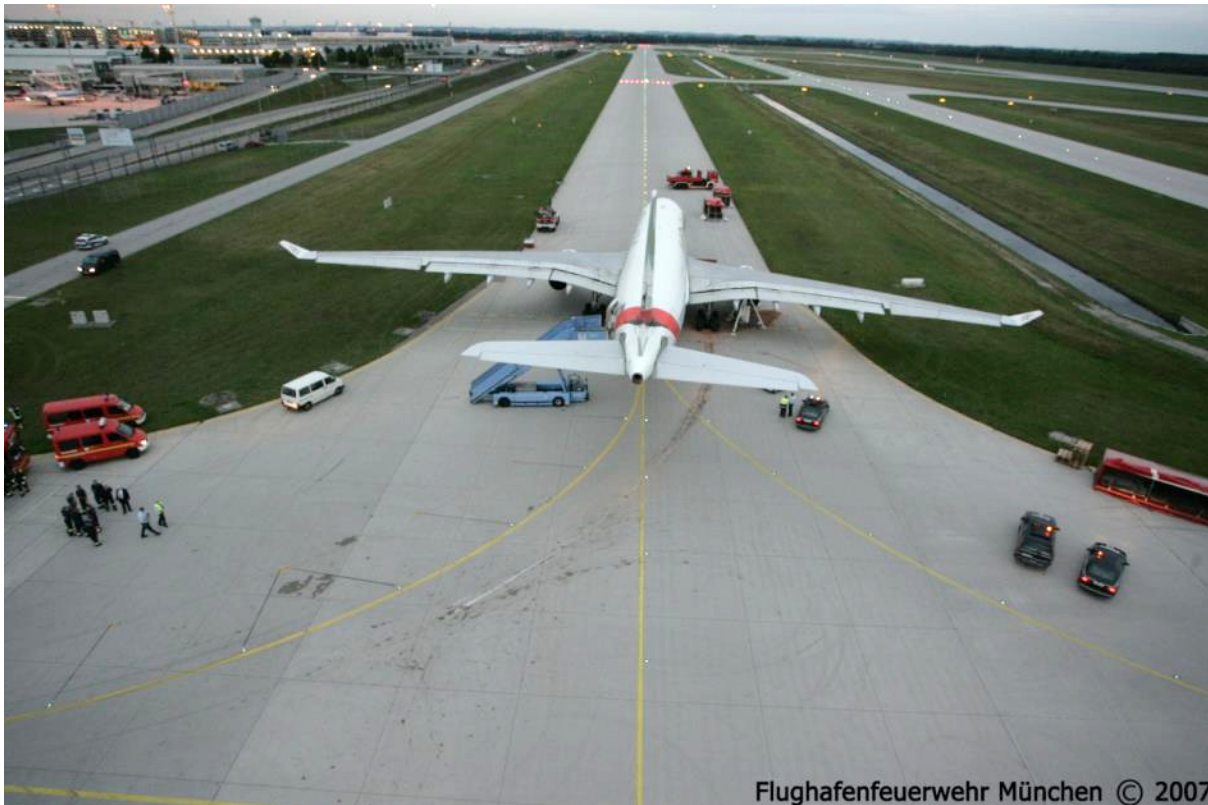
Image 1: Taxiway Sierra

A spot of hydraulic fluid and an impact spot were found in the intersection of entrance Sierra to taxiway Sierra. Beginning at this impact site and all along the turn radius a deep groove was visible. This groove was 42.8 m long and up to 3 cm deep.

The airplane stood on taxiway Sierra behind the intersection Sierra 6 pointing in 082°. It had tilted right. The right engine and the right wing did not have ground contact. The bogie beam of the right main landing gear had fractured into two parts. The fracture had occurred approximately 90 mm behind the pivot pin, which connects the shock absorber with the bogie beam. Due to the fracture the aft part of the bogie beam including the aft axle and the aft wheels had been completely severed. Only two brake rod linkages connected the aft part of the fractured bogie beam, aft axle and aft wheels to the rest of the landing gear. The airplane had come to a halt with the right main landing gear shock absorber sliding tube clevis fork legs contacting the taxiway surface.

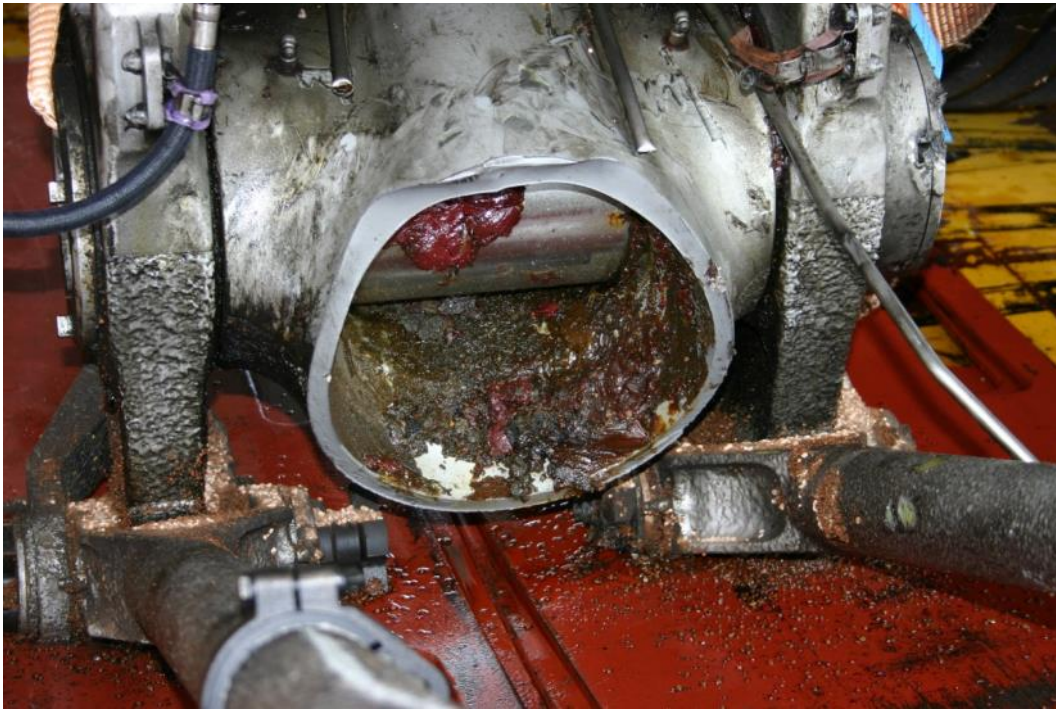
Image 2: Front part of the bogie beam including pivot pin

An initial on-site examination of the bogie beam's fracture revealed that the fracture had its origin in the 6-o'clock position of the bogie beam main bore. The paint on the inside of the bogie beam bore at the bottom was in places locally missing. The two fracture surfaces showed some damages due to dragging along the taxiway surface. The lower edge of the outer diameter was abraded on both sides of the fracture surface. The lower ends of the landing gear shock absorber sliding tube clevis fork legs and the brake linkage were also abraded. The brake hoses for the aft wheels had been torn off. Different substances such as lubricants and contaminants were found inside the bogie beam bore. Images 2 and 3 show the fracture surfaces.

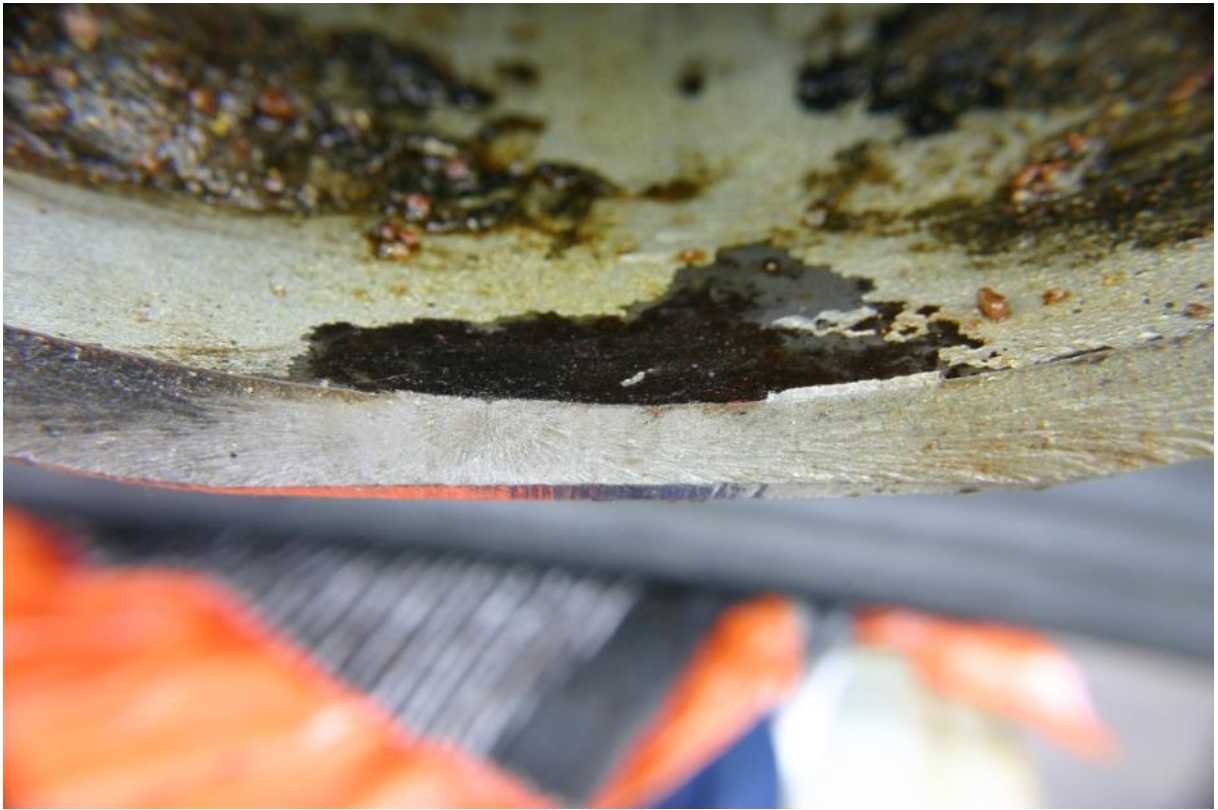
Image 5: Fracture with point of origin

The fracture surface was examined under an optical microscope (30-times magnified) and the fracture origin located on the surface at the bottom of the bogie beam bore. Image 6 shows the corrosion pit, which was the cause of the crack.

The surface of the rest of the fracture showed a ductile appearance. The wall thickness, as shown in the Images 5 and 7, was thinner than the original, because part of the outer radius had been abraded by dragging along the taxiway surface.

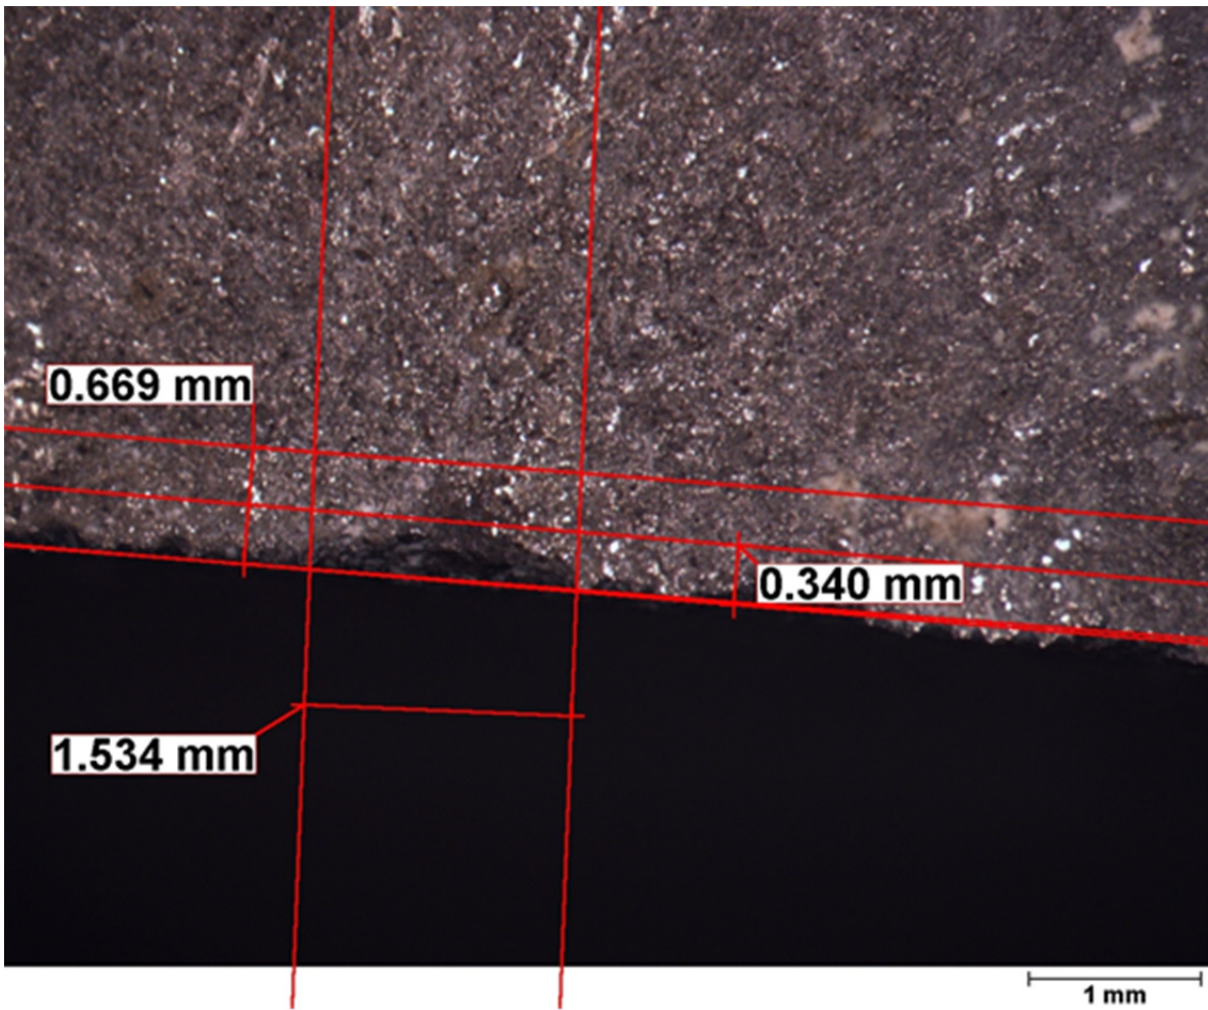
Image 6: Fracture origin at the bogie beam bore

The corrosion pit had a total depth of 0.669 mm and at its surface a diameter of 1.534 mm. The fracture surface surrounding the pitting corrosion showed indications of intergranular fractures with the characteristic thumb nail shape. The length of the shear lips was 10.506 mm and fracture bands of a depth of up to 6.4 mm were found. Stress corrosion was the mode of crack propagation.

Pitting corrosion constituted the origin for the fracture. The crack propagated in an intergranular mode from there until the ductile rupture occurred. Crack initiation and propagation occurred through stress corrosion.

The BFU refrains from issuing safety recommendations, because right after the commencement of the investigation the landing gear manufacturer implemented a corresponding one time inspection program of in-service bogie beams. The landing gear manufacturer described the inspection checks in the Service Bulletins (SB) A33/34-32-271 and SB A33/34-32-272. The aircraft manufacturer used these for its SB A330-32-3212 (for the aircraft type A330) and SB A340-32-4268.
