# Investigation Report

Type of Occurrence:	Accident
Date:	1 August 2008
Location:	Near Zadar / Croatia
Aircraft:	Airplane
Manufacturer / Model:	Piper / PA-44
Injuries to Persons:	Two persons fatally injured
Damage:	Airplane destroyed
Other Damage:	None
Information Source:	Investigation by BFU
State File Number:	BFU 4X029-08

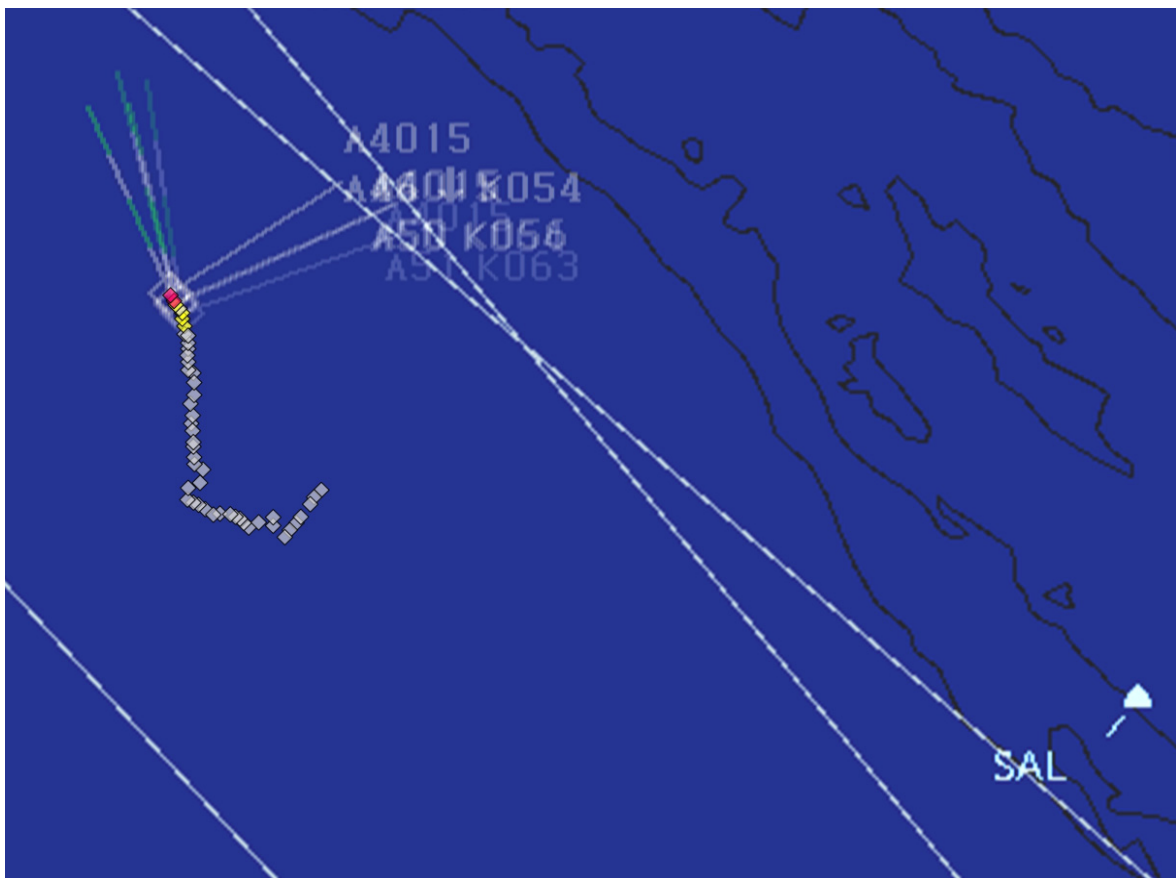
Graph depicting the flight path based on the radar data;  
The yellow data points match a speed of 61 to 68 kt;  
Red data points match a speed of 60 kt.

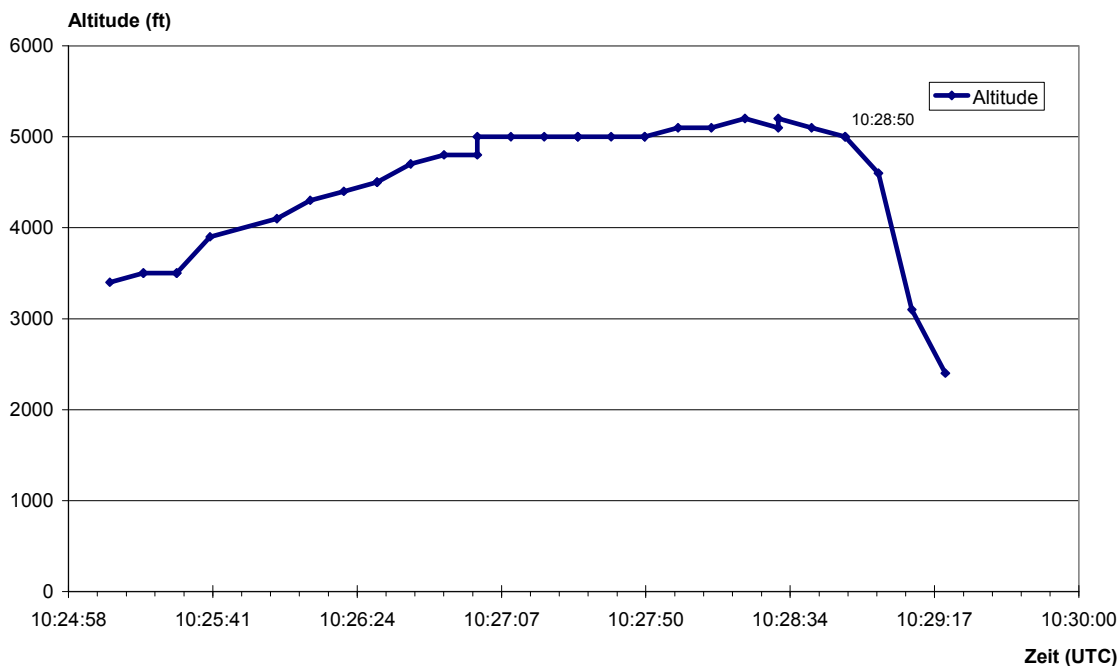
Display of altitude based on the radar data.

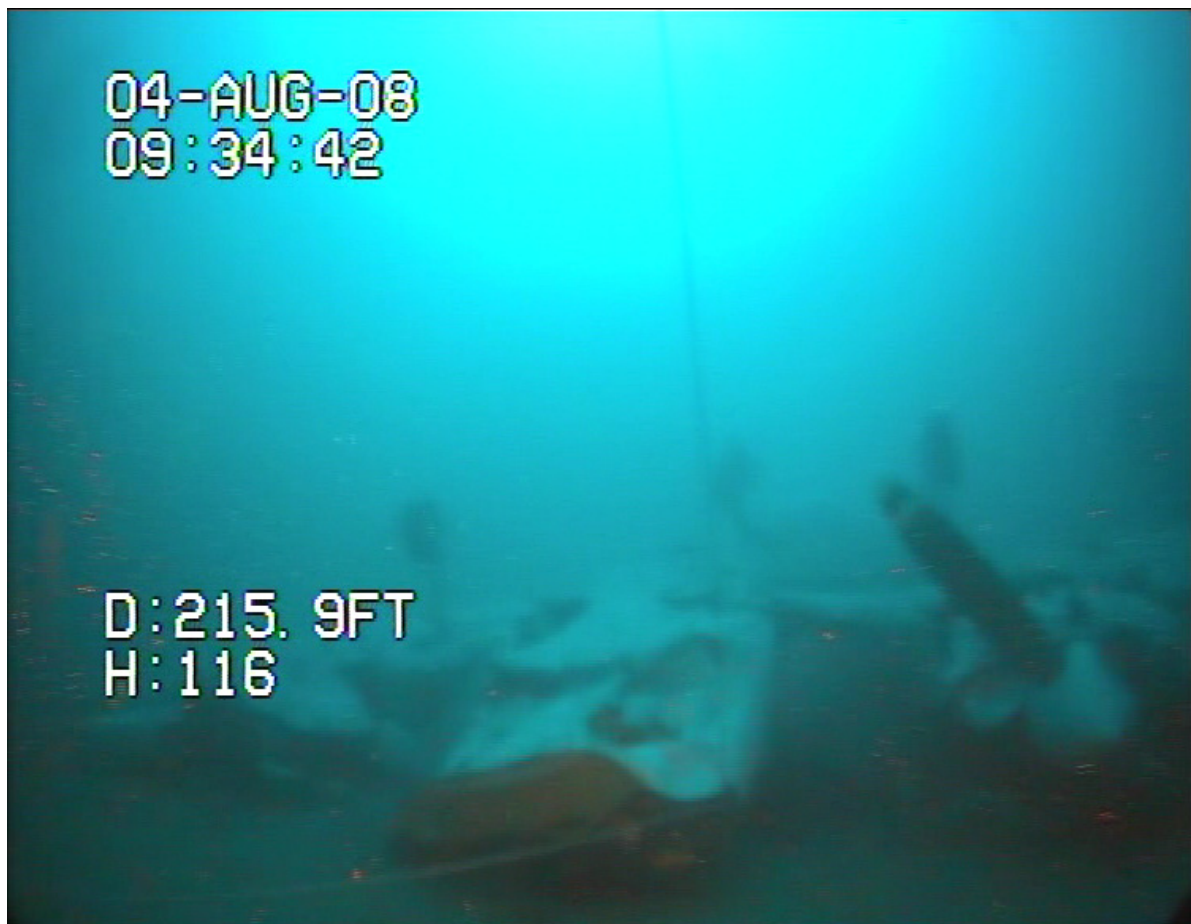
Underwater photo prior to recovery

The airplane tail was laterally bent, but still connected to the fuselage. Big areas of the nose, the fuselage's lower surface as well as the wings lower surfaces extensive dents. The right aileron was torn off. The blades of both propellers did not show any or only very little damage. The main landing gears were extended. The nose landing gear was retracted. The spinners of both propellers were dented at the bottom and did not show damage at the tips. The BFU was not provided with any further information regarding the configuration of the aircraft while still on the seabed (before the recovery).

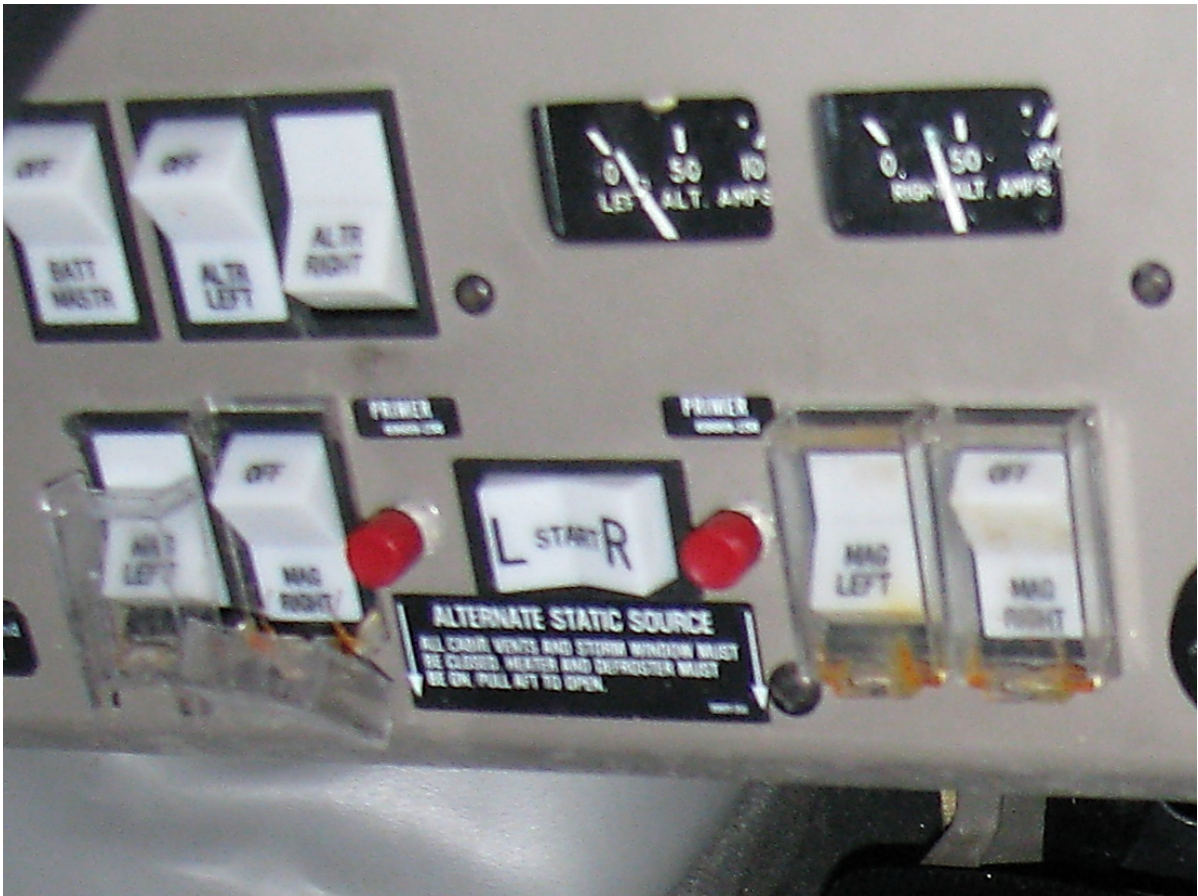
Magneto switch

The Battery Master Switch and the Left Alternator Switch were found in the „off“-position. The Right Alternator Switch was in the “on”-position.

The absence of serious damage to the propellers shows that the engines delivered little or no power at all at the moment of impact with the water surface. This also confirms that the forward speed was low, because the propellers were not bent back-ward. The discovered position of the engine operating levers did not allow any conclusion as to their position during the impact, because the engines had been moved several times with respect to the fuselage and had finally been separated from the wings. This could have led to multiple movements of the Bowden cables, changing the position of the engine operating levers. The undamaged protection caps of the magneto switches show that the right magnetos of both engines were switched off. It is possible that they were not switched back on again during the pre-start check. It is also possible that during an in-flight engine shut-down the right magneto switches of both engines were inadvertently switched off, instead of both magneto switches of the right engine. There are no further indications for both possibilities, so that they cannot be considered for the analysis of the accident. It is very probable that the position of the magneto switches is not related to the cause of the accident

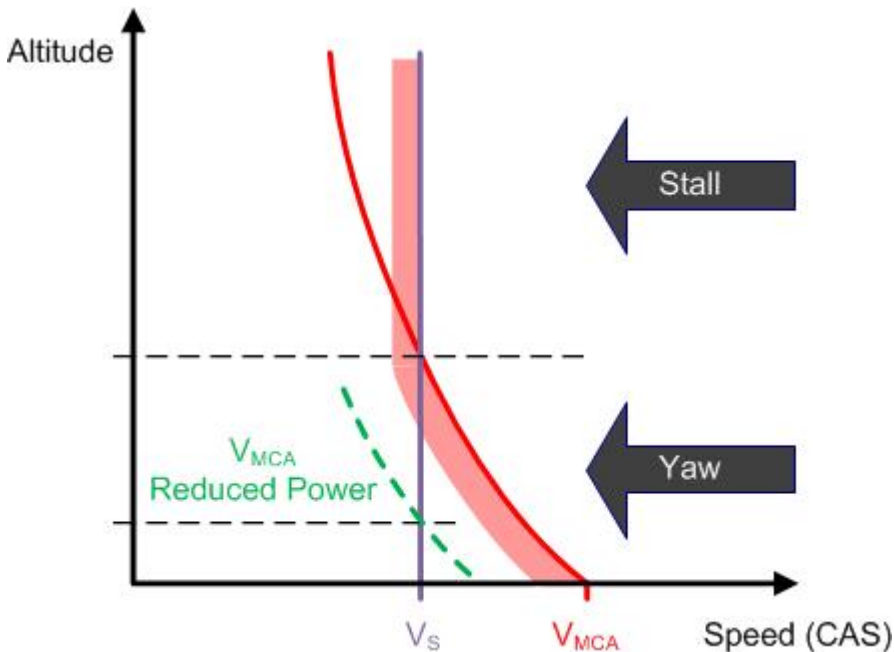
Contrary to the  $V_s$  the  $V_{MCA}$  (CAS) decreases in higher altitudes. Depending on the altitude either  $V_{MCA}$  or the stall speed is reached when speed is decreased in single-engine flight.  $V_{MCA}$  also decreases if the engine power is set to a less asymmetrical condition. Due to this, the altitude decreases by which the  $V_{MCA}$  becomes lower than the stall speed.

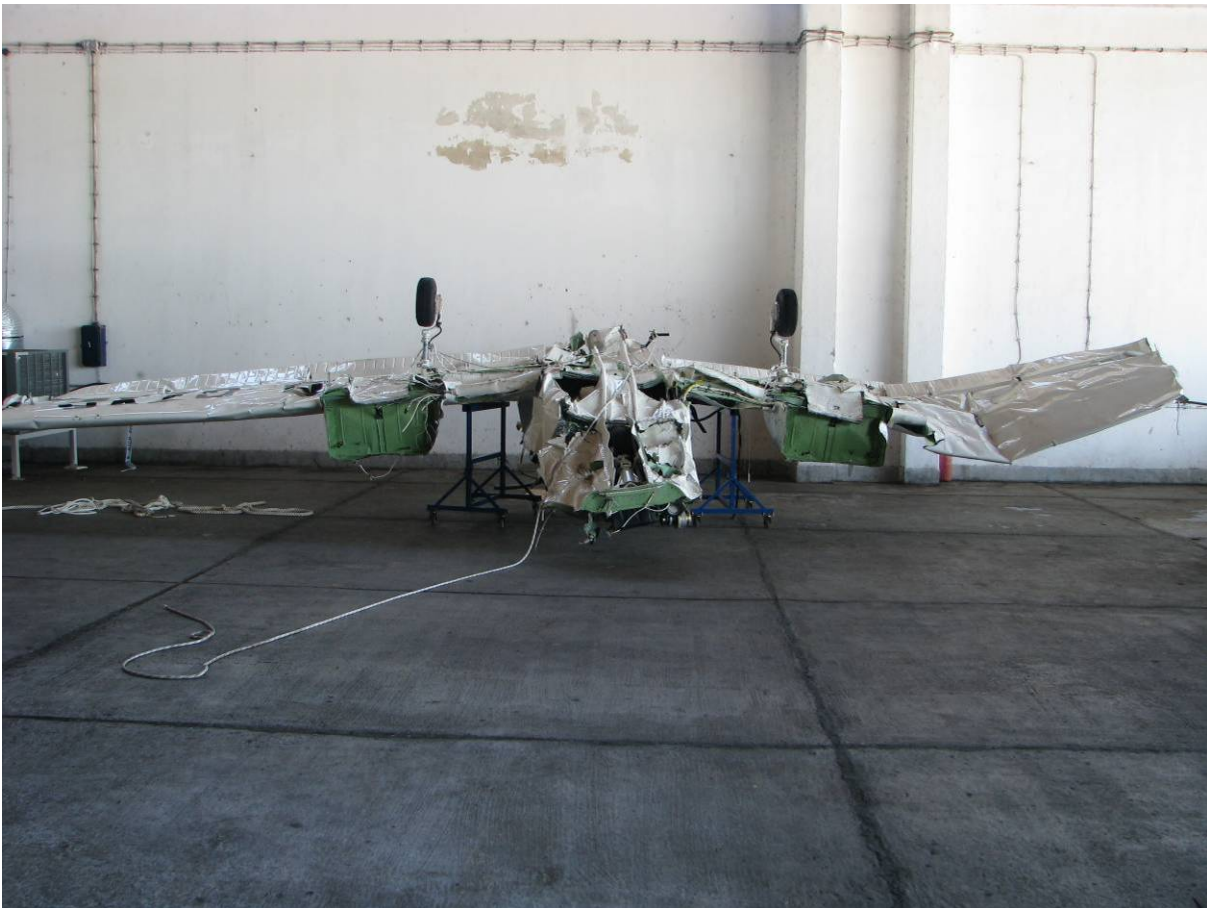
The extensive damage on the bottom side of the aircraft allows the conclusion that the aircraft hit the water surface with a horizontal attitude. The damage to the propeller spinners confirms this. Whereas the lower sides showed the contours of the propeller hub, the upper sides and the tips of the spinners were almost undamaged. From these facts it can be derived that the aircraft hit the water surface with a high vertical and a low horizontal speed.

Aircraft lower surface in the hangar after recover
