Investigation Report

Type of Occurrence:	Accident
Date:	4 April 2009
Location:	Near Hartenholm
Aircraft:	Helicopter
Manufacturer / Model:	Hughes Helicopter / Hughes 369HS
Injuries to Persons:	Two persons severely injured Three minor injuries
Damage:	Aircraft severely damaged
Other Damage:	Minor crop damage
Information Source:	Investigation by BFU
State File Number:	BFU 3X018-09

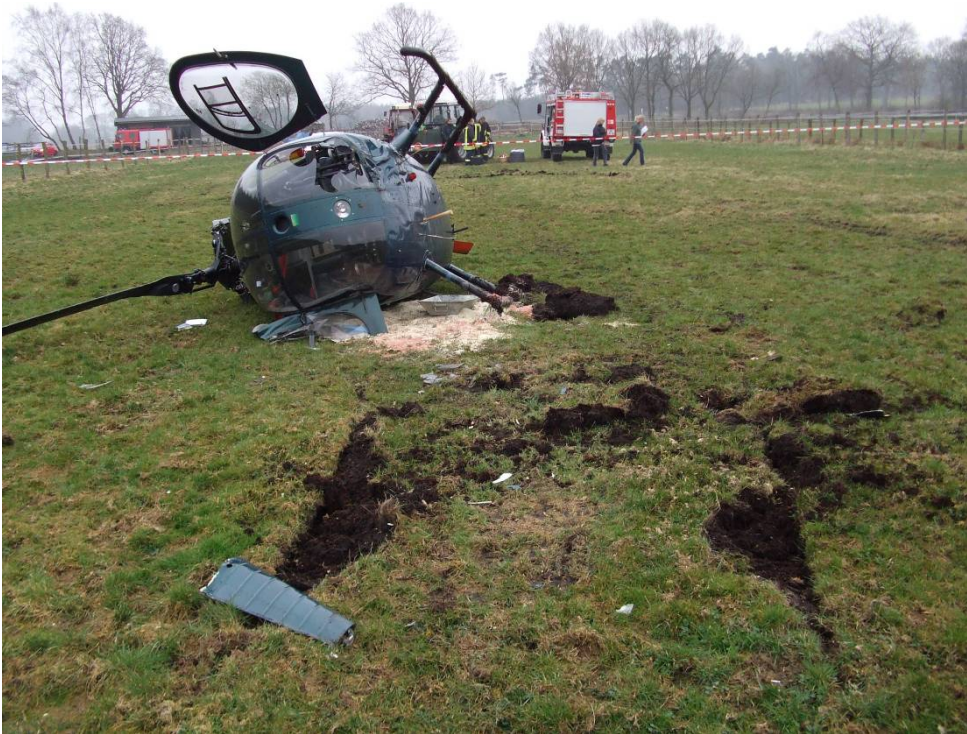
about 6 m north-west of the wreckage. The tail boom had been severed. Parts of the tail boom and the tail section were found about 20 m west of the main wreckage. Indentation marks of the skids were found about 3 m north of the wreckage. An about 3.5 m long indentation mark of the tail skid was found about 8.60 m North of the wreckage and axial to the extension of the indentation marks of the skids.

Indentation marks of the skids and wreckage position from flight direction

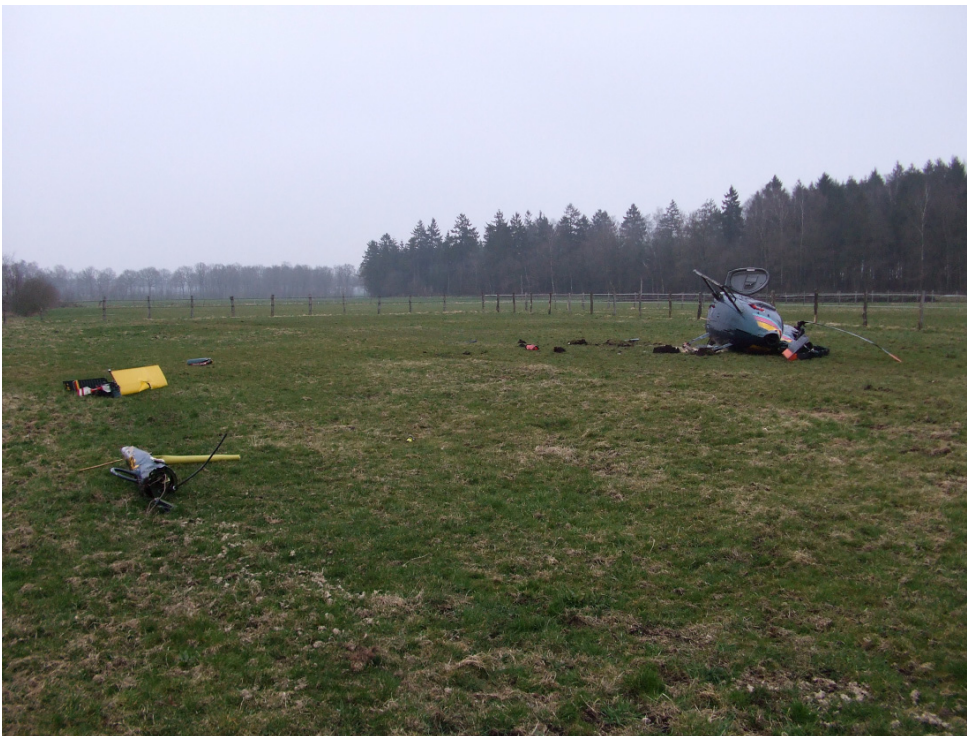
View from opposite approach direction
