Investigation Report

Type of Occurrence:	Accident
Date:	22 August 2009
Location:	Hamburg Harbour
Aircraft:	Airplane
Manufacturer / Model:	Cessna Aircraft Company / Cessna T206H
Injuries to Persons:	Two passengers fatally injured, pilot suffered minor injuries
Damage to Aircraft:	Aircraft seriously damaged
Other Damage:	None
Source of Information:	Investigation by BFU
State File Number:	BFU 3X131-0/09

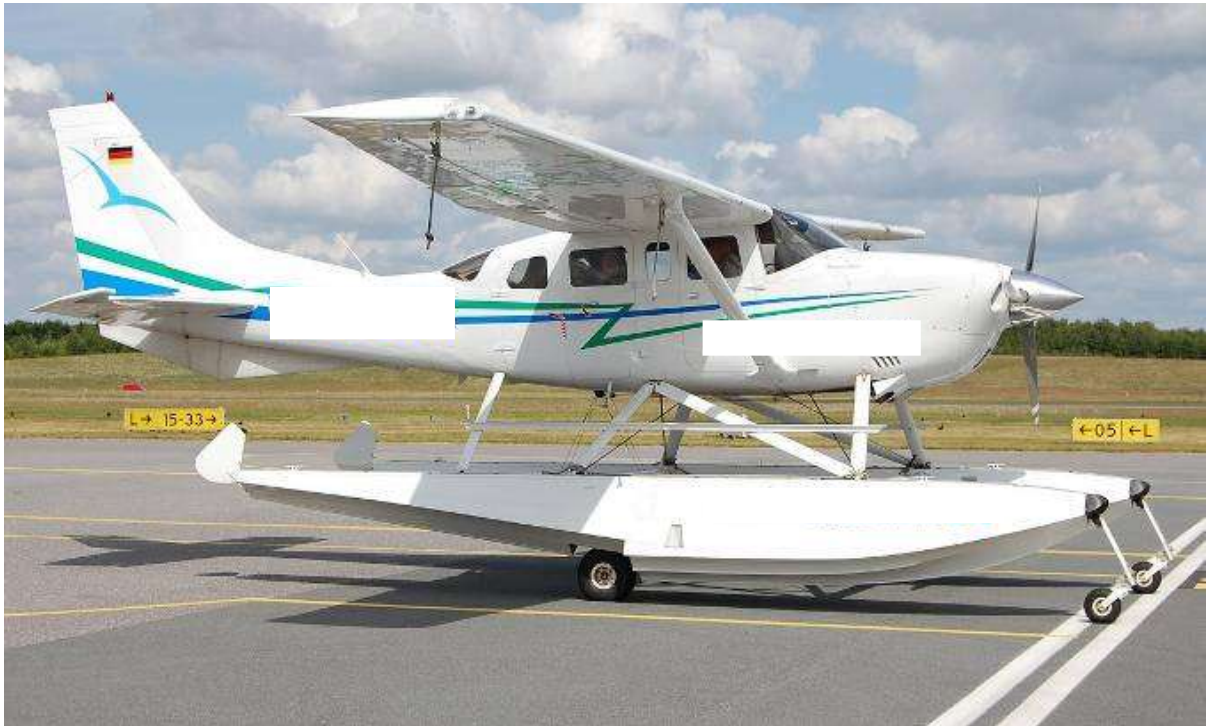
Airplane with extended landing gear

The findings on the wreckage, the pictures of the airplane during approach and the witness statements showed that the landing gear was extended during the landing on water. The resulting deceleration and the high centre of gravity of the airplane caused an immediate nose-over after contact with the surface of the water.

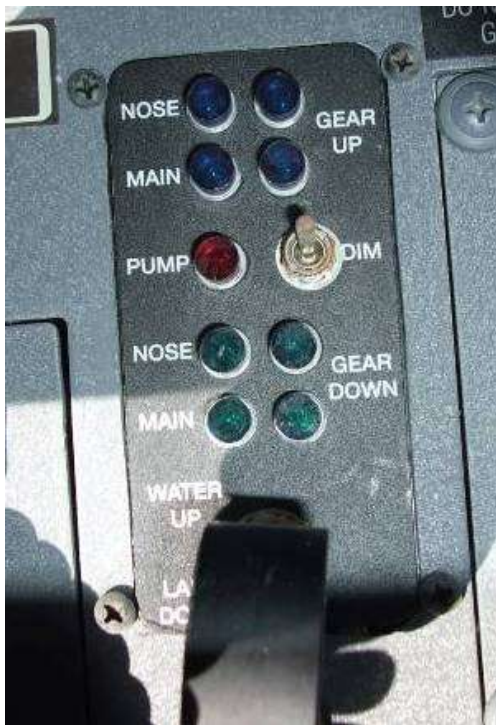
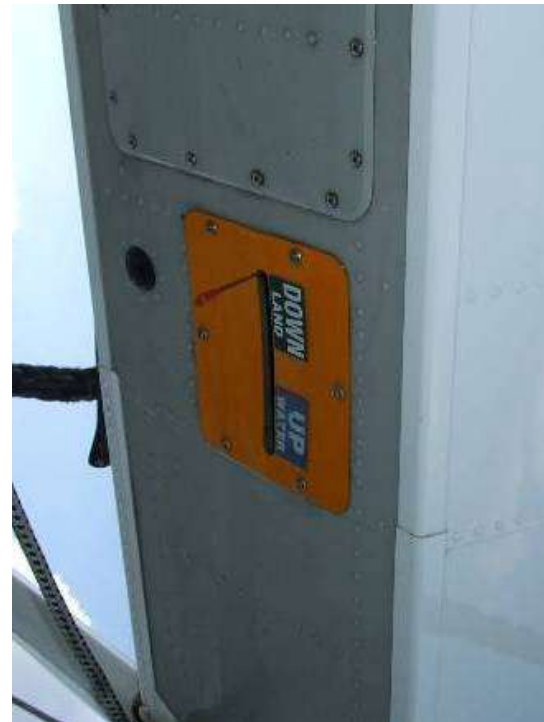
Electrical landing gear indicator in the cockpit and mechanical landing gear indicator on the floats

It must be assumed that the four green lights of the landing gear indication were on. The position of the entire landing gear control device behind the control column is disadvantageous. However, the position complied with the specifications of the design requirements. The landing gear indicator lights were below the large, multi-coloured displays for attitude, navigation and engine monitoring and were compared to the displays quite unobtrusive. The big, obtrusively shaped landing gear lever did not stand out too much from the instrument panel due to its black colour. Due to standardisation purposes for the layout of cockpit controls, a safety recommendation concerning the position of the landing gear lever was not considered.

The pilot stated that the mechanical indication on the left float was not visible; this was confirmed after recovery of the airplane. The pilot and representatives of the operator stated that in the past it had happened that the indicating wire was pressed into the float by embarking passengers if they happened to step onto the wire. It is

also possible that the water pressure forced the indicating wires into the floats during the nose-over since the wires on both sides were found inside the floats. The pilot could not remember the acoustic announcement about the actual landing gear position. It is highly probable that this equipment was not activated, because - according to the radar recordings - during the entire flight the airplane was flying in a speed range below the activation speed.

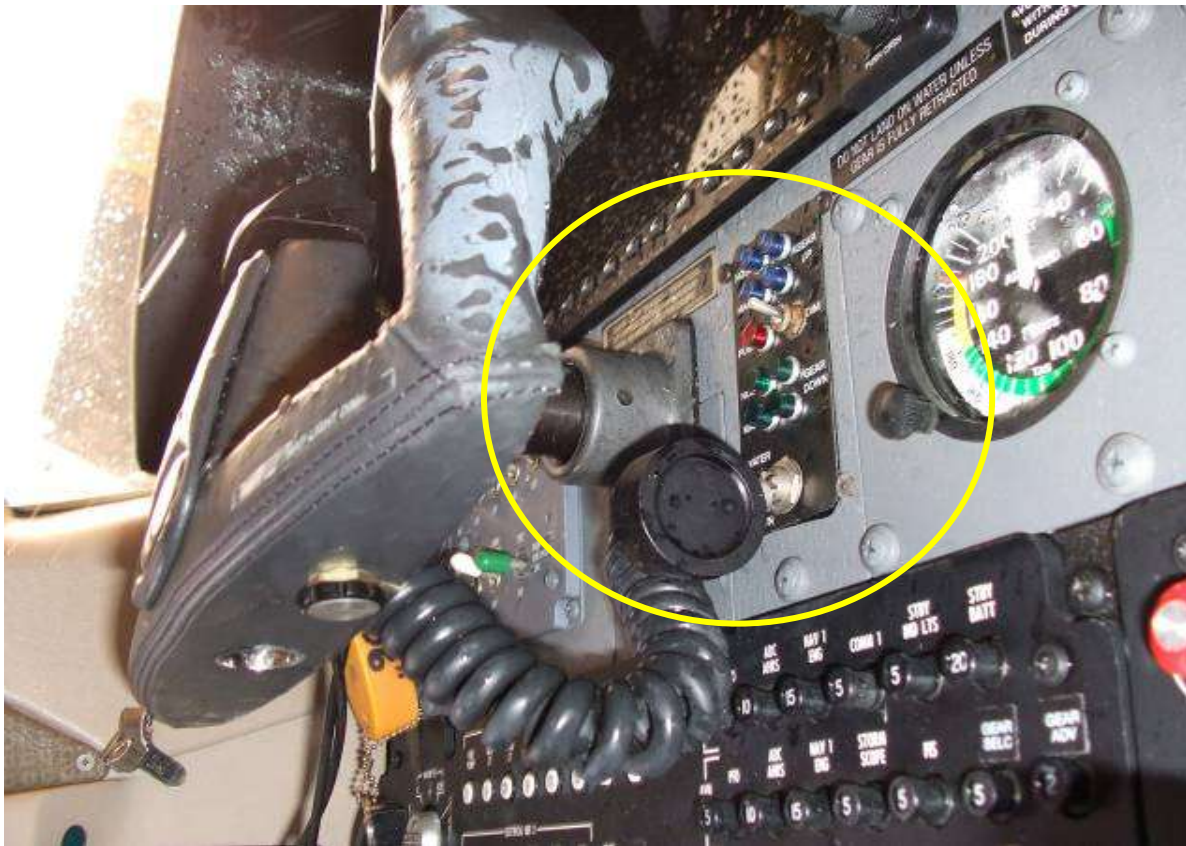
The lever for operating the landing gear was on the right side behind the pilot’s control column. The lever was black; the instrument panel was grey or black, respectively.

The European and American Construction Specifications (CS23 and CFR 23, respectively) require in paragraph 23.777, Cockpit Controls, that the landing gear control lever must be located to the left of the throttle levers.

Landing gear operating lever on the right side behind the control column
