Investigation Report

Type of Occurrence:	Accident
Date:	14 January 2009
Location:	Near Nordhorn-Lingen
Aircraft:	Airplane
Manufacturer / Model:	Socata, Groupe Aérospatiale / TB 20
Injuries to Persons:	Three persons fatally injured
Damage:	Aircraft destroyed
Other Damage:	Crop damage
State File Number:	BFU CX001-09

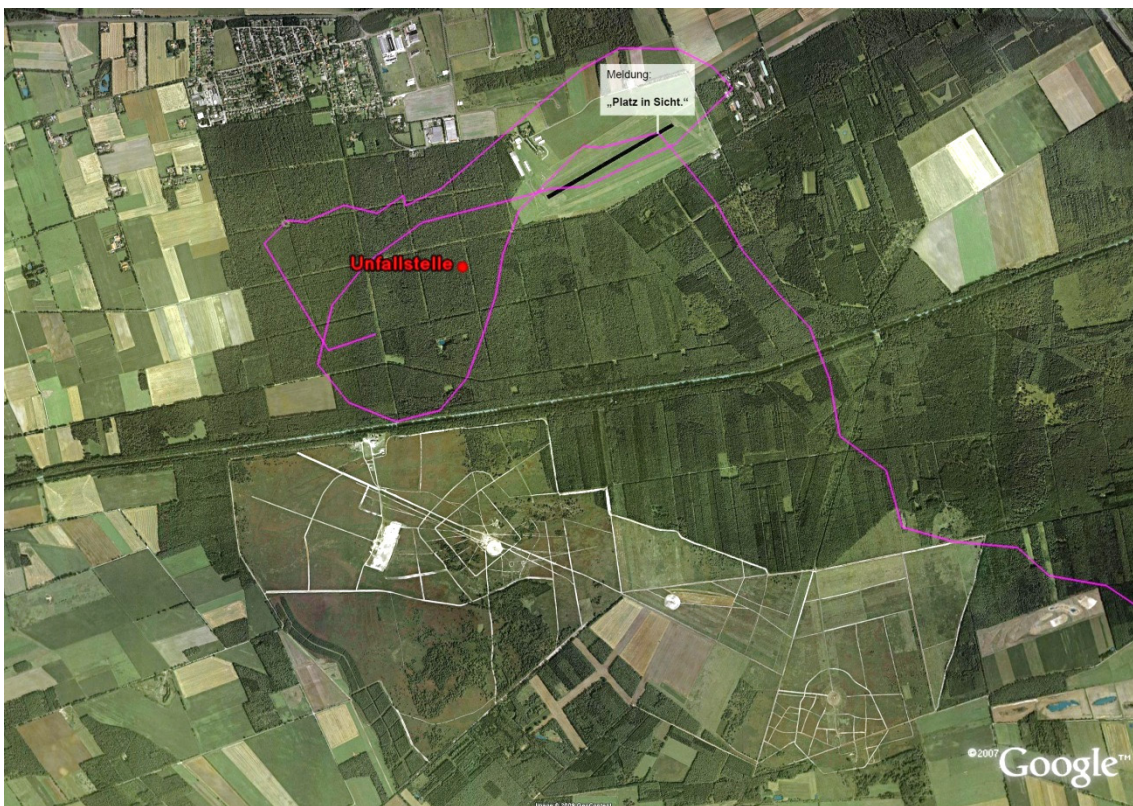
Flight path

The aircraft turned to a western course after it had crossed the airfield and then passed it to the north in approximately 700 ft ASML. Then the flight path changed to southwest. West of the airfield a spacious right-hand turn followed, which ended in the approximate landing direction for runway 06. The aircraft had a speed of 130 to 160 kt and was in 600 ft AMSL to 900 ft AMSL. The first approach was aborted and a go-around conducted.

The flight path in the picture above was reconstructed with the help of the recorded radar data.

During the second approach to runway 06 while performing a left-hand turn into the final approach the low-wing aircraft collided with trees south of the extended centre line. The aircraft crashed to the ground. The three occupants suffered fatal injuries.

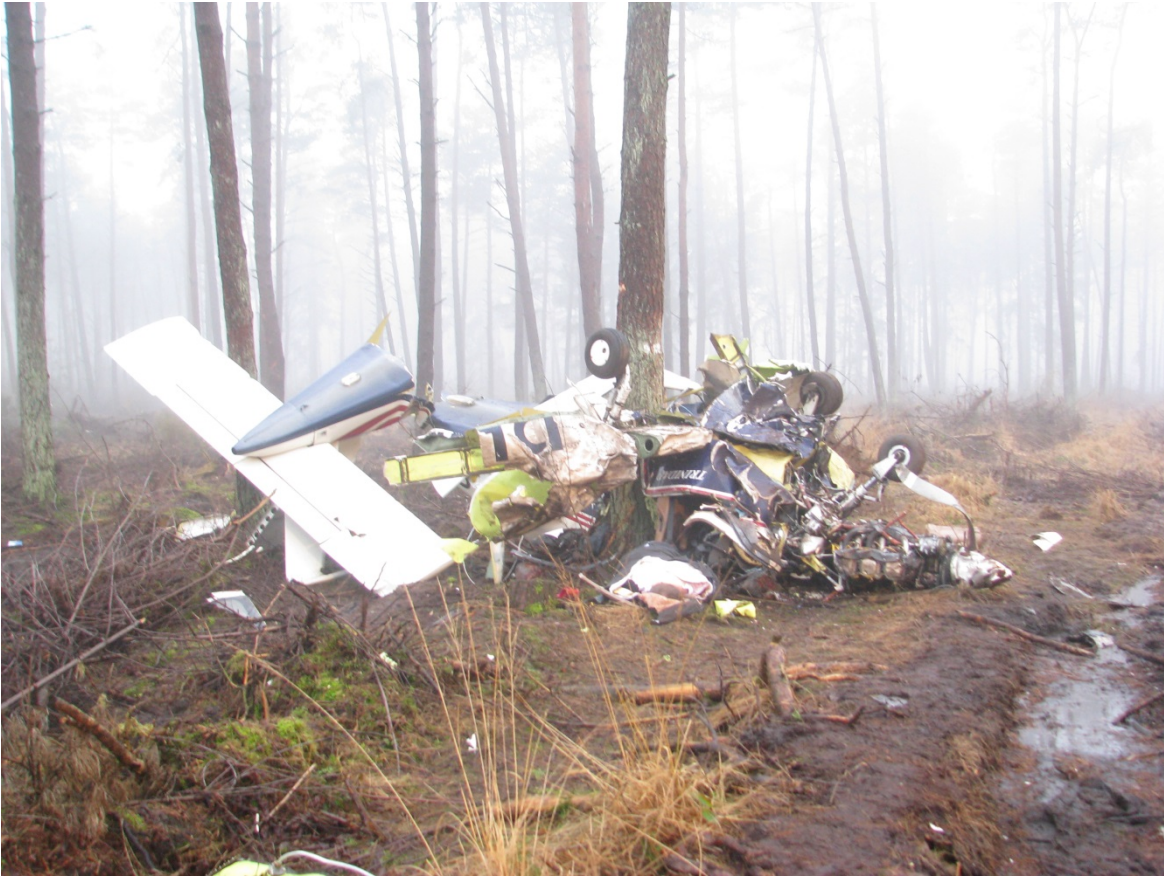
Accident site

The accident site was located approximately 900 m prior to runway 06 of Nordhorn-Lingen Airfield; approximately 100 m right of the extended centre line in a forest with 20 - 30 m high conifers. Approximately 150 m prior to the accident site traces of the initial contact with trees were found. The airplane's moving direction proceeded to 020°. Parts of the aircraft were strewn over an area of approximately 140 m x 50 m, either laying on the ground or hanging in trees.

A trace on the forest floor of approximately 8.5 m in length indicates that the wreckage overturned and then came to a stop on a tree. The aft fuselage area was bent in

the process and the tail section almost completely severed. The investigation did not reveal any technical malfunctions.

The kind of accident site and the distribution of the wreckage parts allow the conclusion that the aircraft impacted the ground with a steep angle, high horizontal velocity, and an almost straight forward movement.
