Investigation Report

Type of Occurrence:	Accident
Date:	11 July 2009
Location:	Near Stadtlohn
Aircraft:	Airplane
Manufacturer / Model:	Cessna / U206G
Injuries to Persons:	Passenger seriously injured
Damage:	Aircraft severely damaged
Other Damage:	Crop damage
Information Source:	Investigation by BFU
State File Number:	BFU CX008-09

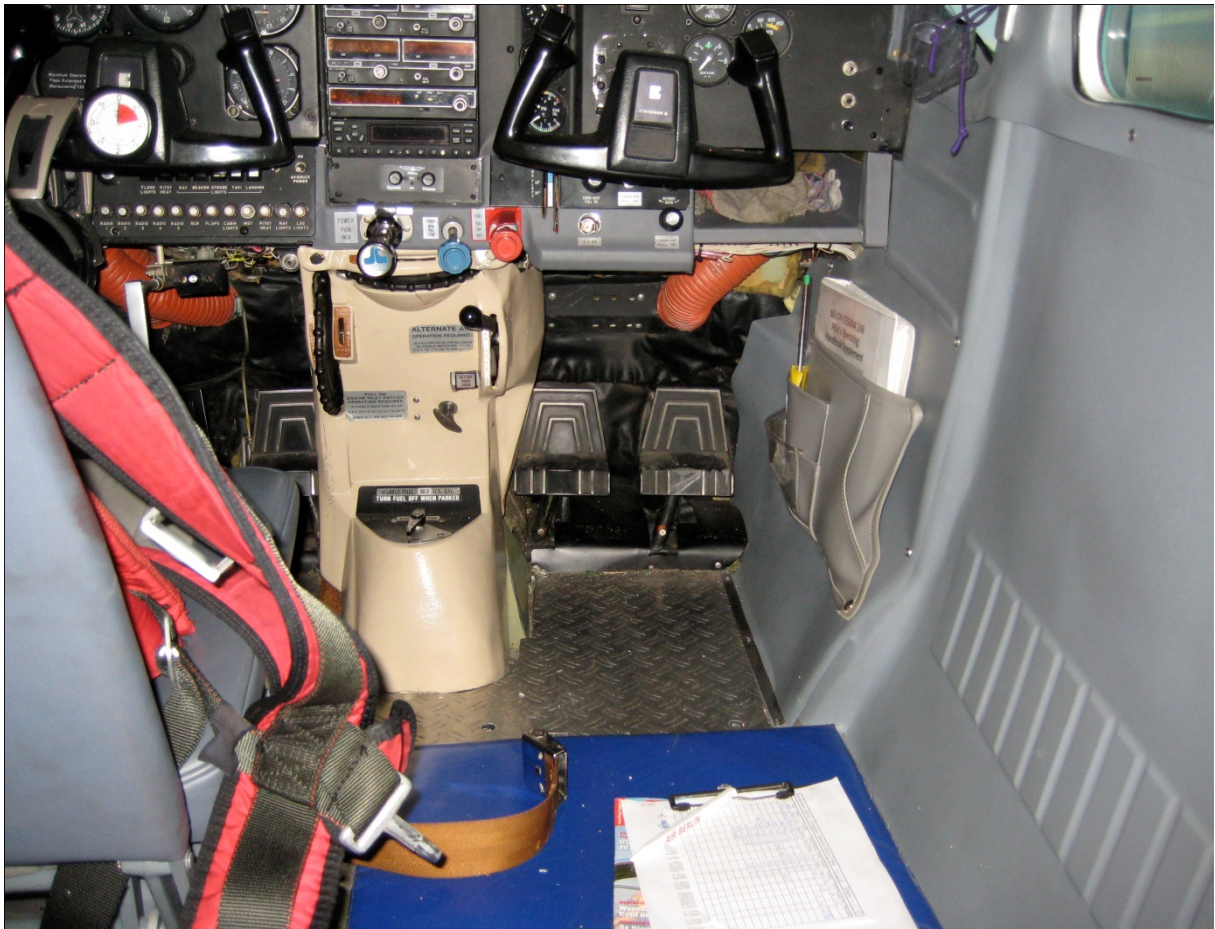
The passenger sat in the Cessna on position six (Appendix Eichenberger Supplement No 1). According to the manual the reversed seat for the co-pilot was meant to be.

Cabin of the Cessna on the day of the accident, missing co-pilot's seat

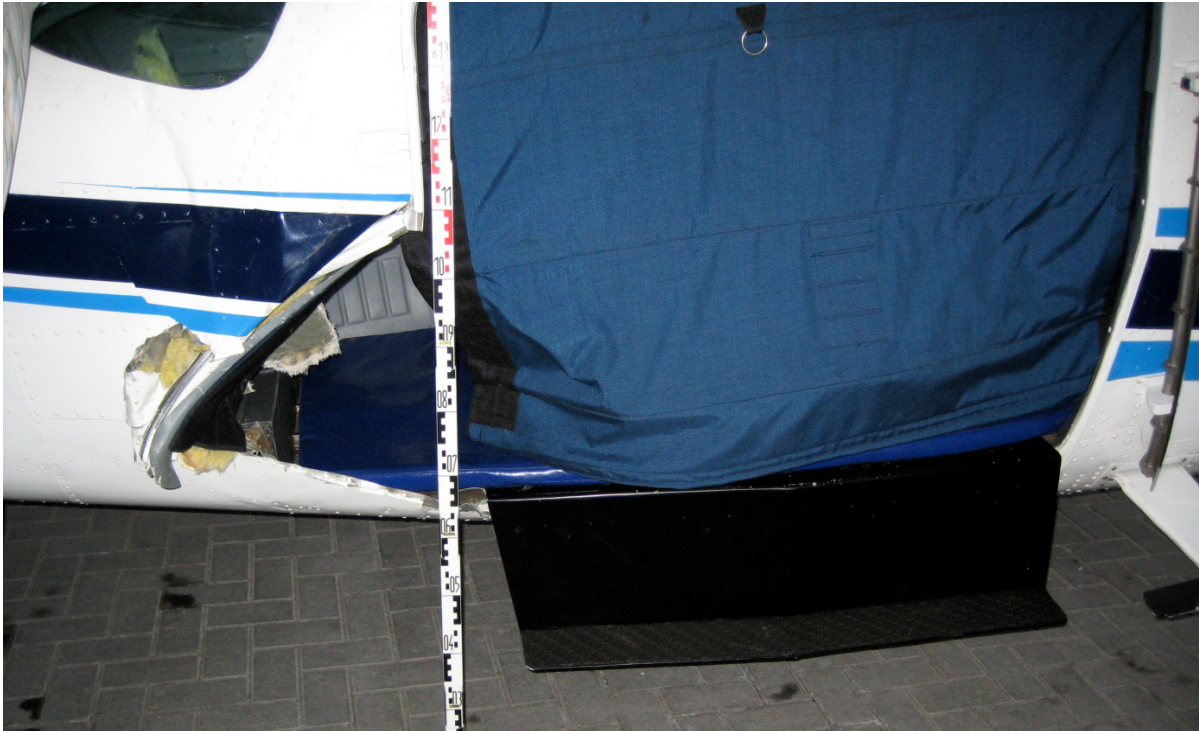
Closed door and damages in the area of the door

The aft door frame of the Cessna had been dented on the lower part in an area of about 80 x 40 cm. The door frame and the outer skin were damaged.

The damage to the door area and the injuries the passenger had suffered were attributed to the impact of the passenger while he was pulled from the cabin.

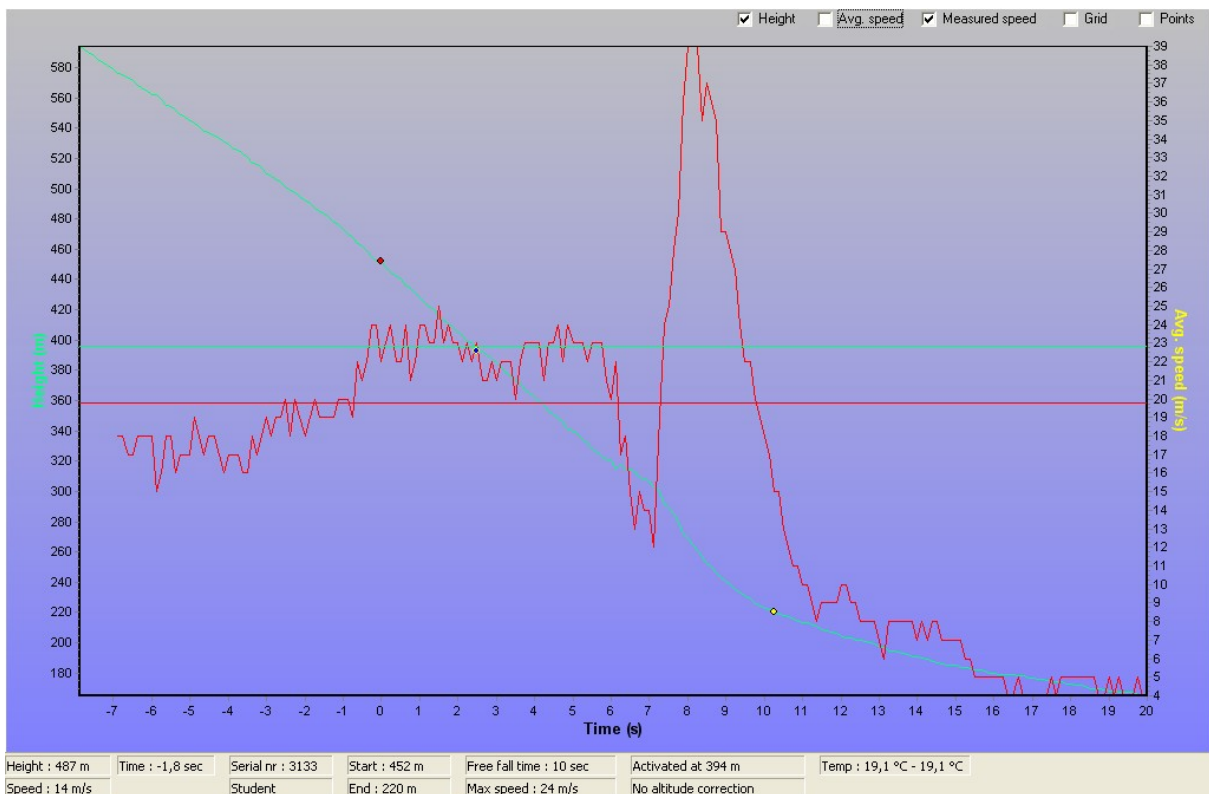
The AAD had recorded several jumps. For the accident the data from File Jump 5-8 were important. The recordings started in about 3,400 m and ended in about 100 m. The mean sink rate was between 30 and 15 m/s. Between 480 m and 420 m higher sink rates of more than 20 m/s were reached. The AAD activated in an altitude of 394 m / 1,292 ft at a sink rate of 23 - 24 m/s (4,500 - 4,700 ft/min). The data showed that about 4 seconds after the AAD had been triggered the passenger left the airplane. The graph shows that the sink rate increased due to the incompletely opened reserve canopy. The graph also shows that the sink rate became normal - 5 m/s - after the reserve canopy had opened. The recording ends in about 165 m (Graph Jump 5-8).

File Jump 5-8 read out from the AAD.

The read-out of the AAD data showed that it was activated and had deployed correctly in accordance with the selected Student mode. After the reserve canopy had deployed a normal rate of descent prevailed. It allows for the conclusion that there was no opening malfunction.

The documented rate of descent of the airplane of not more than 30 m/s was above the trigger value of the Student mode and below the Pro mode.
