# Investigation Report

Type of Occurrence:	Accident
Date:	14 September 2009
Location:	Near Jena-Schöngleina Airfield
Aircraft:	Airplane
Manufacturer / Model:	G. J. Vicherek, Czech Republic / Europa XS
Injuries to Persons:	Two persons fatally injured
Damage:	Aircraft destroyed
Other Damage:	Minor damage to forest
Information Source:	Investigation by BFU external experts for field investigation
State File Number:	BFU CX014-09

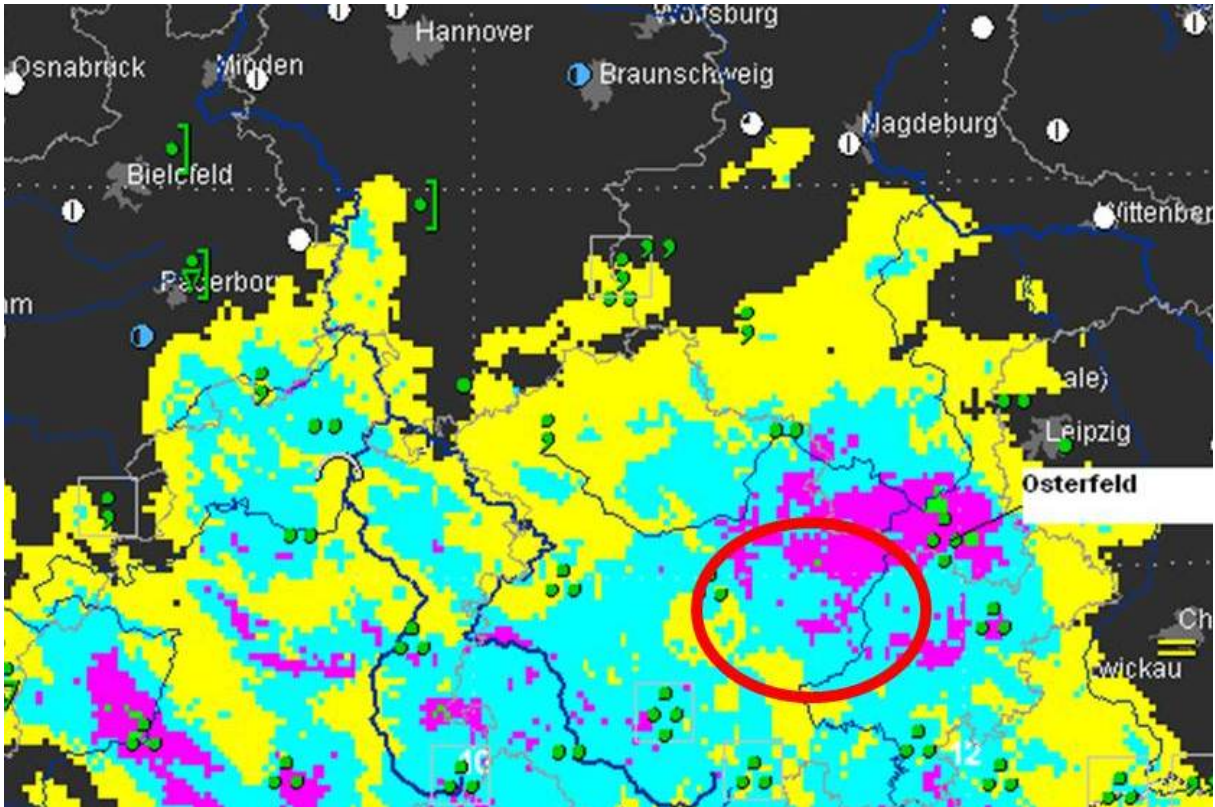
Moderate to heavy rainfall at 1900 hrs in the accident region

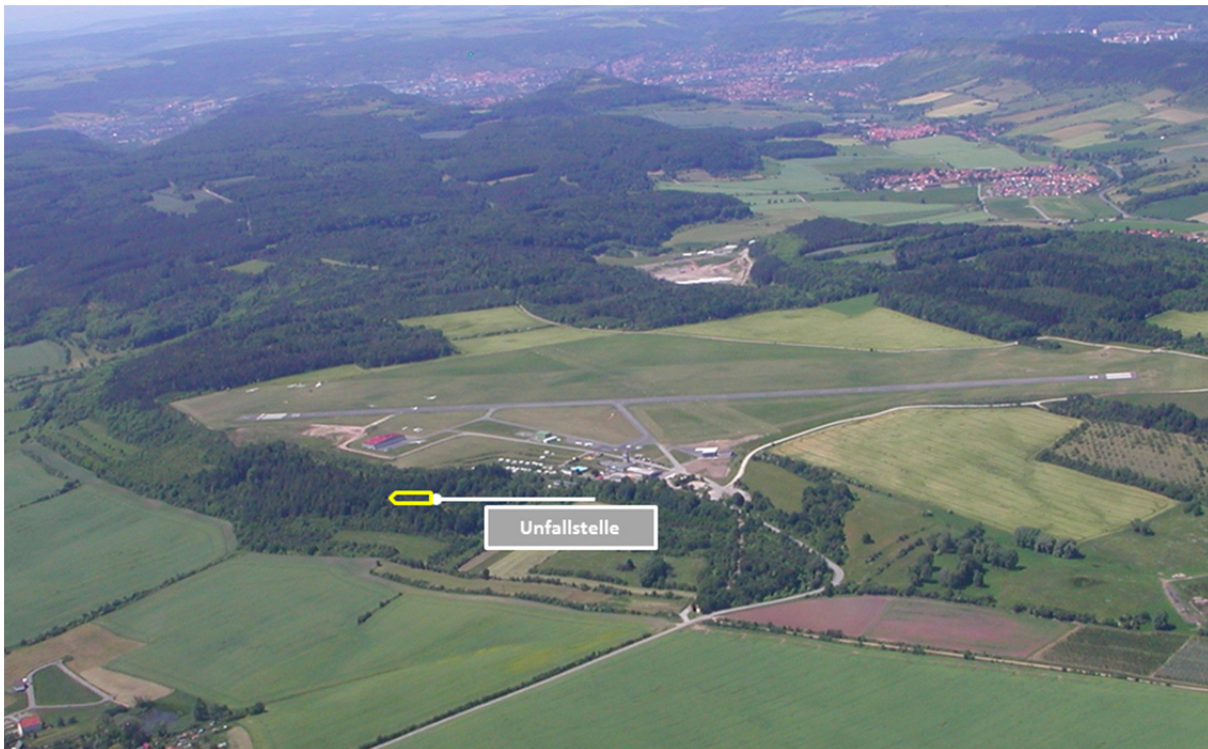
The accident site was located about 20 m below the airfield elevation on a hillside which slopes to the south-east and has a dense, broad-leaved forest with 10 - 15 m high trees. The collision occurred with the tress parallel to the hillside with a south-western heading.

The accident site including the collision direction

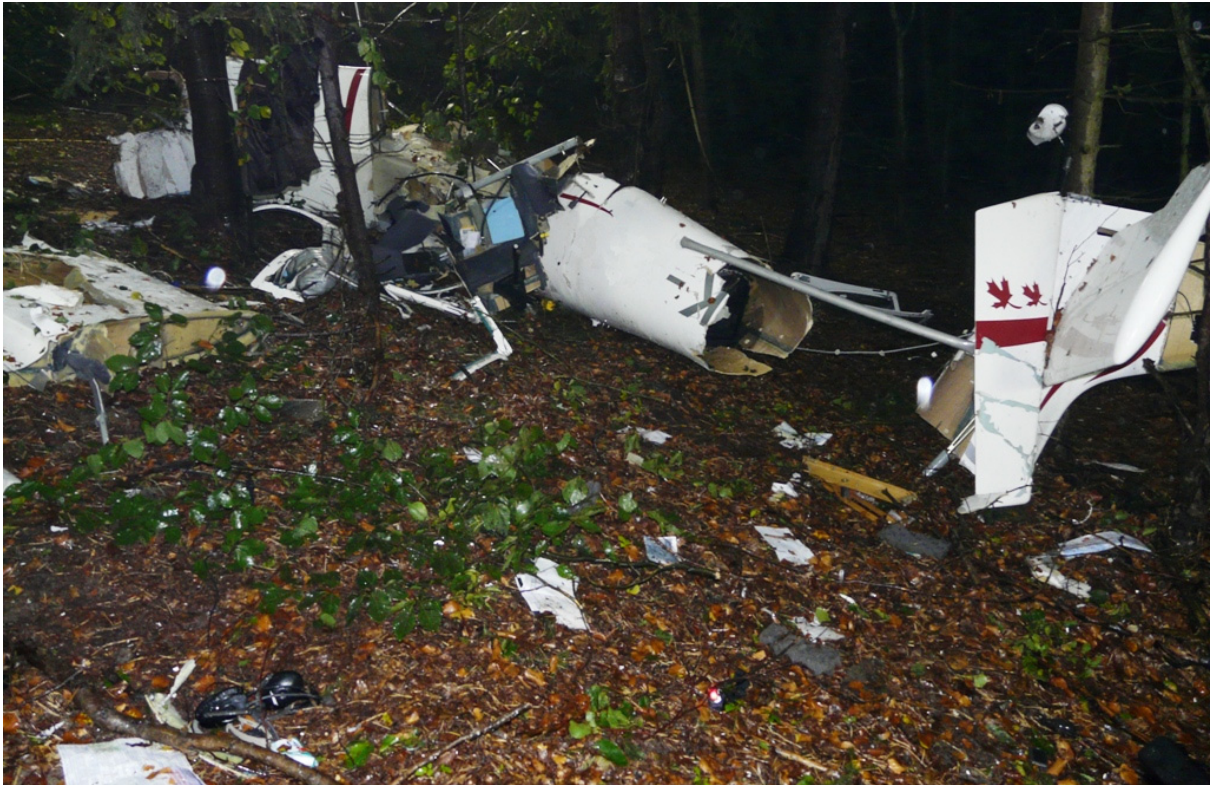
During the initial collision both wings had their end parts on a length of about 2 m torn off. One of these pieces became stuck in about 5 m in one of the thick treetops. The subsequent collisions also occurred with trees. The impact marks on the trees show a slope angle - compared to the horizontal - of about 25°. The inner wing parts, the tail section, the engine and the fuselage were found distributed in collision direction on the forest soil. The wreckage was distributed over a distance of about 50 m with very little lateral distribution.

High degree of destruction due to the collision with trees

The traces on the trees, the high degree of destruction and the characteristic of the wreckage distribution indicate a collision with trees with regular cruise speed and horizontal flight attitude (controlled flight into terrain).

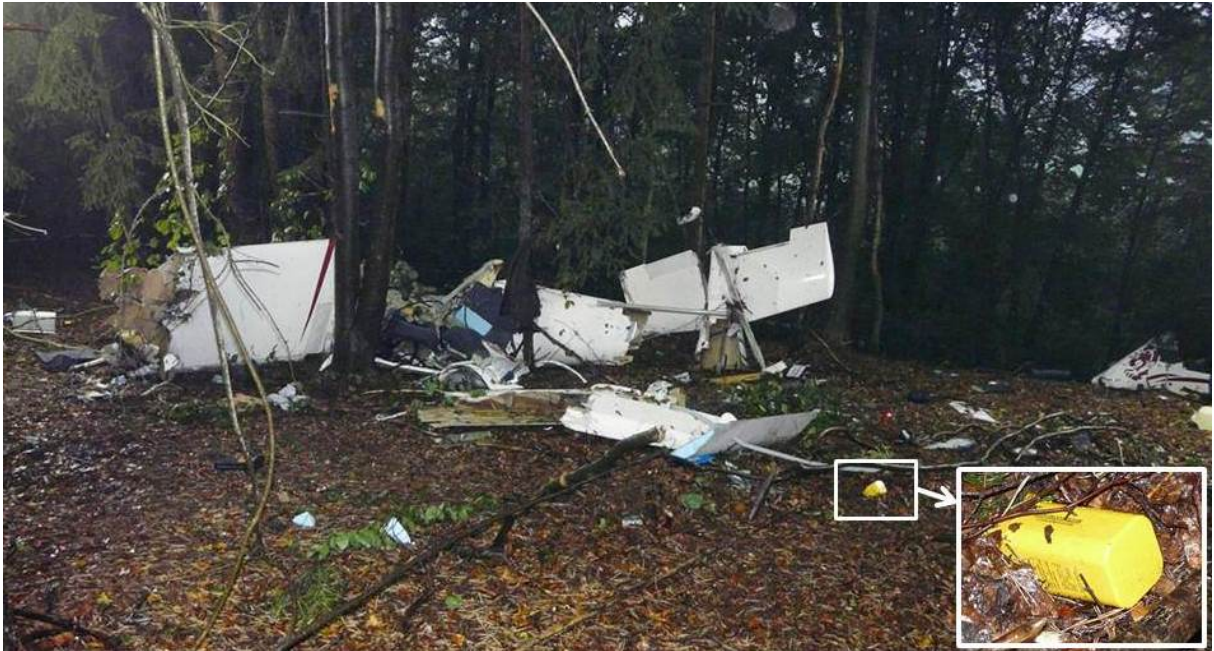
The damaged ELT did not send any signals.

Location of the ELT within the wreckage area

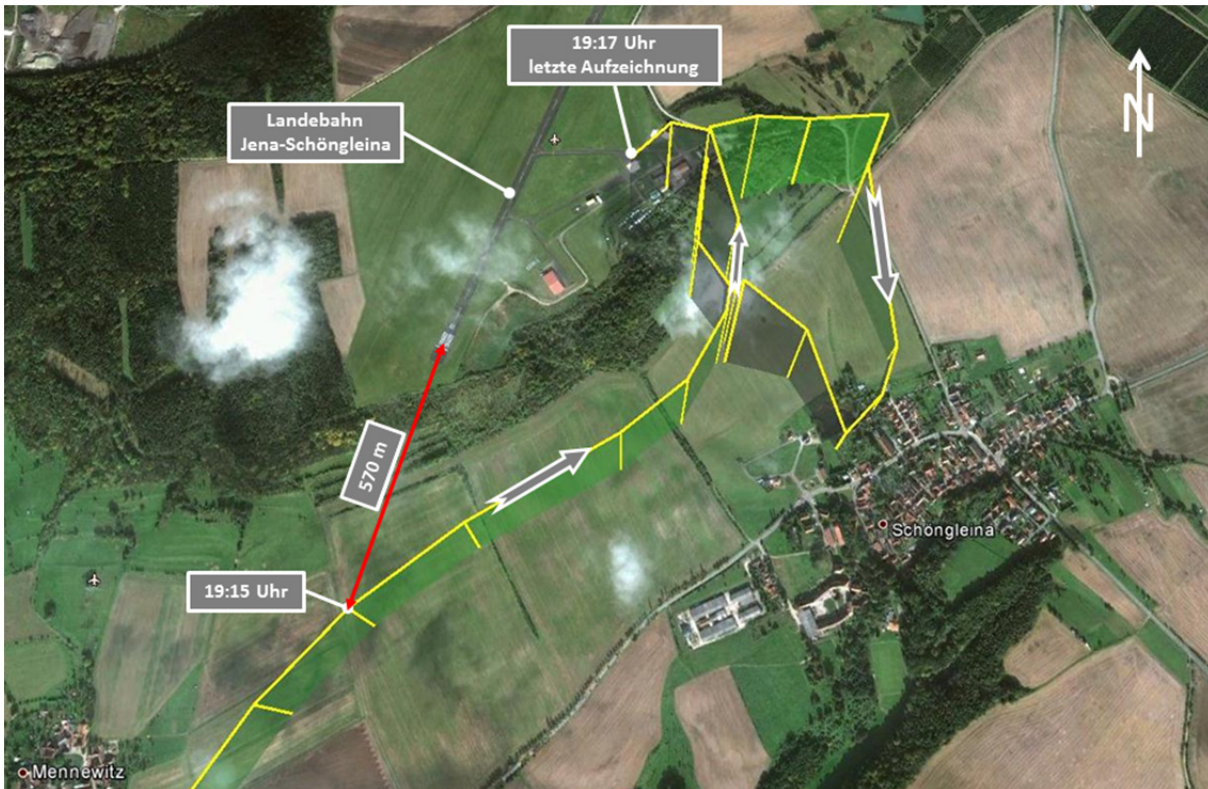
At exactly 1915 hrs the airplane was on the extended centre line 570 m away from runway 02. However, the airplane veered right and remained in the valley south-east of the airport. Witnesses observed it there as it was flying twice very low across a field. The BFU is of the opinion that there was suitable terrain available in this valley also for a precautionary landing due to weather conditions.

After a full right circle the airplane flew towards the hill on the south-east side of the airfield which was in clouds at the time. Under these circumstances the collision with terrain was inevitable.

Approach attempt to Jena-Schöngleina Airfield
