Investigation Report

Type of occurrence:	Accident
Date:	18 November 2009
Location:	Emden
Aircraft:	Civil Air Transport
Manufacturer / Model:	Dassault / Falcon 900EX
Injuries to persons:	None
Damage:	Aircraft seriously damaged
Other damage:	Slight crop damage
Source of Information:	Investigation by BFU
State File Number:	BFU CX015-09

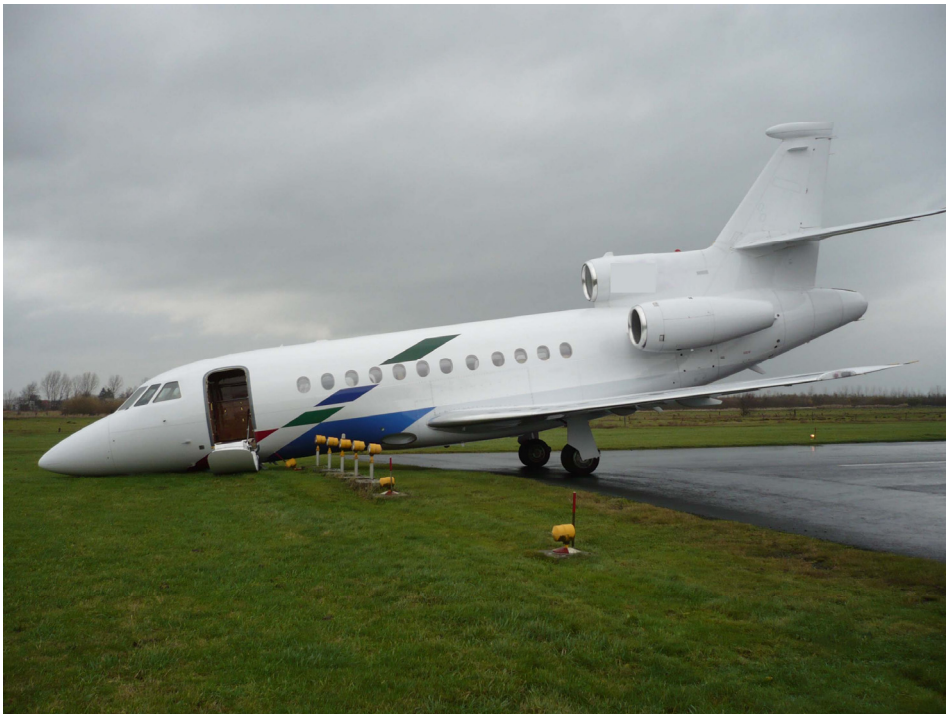
Having overrun the end of Runway 25, the Falcon 900EX came to a halt with the nose gear on the grass. The fuselage nose was about 8 m beyond the runway end. About 2.70 m of the front fuselage rested on the grass on the collapsed nose gear. Both main landing gears were still on the runway, the left gear about 1.50 metres in front of the runway end. The fuselage longitudinal axis was directed about 12° to the right of the runway heading and located to the right of the runway centreline.

Final position of the aircraft

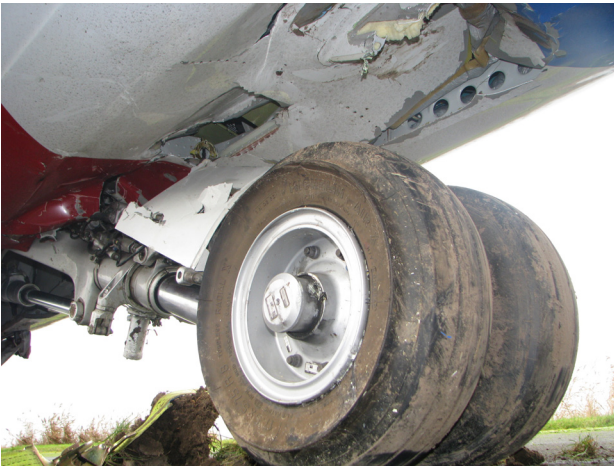
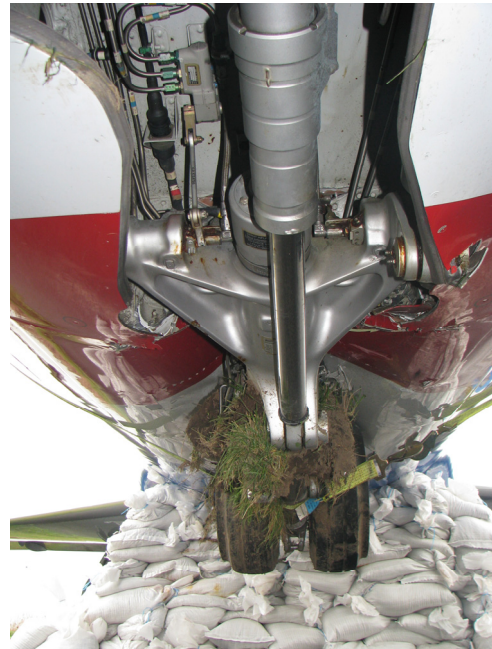
The nose gear under the aircraft had broken off, and bore traces of an impact. The nose gear doors were partly torn off or badly damaged. The fuselage belly had been pushed in behind the nose gear shaft, and had horizontal and vertical dents reaching almost to the cockpit windows on both sides. The underlying airframe structure was partly damaged.

After impact with the concrete plinth and fall of the fuselage nose to the ground, the aircraft was damaged mainly on the lower fuselage from frames 0 to 8.

- Frame A bent and broken on the lower side; nose profile deformed, no longer fitting Frame 0
- Frame 0 bent at the attachment area; radome closure bent; attachment points and closing pin broken on lower side.
- TAT sensor defective.

- Strong deformation in lower area between Frames 2 and 4.
- Nose gear attachment points broken.
- Lower part of Frame 4 broken.
- The entire structure around the nose gear must be examined and surveyed.
- Nose gear doors torn off.
- Transverse members bent Frames 4 to 7.
- Floor structure bent or broken between Frames 4 to 8.

Damage to nose gear and front fuselage

The main damage to the aircraft was due to the fact that the nose gear impacted with the runway lamp concrete plinth and then broke off. Further damage resulted to the airframe cell and structure when the fuselage then dropped onto the broken nose gear, which lay under the fuselage in a longitudinal position.

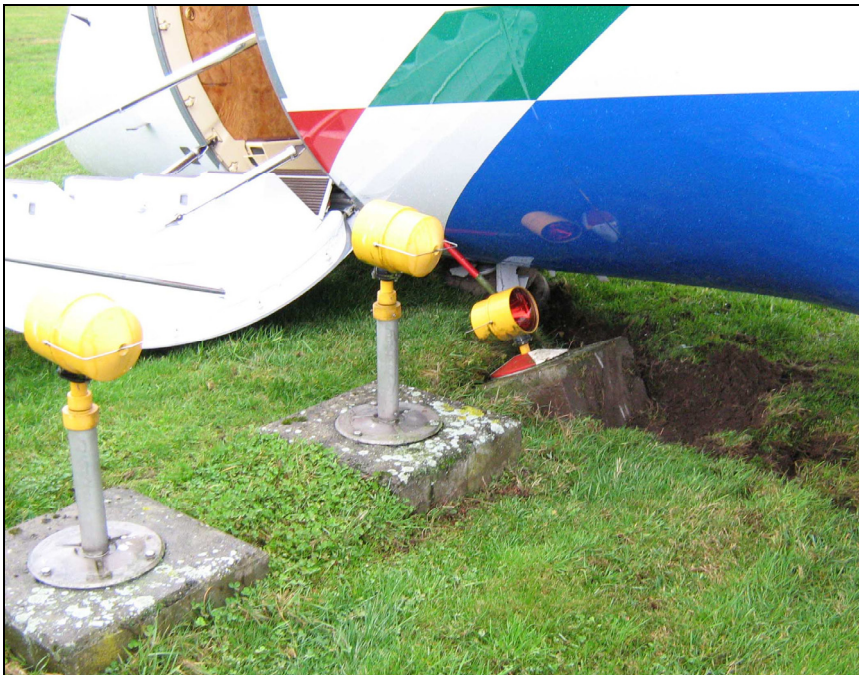
The end of Runway 25 is denoted by marker lights, plus a line of approach lights to Runway 07 which are located about 2.40 m away from the asphalt surface. Together with its concrete plinth, one of these lamps had been pushed backwards and was found behind the cabin door after the aircraft came to rest. The lamp remained operable.

Runway lighting

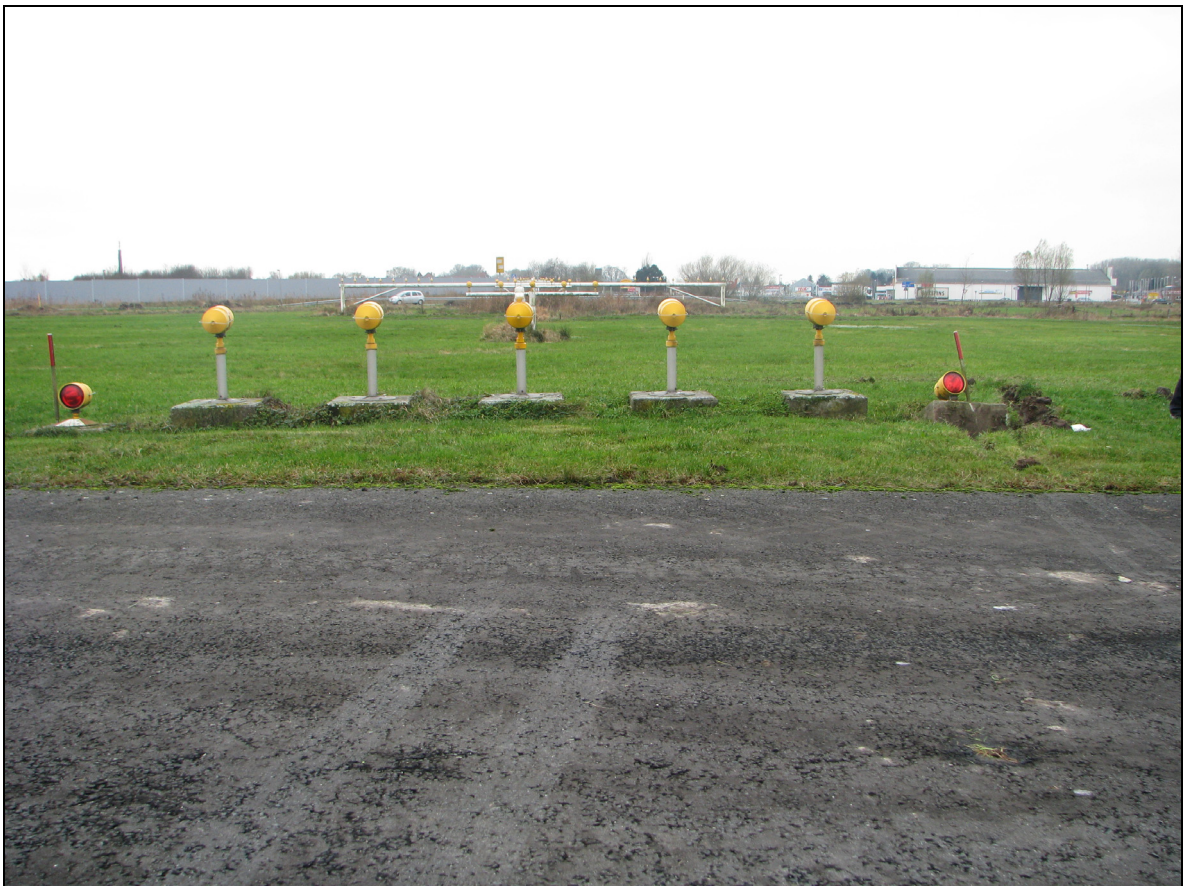
Runway lighting on concrete plinths

The runway lighting concrete plinth was a major cause of damage. The plinths were not countersunk into the earth, but projected about 15 cm above the surface. Thus

If the aircraft had only collided with a lamp, this would have bent at the design break point and avoided serious damage to the aircraft. If the lamps had been correctly installed, they would have bent upon impact, the electrical supply would have switched off, and there would have been less danger from the possibility of setting light to fuel escaping from possibly ruptured tanks.

Serious damage to the aircraft resulted from impact with a protruding concrete plinth that supported a lamp.

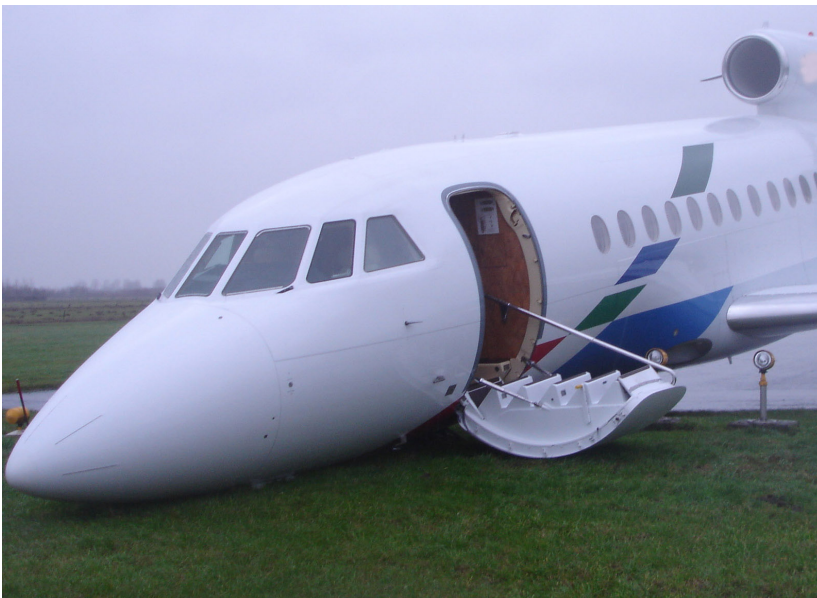
When the aircraft had come to rest, it was not possible to open the door to its fullest extent. It was half-opened and then rested upon the ground in an almost horizontal position. In this position, the stairs were presented as a line of triangles with the apex directed upwards.

Post-accident position of the passenger door

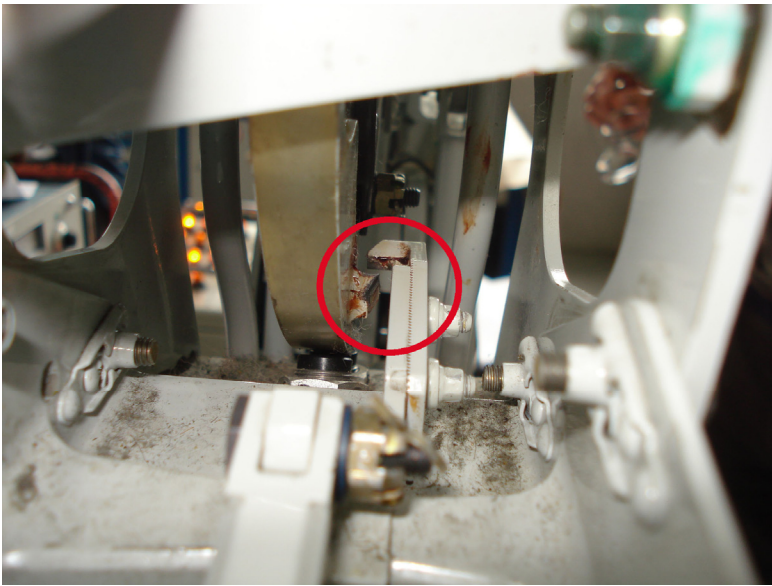
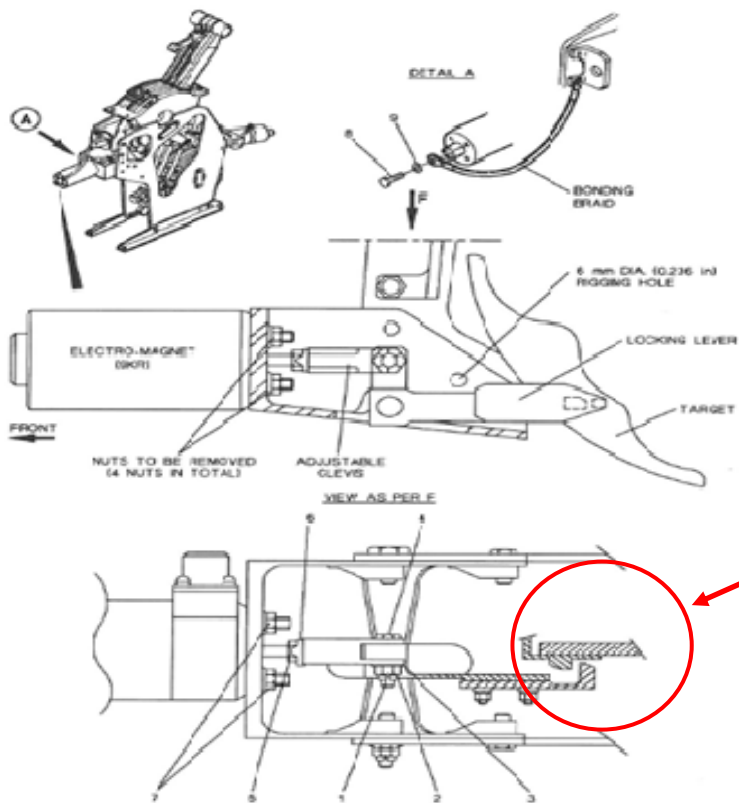
During both series of investigations, it was evident that the first mechanical lock did not operate correctly, and it bore clear traces of a high degree of mechanical wear. When on the laboratory test stand, it was repeatedly possible to immediately and fully advance the reverse thrust lever by the application of a force of 500 gF (as measured with a dynamometer).

Mechanical lock on the TCU

Due to the short runway the thrust reverser had to be selected as early as possible which was performed by the PF immediately after touchdown. Since the mechanical stop of the reverser lever did not work properly it was possible to select the lever directly to full reverse. This resulted from the combination of the defective thrust reverser lever and the non-adherence to the checklist which requires to check the indications "TRANSIT" and "DEPLOYED" before using the reverser without restrictions.

Traces of abrasion on the mechanical lock have been found. A third-party exposure could not be confirmed while investigating the lock with a microscope. The abrasion traces showed that the condition of the lock existed for a longer time and was already overridden more often.

New measurements were made after the locking mechanism had been correctly adjusted, following which the lock remained effective when subjected to a force of more than 11.5 kgF.
