Investigation Report

Type of Occurrence:	Accident
Date:	07 June 2010
Location:	Münster / Osnabrück
Aircraft:	Airplane
Manufacturer / Model:	Embraer / ERJ 170-100 LR
Injuries to Persons:	None
Damage:	Aircraft seriously damaged
Other Damage:	None
Source of Information:	Investigation by BFU staff
State File Number:	BFU 1X002-10

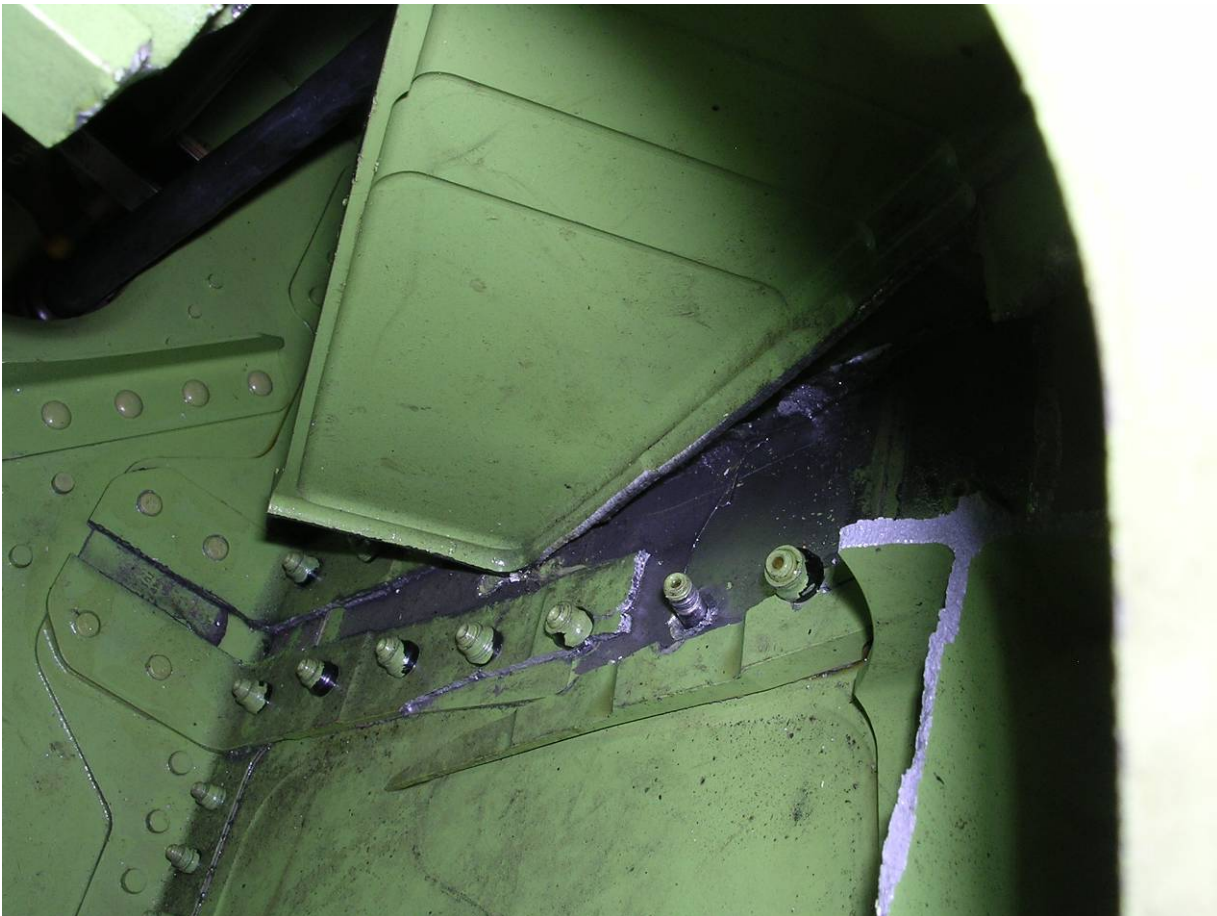
In the right wing, the support fitting for the retracting actuator of the right main landing gear was broken off including a part of rib 6 (Appendix, photo 1). The hydraulic cylinder of the actuator broke through rib 4A. The cylinder of the retracting actuator was externally damaged. The same applied to the connected hydraulic hoses.

Both, the broken support fitting of the right wing and the cracks in the support fitting of the left wing were fatigue fractures.

The spar of the right main landing gear actuator support fitting failed due to a fatigue fracture. As a consequence, a piece broke out from rib 6, and the hydraulic cylinder of the actuator then broke through rib 4A.

The right main landing gear retracting actuator support fitting, which should have been replaced after 5,000 flight cycles at the latest, according to the manufacturer's service bulletin, broke during the 8,641 flight cycles and caused the severe damage to the aircraft.

Photo 1: Right wing, support fitting torn out

The ANAC, Brazil responsible for the type certificate of the aircraft should ground the aircraft identified in Service Bulletin 170-57-0008 "Wings – Replacement of the Main-Landing-Gear Actuator Support Fitting" and initiate an inspection in regard to cracks in the support fitting and pins before the next flight.

The ANAC, Brazil responsible for the type certificate of the aircraft should upgrade the Service Bulletin 170-57-0008 "Wings-Replacement of the Main-Landing-Gear Actuator Support Fitting" to an Airworthiness Directive (AD).

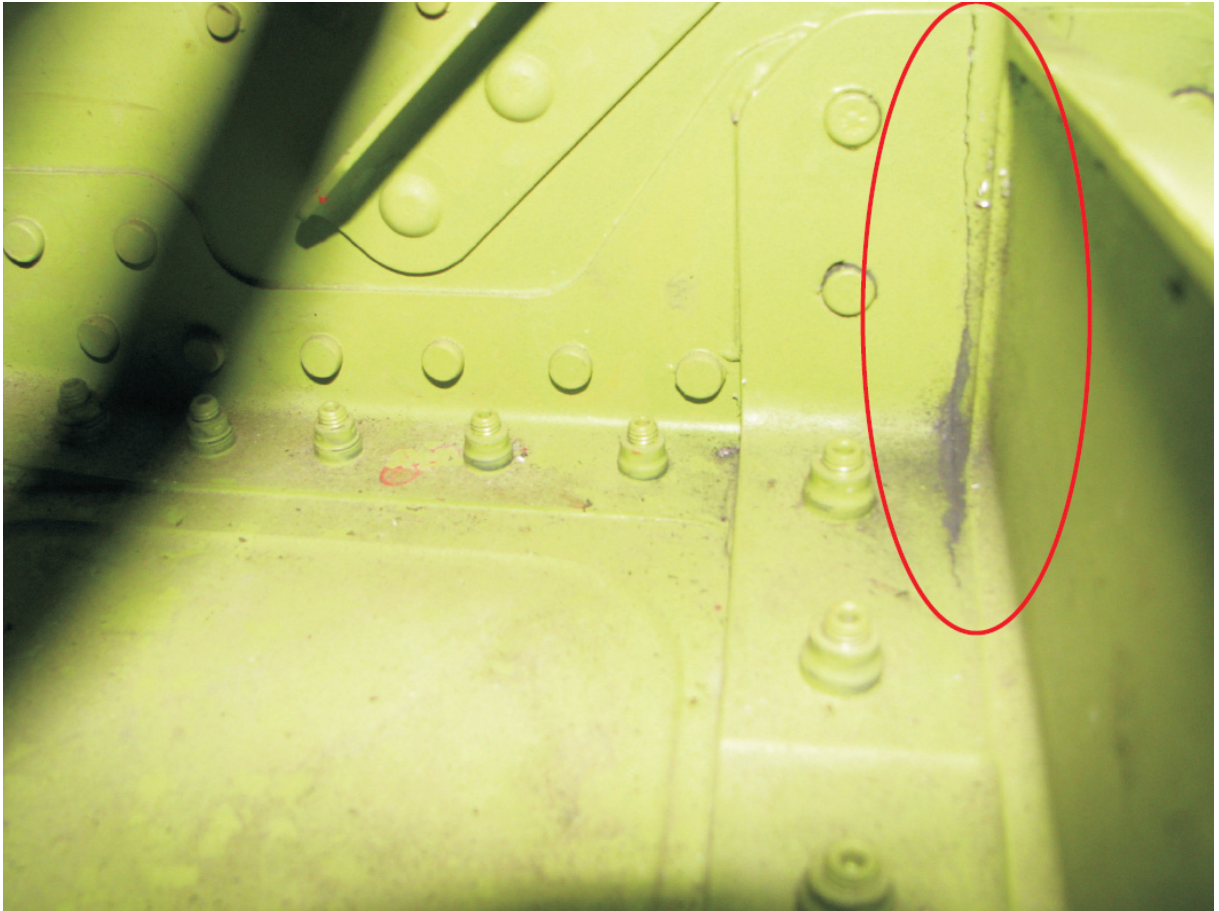
The support fitting for the retracting actuator of the left main landing gear showed two cracks between the spar and the left and right fixing flange in the upper area of the connection to rib 7 (Appendix, photo 2).

Photo 2: Left wing, incipient cracks at the support fitting flange at the connection to rib 7
