Investigation Report

Type of Occurrence:	Accident
Date:	9 February 2010
Location:	Porta Westfalica Airfield
Aircraft:	Helicopter
Manufacturer / Model:	Agusta / A109A
Injuries to Persons:	None
Damage:	Aircraft severely damaged
Other Damage:	None
Information Source:	Investigation by BFU
State File Number:	BFU 3X008-10

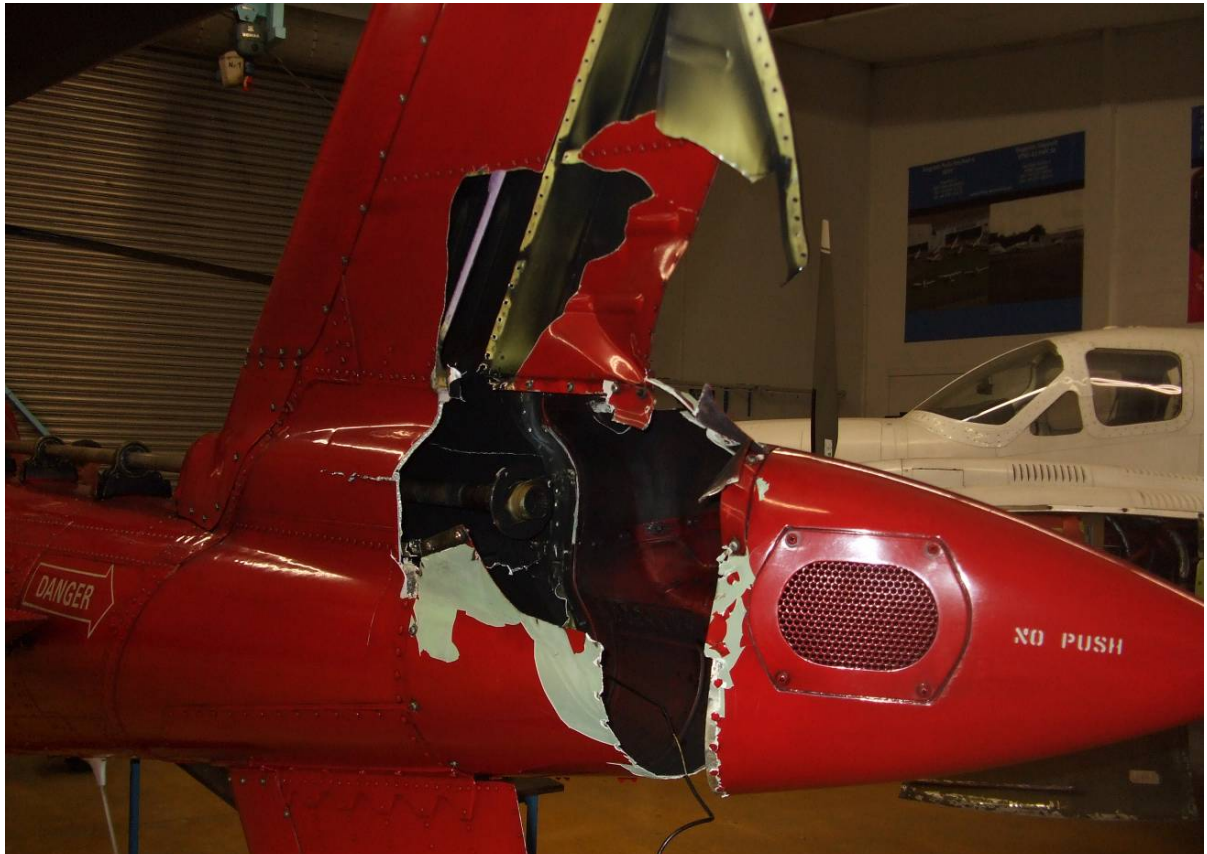
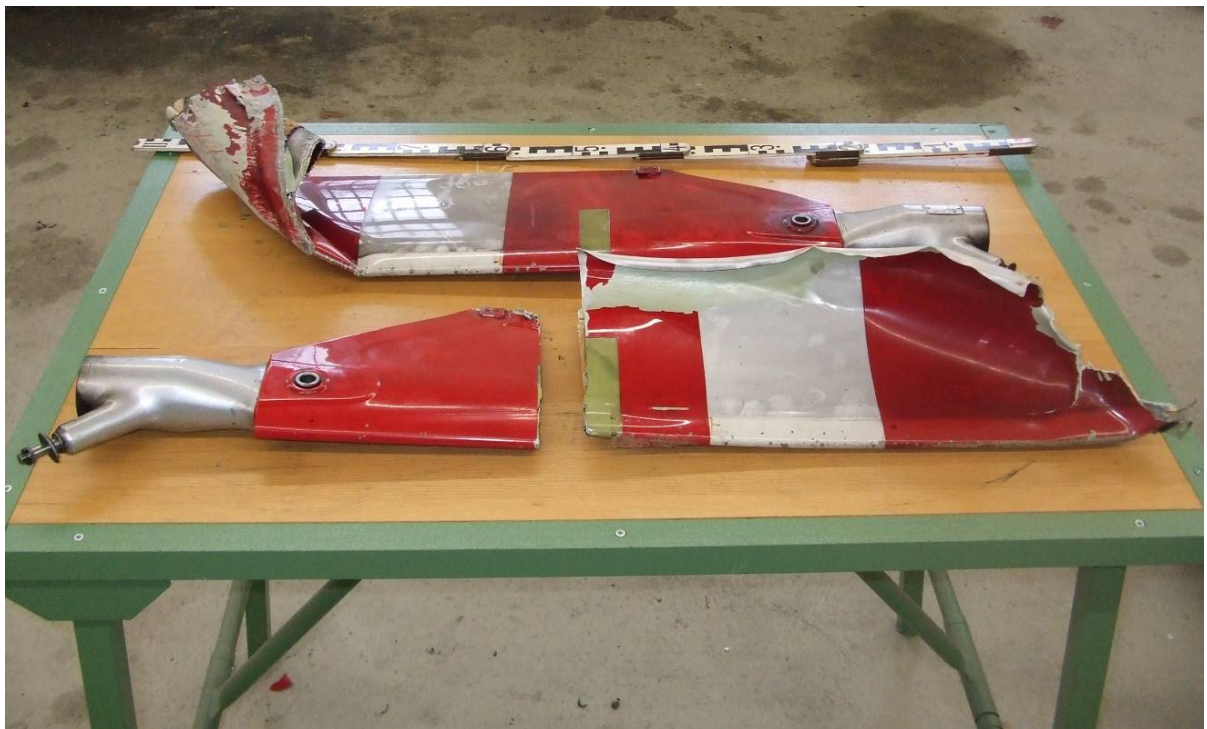
Appendix 2: Damage to the helicopter's tail and tail rotor blades

The tail rotor gear box including the bulkhead had been torn out of the helicopter's tail. The push rod of the tail rotor pitch control was severed at the area of the missing bulkhead. At the tail rotor one blade (S/N A5-0092) was bent at the tip and the other blade (S/N A5-0253) was torn at the end of the blade re-enforcement in the area of the colour change from red to transparent lacquer. The sheeting of the vertical fin was torn open and the tail cone was bent to the right. The torn-off tail rotor blade piece was found in the area of the left main landing gear.

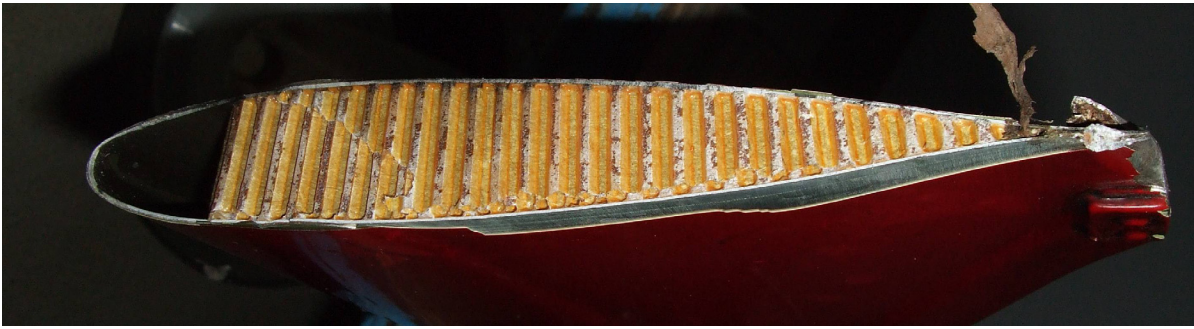
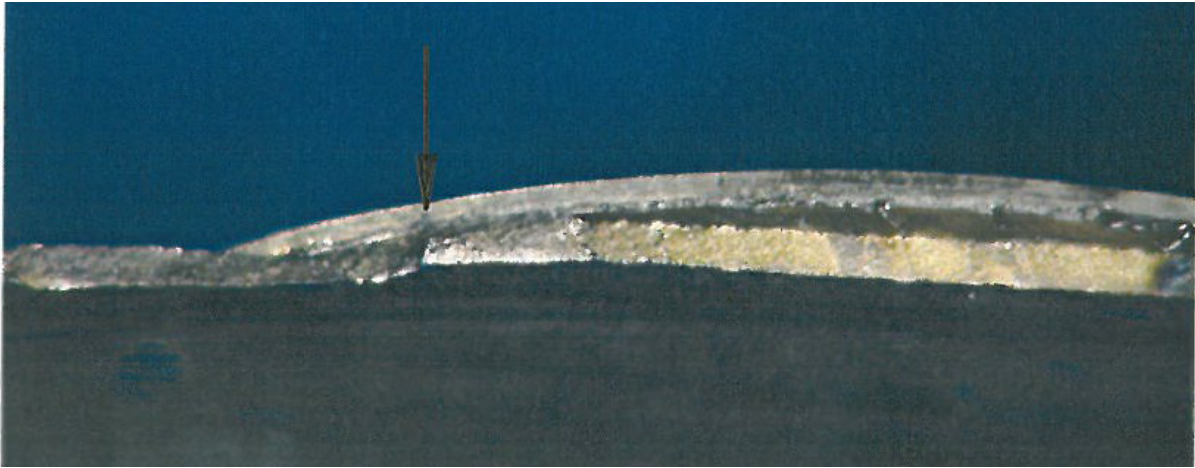
Appendix 3: Detail of Fracture Surface

- The tail rotor blade was destroyed by a fatigue fracture. All macroscopical characteristics pointed emphatically to a fatigue fracture (fatigue failure).
- Beginning at the end of one of the re-enforcement sheets for the blade grip two fatigue cracks running in opposite directions had formed. One was 97 mm long and the other 37 mm.

- Their common point of origin marked a weak point in the design. In this area a change in stiffness occurred. The local stress peak at the end of the enforcement sheet overlapped with a high side load and a high centrifugal force and aided the development of a fatigue crack.

- The fracture surfaces show signs of a fatigue fracture.
- At the end of the affixed enforcement sheet two separate starting points of a shared fatigue fracture were found.
- On the surface of the aluminium sheeting scrape marks were found on both starting points.
- After the coat of lacquer had been removed, the opposite upper surface of the tail rotor blade showed similar scrape marks.

Fracture analysis showed fatigue fracture as cause for the torn-off tail rotor blade. The length of the fatigue fracture finally causing the malfunction of the blade was 134 mm. The crack started in the area of the colour change from red to transparent lacquer. This made an early crack finding more difficult. Based on the UK Study concerning crack propagation it must be assumed that the crack has been in existence for quite some time, i.e. at the time of the last documented crack inspection 17 operating hours ago and during the daily pre-flight checks.
