# Investigation Report

Type of Occurrence:	Accident
Date:	12 September 2010
Location:	Abbesbüttel
Aircraft:	Hot Air Balloon
Manufacturer / Model:	Lindstrand Hot Air Balloons Ltd. / LBL 330A
Injuries to Persons:	Eight people with severe and five people with minor injuries
Damage:	Aircraft severely damaged
Other Damage:	Damages to buildings, cars and fences
Information Source:	Investigation by BFU
State File Number:	BFU 3X134-10

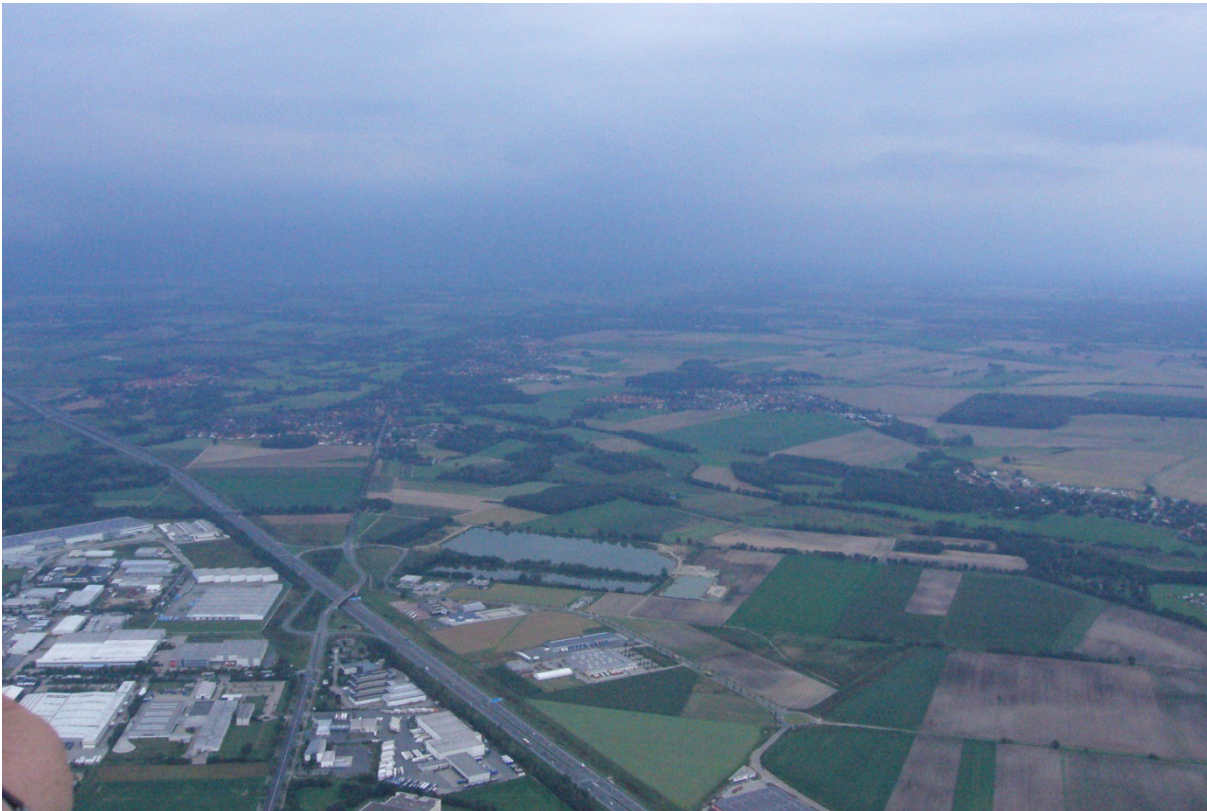
Weather situation during the flight; viewing direction west-north-west

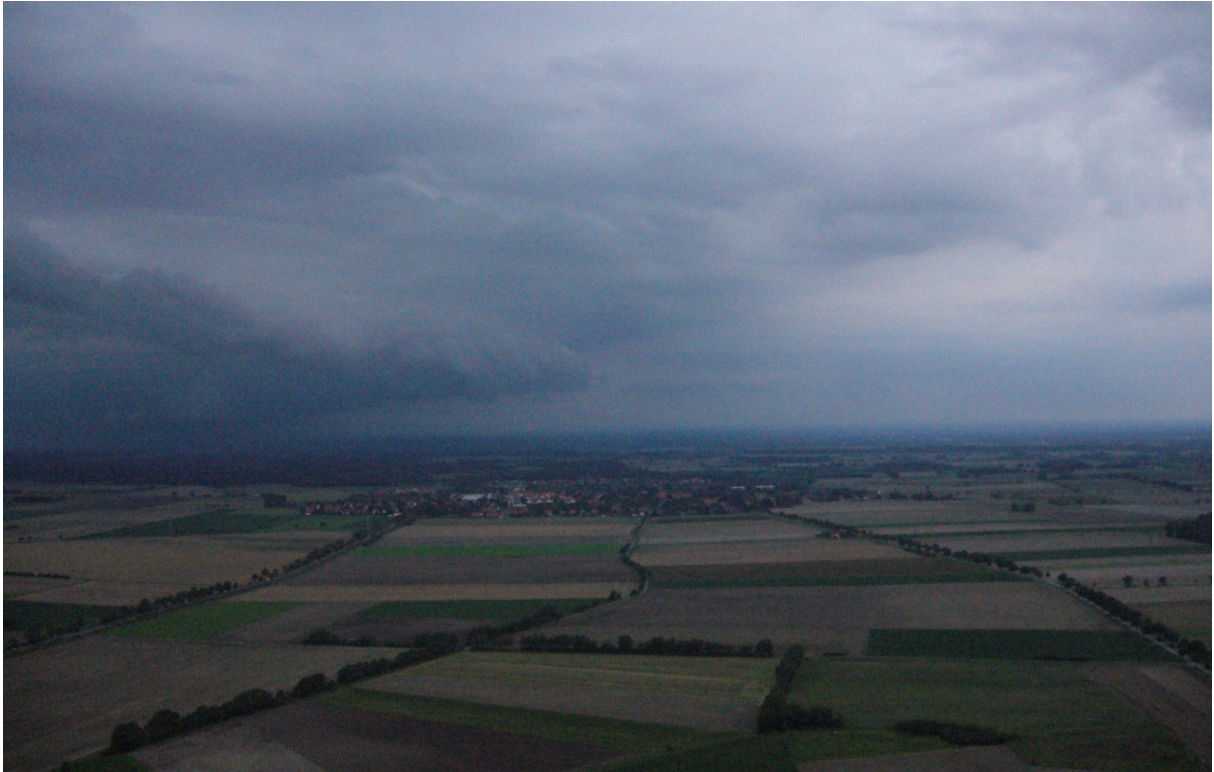
Development of the weather situation during the flight

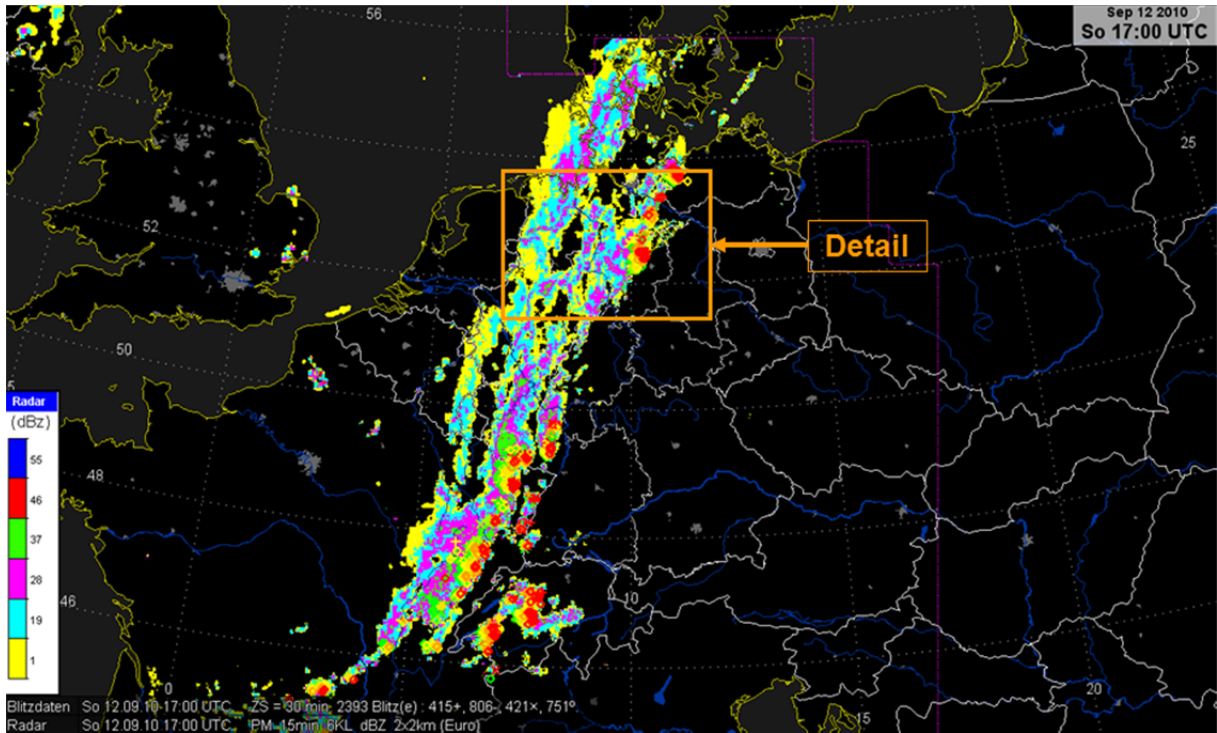
According to the DWD expert opinion and the data of the Wetterwarte Braunschweig (weather station) the wind increased between 1850 hrs and 1900 hrs on average by about 8 kt with gusts of 22 kt. Up until 1920 hrs the wind increased further to an average of 15 kt with gusts of 25 kt. At the time of take-off heavy thunderstorms occurred in Hanover. Until the time of the landing, the so-called squall lines shifted further east up to the landing area.

Rain radar and lightning (red) at 1900 hrs.

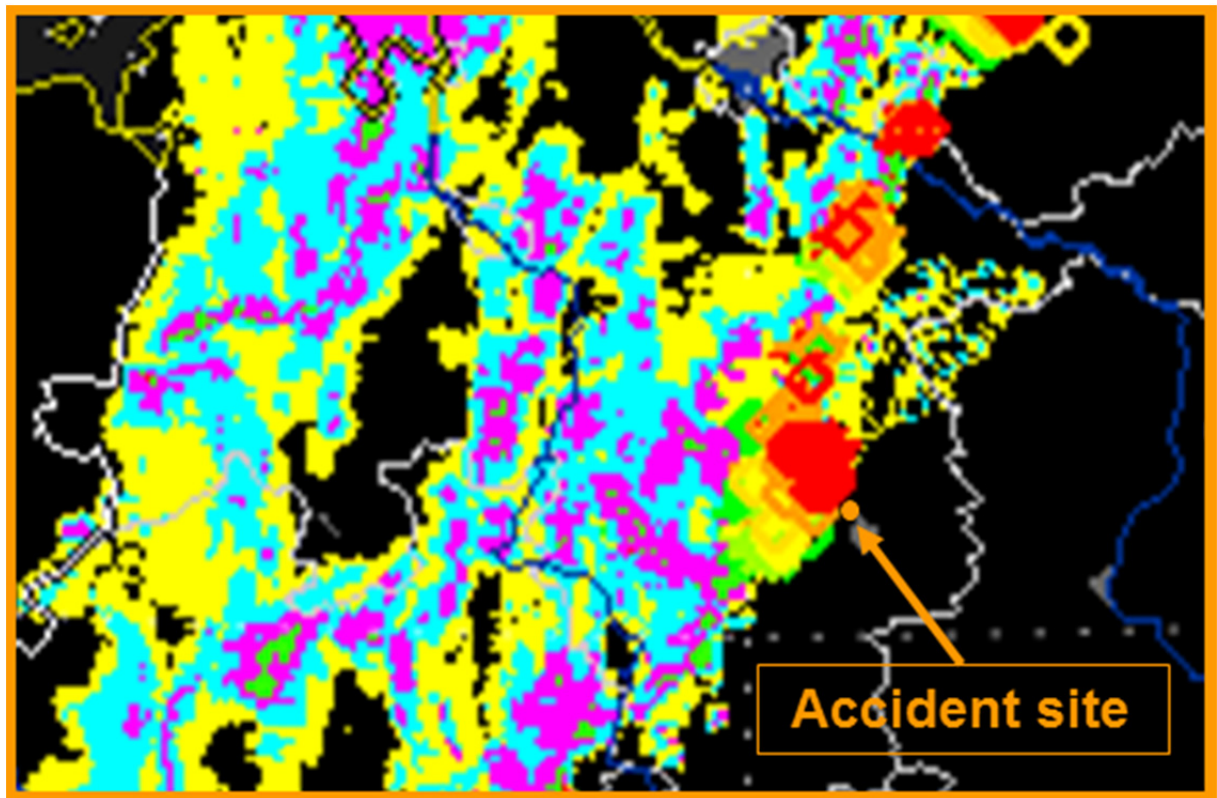
Detail: Progress of the front at 1900 hrs in regard to the accident site

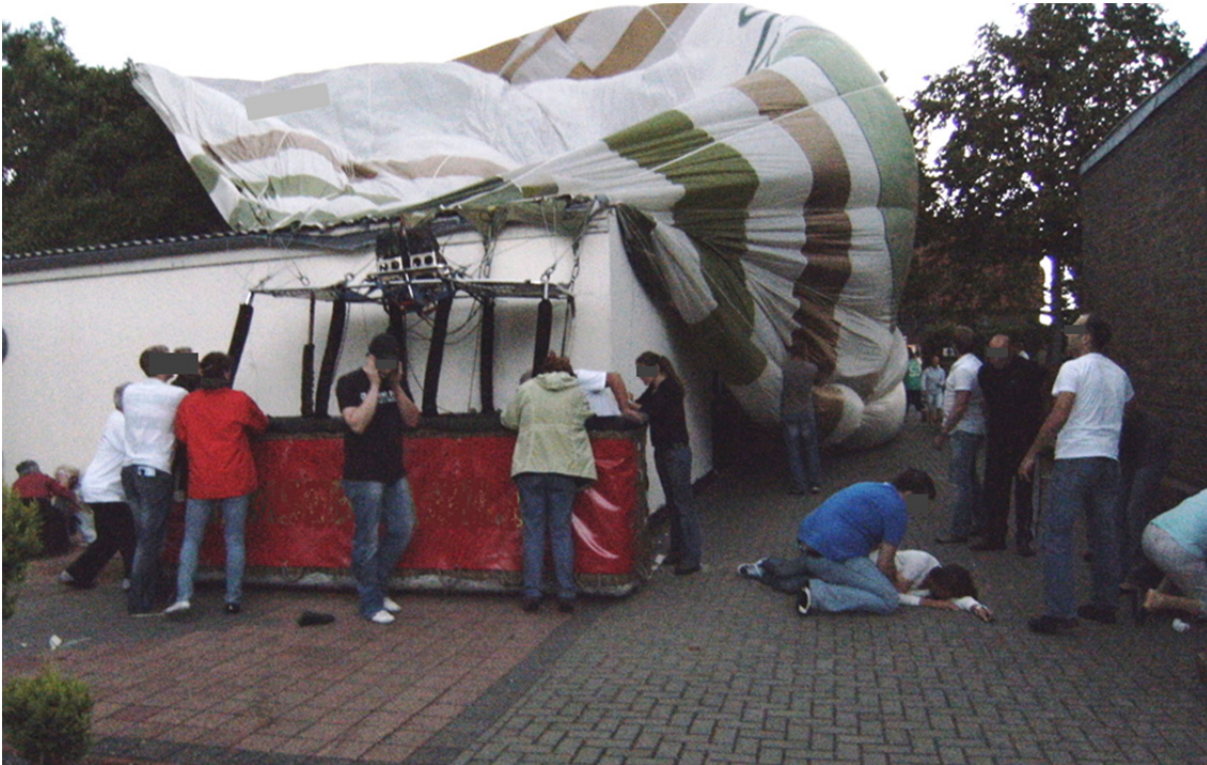
The touch-down occurred on an even meadow. For about one to one and a half minutes the balloon came to a stop. A sudden wind set the balloon in motion again and after about 65 m the basket collided with an approximately two-meter-high hedge and subsequently crashed into the wall of a house with a platform roof. The entire balloon was pulled over the house. After about 130 m the basket penetrated a wire mesh fence and collided with a solid shed. Subsequently the basket was pulled through a second wire mesh fence, crossed a garden, collided with a solid metal fence after about 180 m and came to rest at a garage. After about 200 m the envelope came to rest on top of the roof of a house.

Final position of the balloon

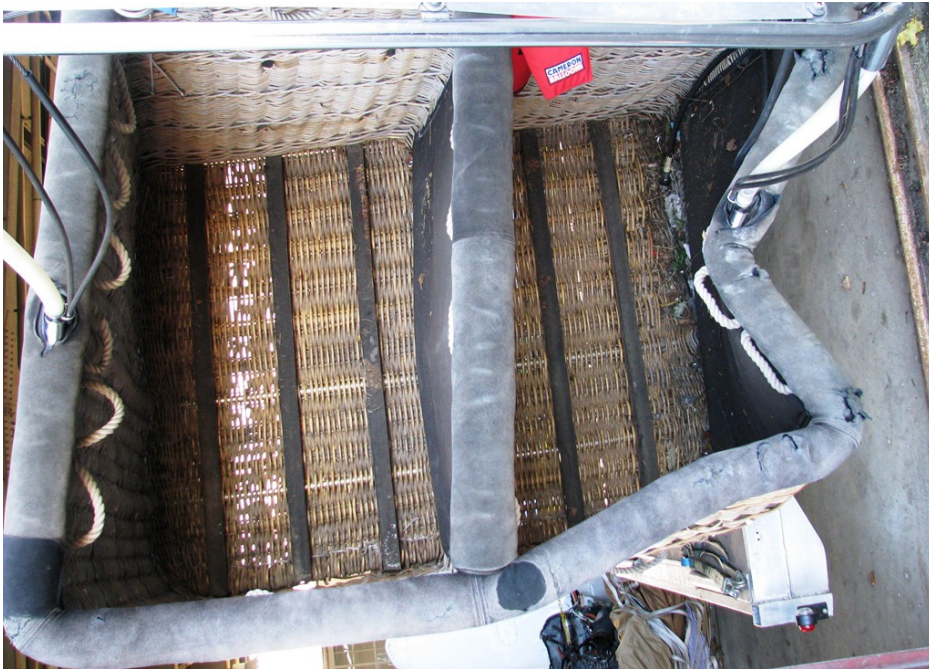
The metal tube frame was deformed in the area of the basket railing.

Deformation of the metal railing on one of the compartments

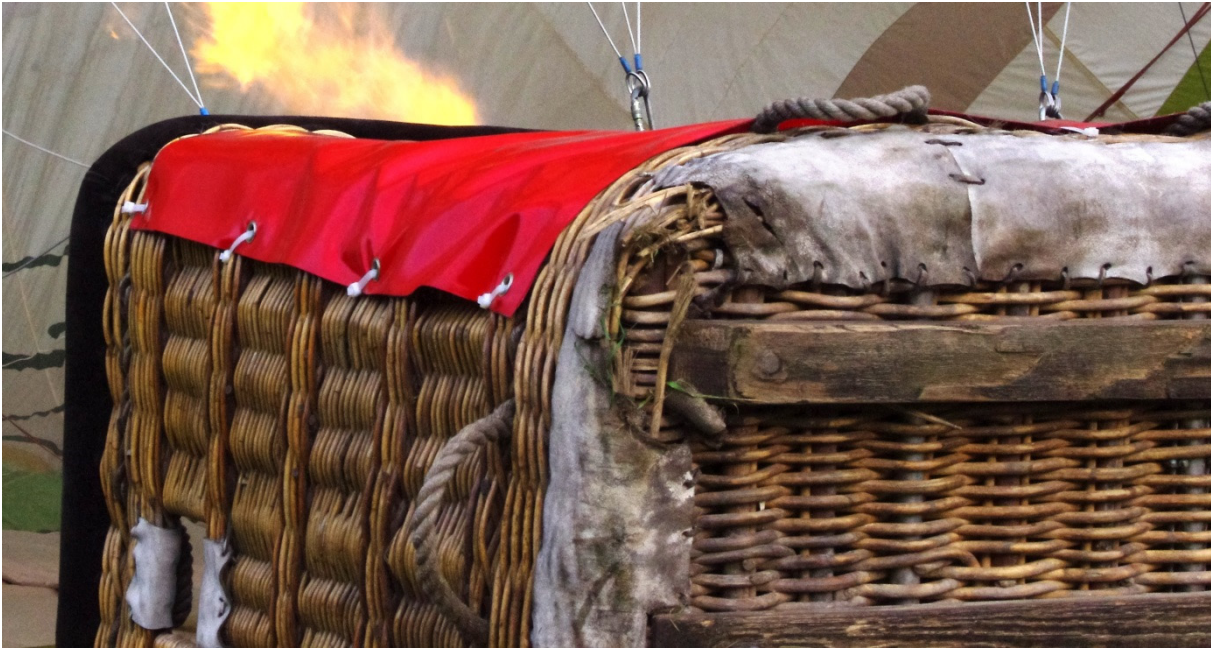
The basketwork on the lower edge of the basket was fractured but also partly decayed. The sliding runners on the right basket bottom were split.

Visibly fractured basketwork on the bottom (prior to take-off / rigging process)

Prior to the flight or during rigging of the balloon, the pilot did not assure himself to the full extent of the technical condition of the basket on the basis of the checklist. At the latest while rigging the balloon as the basket was laying on its side the pilot could have noticed for example some cracks in the basketwork.

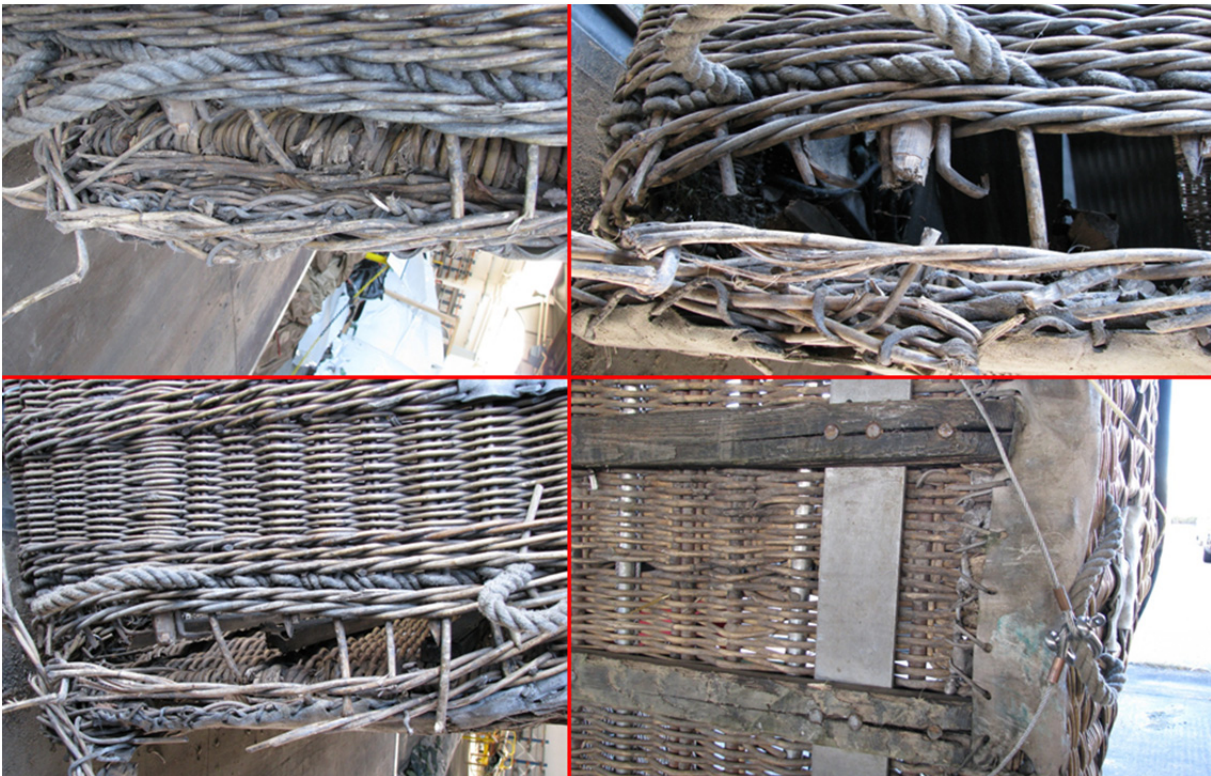
State of the basket in the area of the lower basketwork - after removal of the rawhide - and on the basket floor

The basket was severely damaged. After the basket mats and the leather lining had been removed partially decayed and broken basketwork became visible. The sliding runners on the underside of the right basket bottom were split. A connection between the sliding runners and the basket did no longer exist. The condition of the fractures - differentiation between light, new and dark, old fracture surfaces - allowed the conclusion that some damage on the basket and the basketwork occurred before the accident. On 16 June 2010 the last technical inspection of the basket took place, i.e. 12 weeks prior to the accident. This inspection did not result in any findings. Thus the damages must have occurred in this space of time. The fractured sliding runners on the underside of the basket and the fractures in the basketwork could have been noticed by each pilot rigging the balloon prior to a flight. Prior to the accident flight the

pilot could have noticed during a thorough pre-flight check and due to his experience that because of the damages the balloon was no longer airworthy.

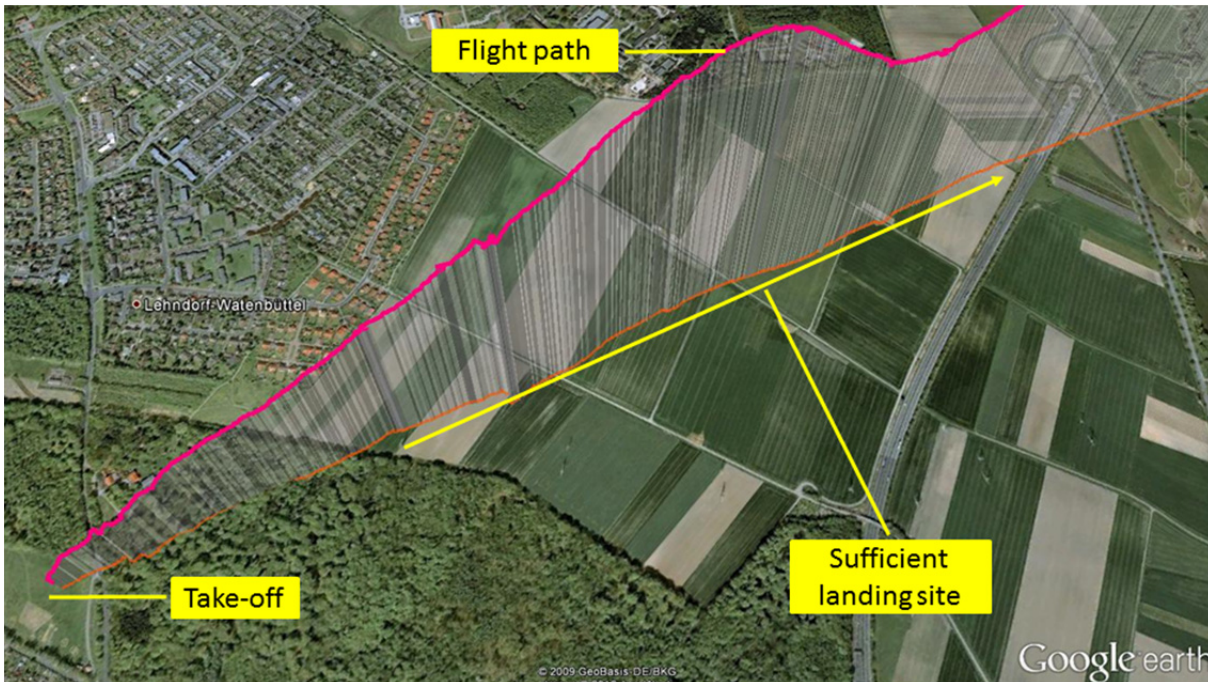
According to his own statements, the pilot was not overly concerned about the weather. Several passengers saw the dark cloud formation and lightning and one passenger even requested him to land. At that time, he would have had sufficient landing areas available after traversing a wooded area. The pilot, however, decided to continue the flight.

Available landing sites immediately after take-off

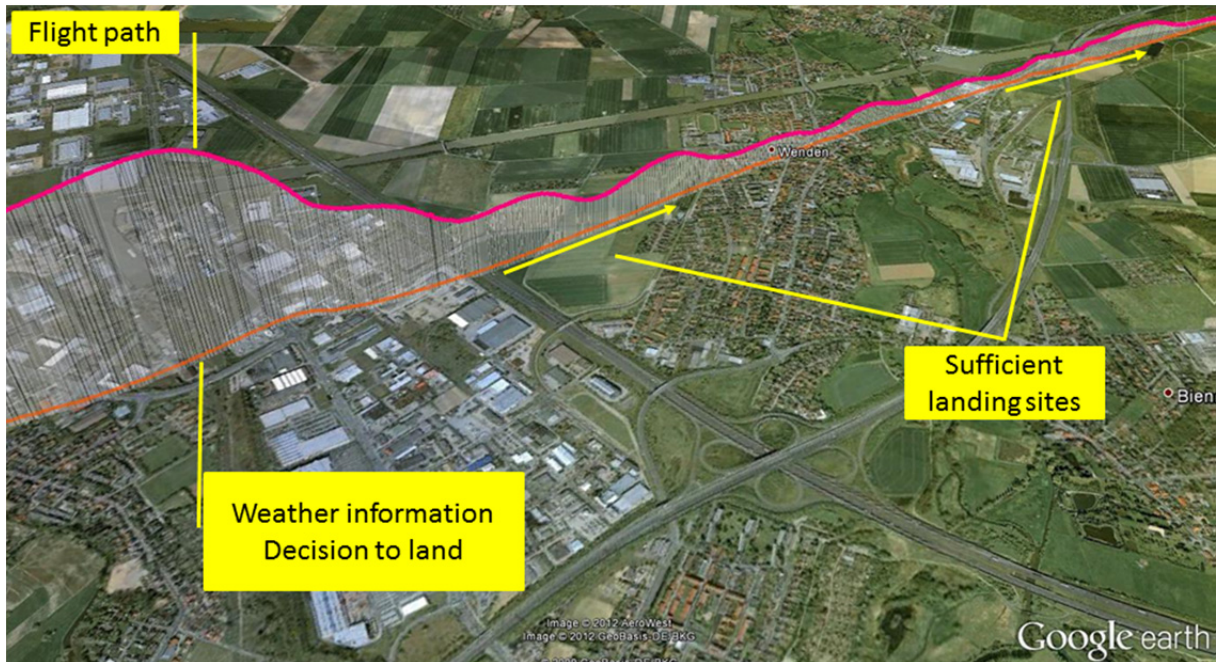
The balloon pilot stated, he contemplated a landing and let the balloon descent to about 200 m - 150 m AMSL but continued the flight. The BFU is of the opinion that - contrary to the opinion of the pilot - sufficient landing areas were still available.

Available landing areas in the further course of the flight      Source: Google Earth map service™ / Adaption BFU

During the subsequent flight in about 10 to 100 m GND the pilot reached further well-suited landing sites after he had traversed some fields and a town; once again he did not use them to land.

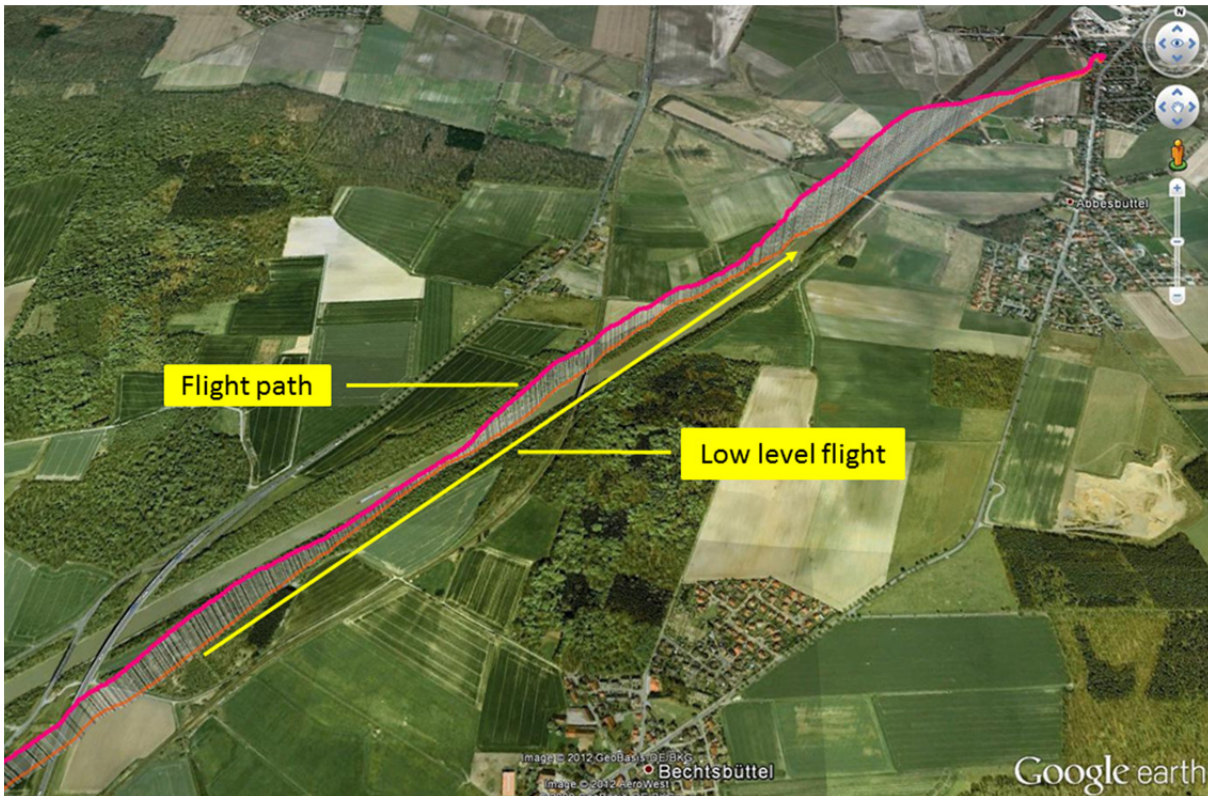
Until reaching the shipping canal, wooded on both sides, he had traversed three well-suited landing sites and here he should have, at the latest, gained altitude in order to maintain the minimum safety height of 150 m above ground.

Flight above the shipping canal

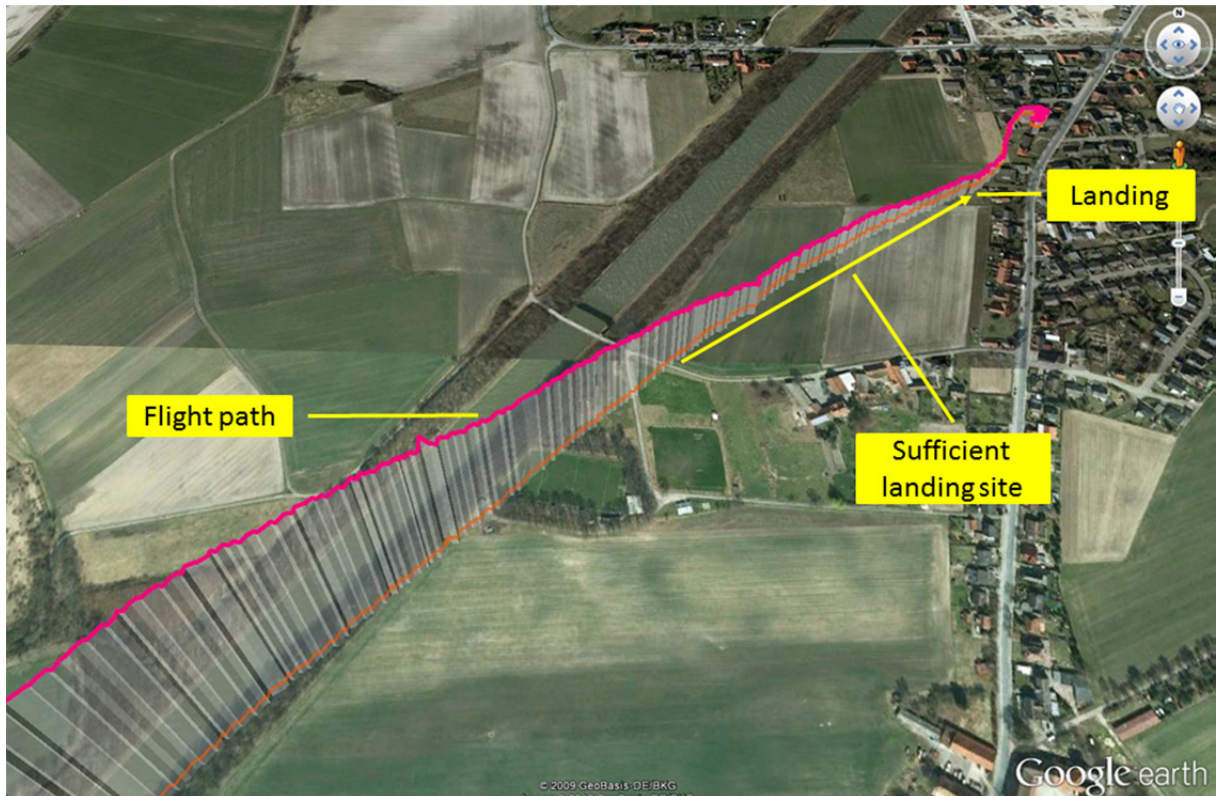
During the continued flight below the minimum safety altitude in the area of the canal the balloon moved toward an unsuitable direction which did not provide any landing sites. The BFU is of the opinion that in this phase this does not attest to the pilot trying to find a landing site.

Flight profile after climb and corresponding change of direction
