Investigation Report

Type of Occurrence:	Serious incident
Date:	19 January 2010
Location:	Stuttgart Airport
Aircraft:	Airplane
Manufacturer / Model:	Fairchild Dornier /SA 227 - DC „Metroliner“
Injuries to Persons:	None
Damage:	Minor damage to aircraft
Other Damage:	None
Information Source:	Investigation by BFU
State File Number:	BFU 5X003-10

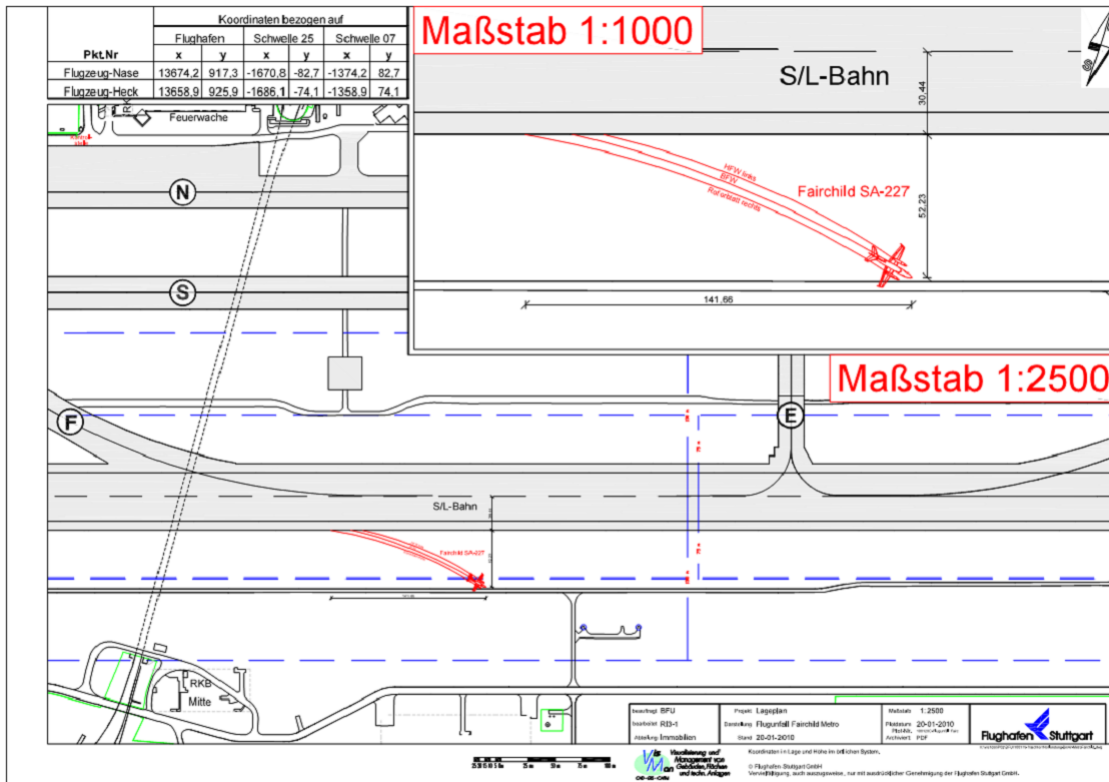
Site plan

After the landing the aircraft had left runway 07 towards the right beyond taxiway F. It came to a complete stop with the aircraft nose 1,374.2 m behind the threshold and 82.7 m right of the extended centre line (see Appendix). The ground next to the runway showed traces of the left main landing gear, the nose landing gear and the right propeller. The aircraft's longitudinal axis pointed towards 100°.

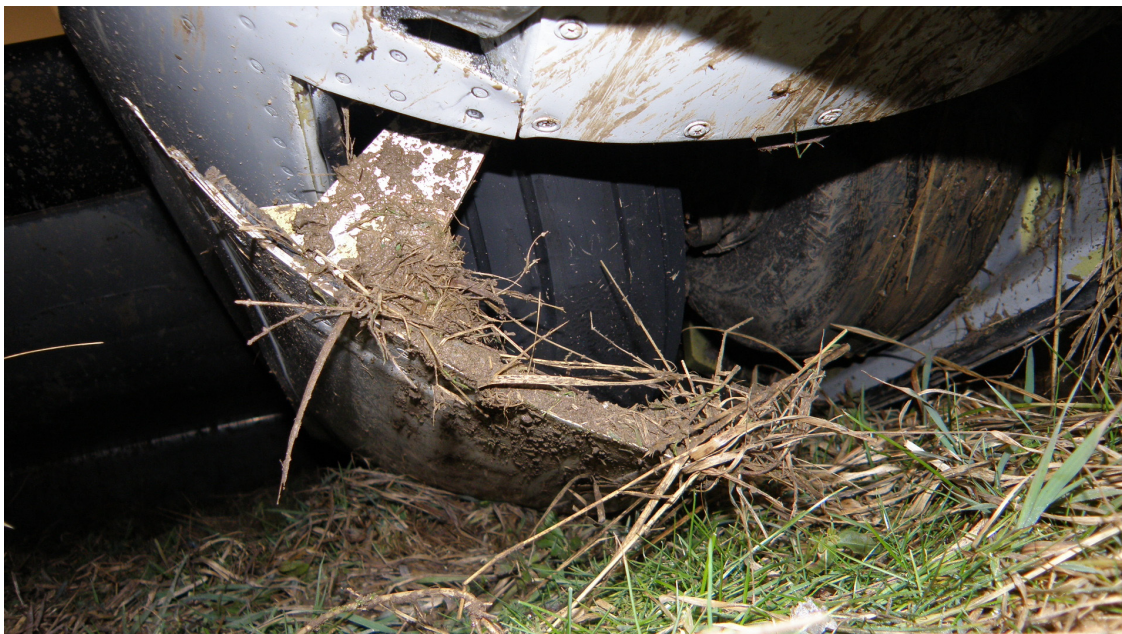
Right main landing gear

side the aircraft rested on the engine nacelle, where the main landing gear is located, and the right outer wing. The landing gear doors of the right main landing gear were partially open (see Appendix). The tyres of the right main landing gear rested on the landing gear doors. The wing tip and the outer area of the right wing were damaged. The tail section had ground contact.

The outer landing gear door of the right main landing gear was dislocated by about 2 cm toward the back. An opening of about 2 cm between the front bay edge and the door appeared when the landing gear doors were pushed closed. In front of the aft hinge the outer skin of the door was slightly rippled.

Level with the aft hinge a dent was worked into the bay edge; the edge itself was rippled. The connection rod between the landing gear door lever and the bellcrank was bent.

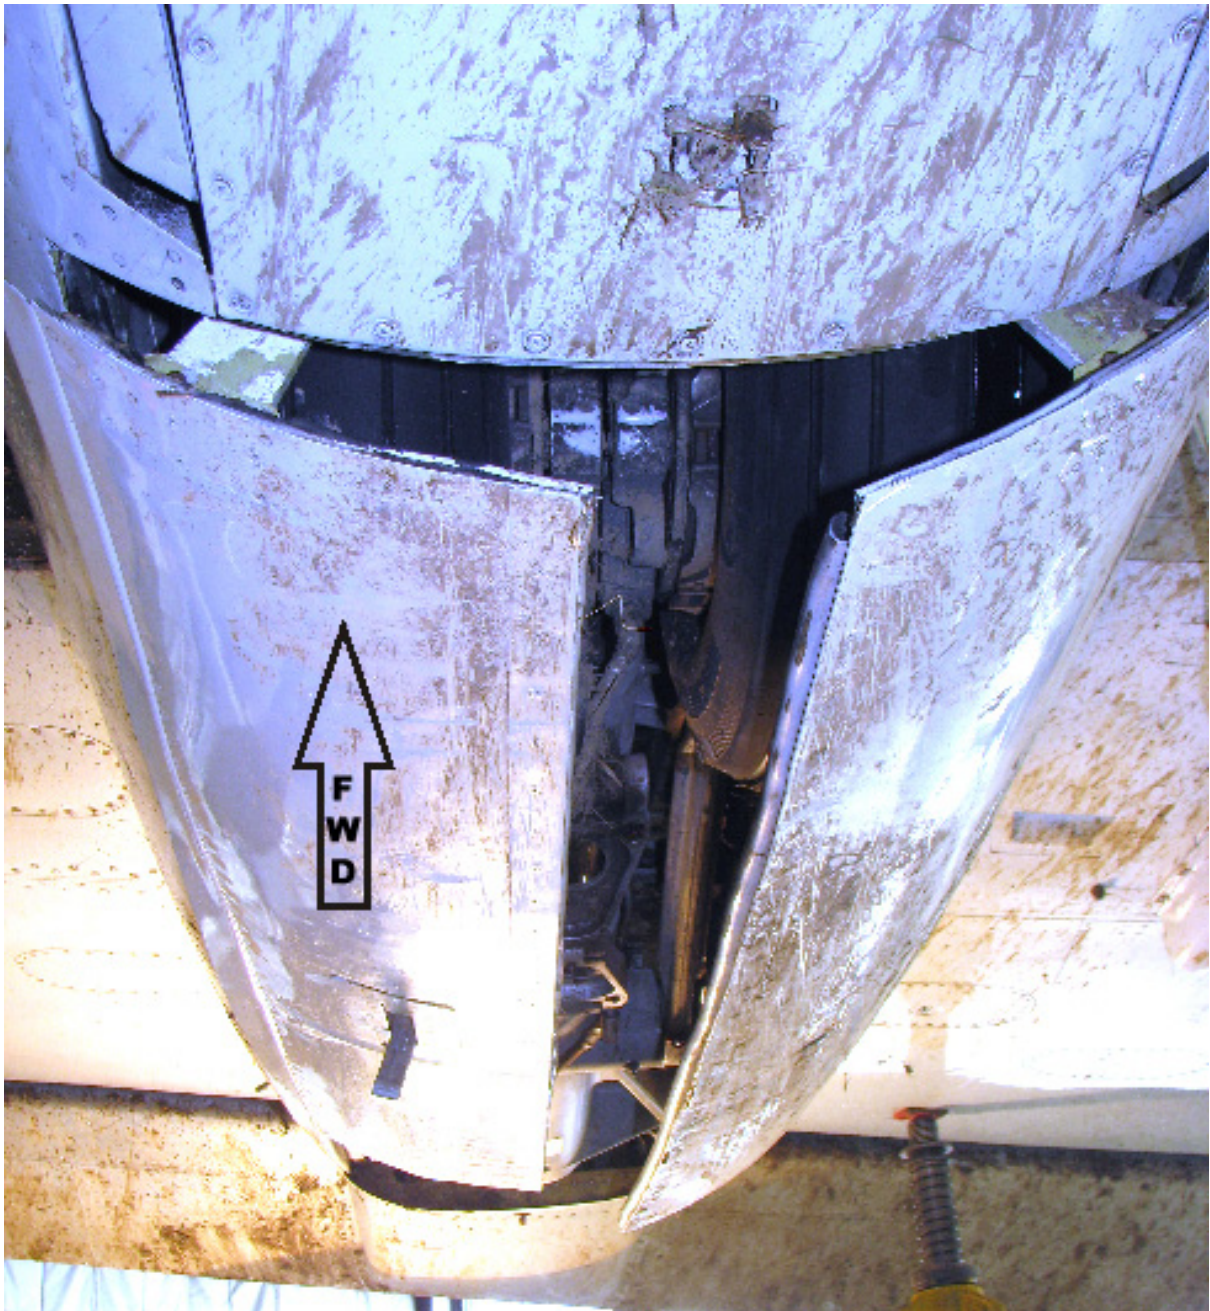
Right main landing gear in the jammed position

After these function tests the right main landing gear was manually put in the position in which the indication in the cockpit shows red. This was very likely the position in which it jammed during the approach to Stuttgart. Afterwards the connection between the outer landing gear door and the landing gear lever was reconnected. It was determined that the door slides into the outer edge and gets stuck on a rivet head. The landing gear was retracted hydraulically and locked; the door was closed manually. During the subsequent extension the landing gear remained in the previously simulated position; the same was true for the emergency procedure (refer to the photo in the Appendix).

The extension and retraction trials conducted by the BFU showed that the right main landing gear could not be extended because the outer landing gear door jammed on the bay edge. The jamming occurred in the area of the aft hinge. The dent and the rippling of the outer skin were caused by the bar of the hinge arm. The traces showed that this had occurred over a longer period of time. On the opposite side the bar had rubbed off the primer.

The non-extension of the main landing gear was caused by the jamming of the outer landing gear door on the bay edge.
