Investigation Report

Type of Occurrence:	Accident
Date:	23 May 2010
Location:	Near Mönchgrün
Aircraft:	Helicopter
Manufacture / Model:	Fairchild Hiller / FH 1100
Injuries to Persons:	Pilot and three passengers fatally injured
Damage:	Aircraft destroyed
Other Damage:	Crop damage
Source of Information:	Investigation by BFU
State File Number:	BFU CX004-10

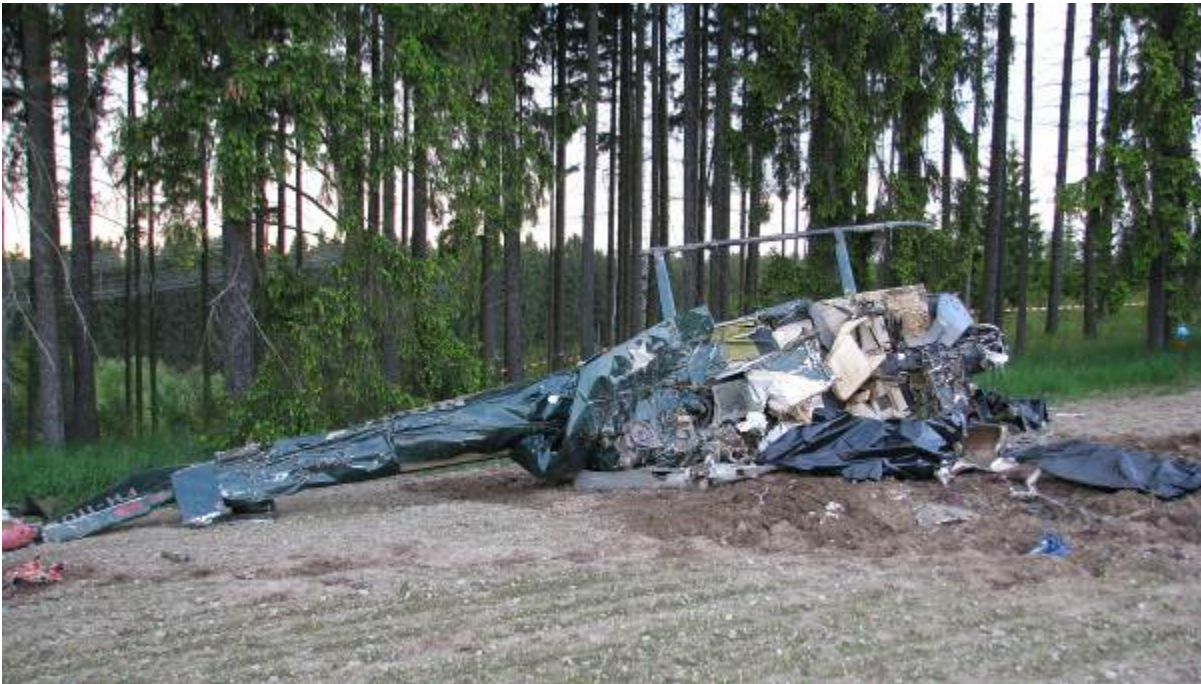
The accident site was northwest of the village of Mönchgrün on the western edge of a field with an early crop sown in firm soil. The helicopter came to rest on the right side of the fuselage with the skids pointing towards the woods on the field western edge. The four fatally injured occupants were found immediately adjacent to the helicopter.

All parts of the wreckage were found within a small, limited area around the helicopter main wreck. Impact marks from the main rotor, the rotor mast, the cabin and tail rotor were found directly alongside the main wreck. The main rotor was found underneath the helicopter, with rotor blades straight and only slightly deformed. The rotor head had separated from the rotor mast, and the main gearbox had torn loose from within the airframe cell. The control rods had separated from the swash plate and the rotor head and were jammed. The upper surfaces of engine exhaust pipes and en-

The cabin roof and doors were destroyed and scattered about the wreck. The instrument panel was badly damaged; some individual instruments were missing or were destroyed and scattered about the wreck. The N1-tachometer instrument had jammed at 19%. The tail boom upper side and the rear third lower surface were dented. The tail rotor universal joint gearbox was found in the tail boom; it had oil and moved freely. The tail rotor gear had torn off and remained attached to the control wires. One tail rotor blade had detached and was found close to the boom on the ground near impact marks.

The accident site

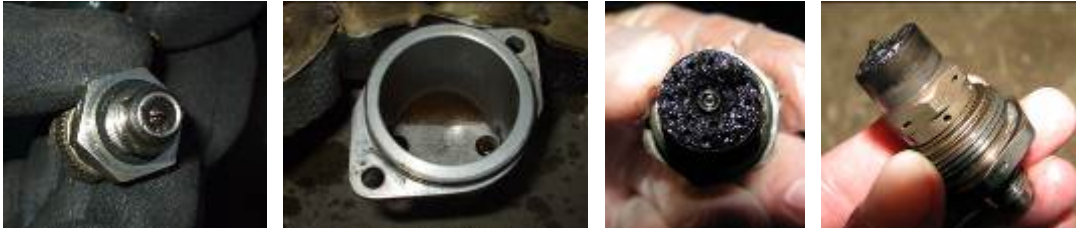
After the wreck had been recovered, investigators examined the engine chip warning detectors. There were a number of chips in the oil sump. The fuel injector jet was unscrewed for examination and found very dirty. Fuel was found in the engine-side oil filter. The filter housing contained brown impurities.

Detailed photos: chip warning detector; fuel filter housing; fuel injection jet Photos: BFU

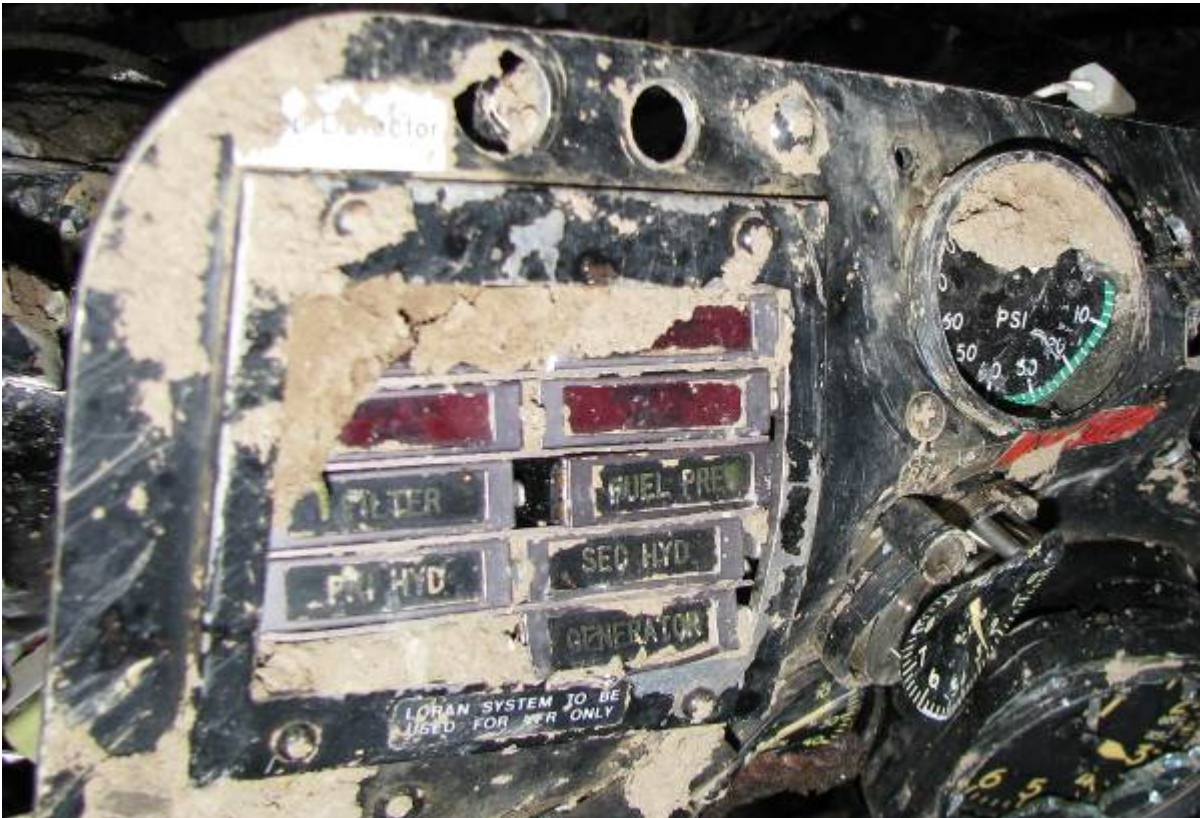
The helicopter's caution panel

Warning Lamp	Bulb 1	Bulb 2	Remarks
ENG AREA HOT	OFF	OFF	-----
XMSN OIL TEMP	OFF	OFF	-----
FILTER	absent	OFF	-----
PRI HYD	OFF	OFF	-----
ENG OUT	ON	indistinct	Glass black
XMSN OIL PRESS	ON	ON	-----
FUEL PRESS	ON	ON	-----
SEC HYD	ON	ON	-----
GENERATOR	OFF	indistinct	Bulb filament slightly elongated

The engine stopped during flight as confirmed by witnesses, observations at the accident site, examination of the warning light bulbs, and the findings on the engine. The pilot probably reacted to the engine failure with an attempt to restart the engine. This inference is supported by the fact that, post accident, the engine N1 tachometer had stopped at 19%; also the damage pattern to the compressor blades, and that fuel was found in the filters and fuel lines. Either the pilot did not initiate an autorotation or was too late in so doing, as a result of which the main rotor speed dropped off, the helicopter became uncontrollable and crashed.

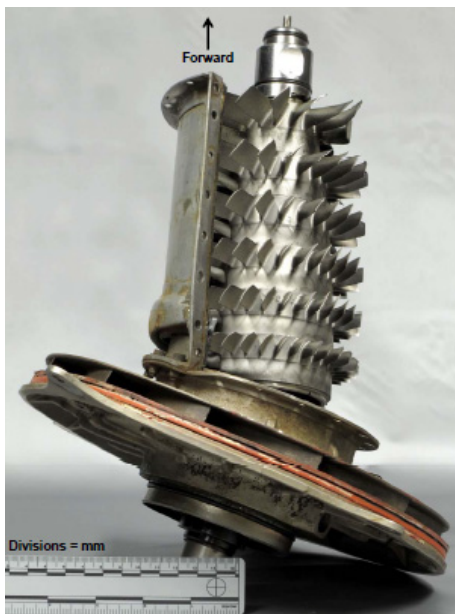
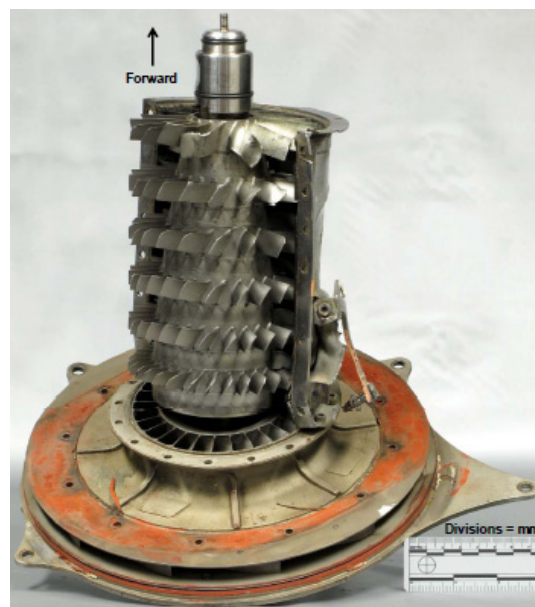
After opening the bent compressor housing, inspectors found that some of the compressor blades were bent against their direction of rotation.

Compressor with blades bent against the normal direction of rotation
