Investigation Report

Type of Occurrence:	Accident
Date:	31 May 2010
Location:	Near Bielefeld
Aircraft:	Airplane
Manufacturer / Model:	Cirrus / SR22
Injuries to Persons:	Pilot and three passengers fatally injured
Damage:	Airplane destroyed
Other Damage:	Crop damage
Information Source:	Investigation by BFU
State File Number:	BFU CX007-10

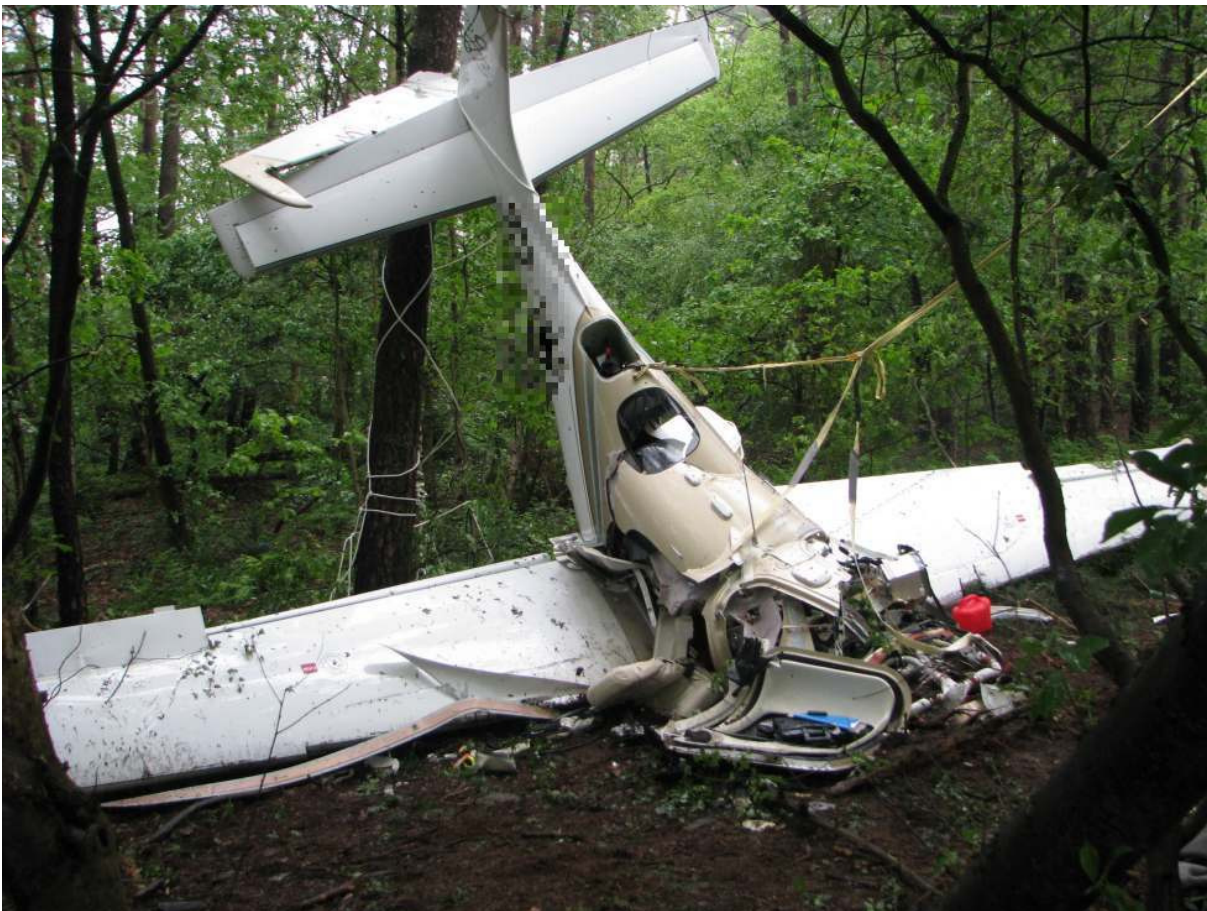
The accident site was located about 200 m north of the extended centre line and 1 km east of Bielefeld Airfield in a small forest. The airplane rested almost vertically on a tree. The propeller blades were torn off. The front part of the airplane up to the seats was destroyed. Fuel was in the tanks. The wing leading edges were smashed and partially torn open. The rescue system had been deployed. The control handle was unlocked but not pulled.

The examination of the wreckage determined no evidence of technical defects.

Wreckage overview

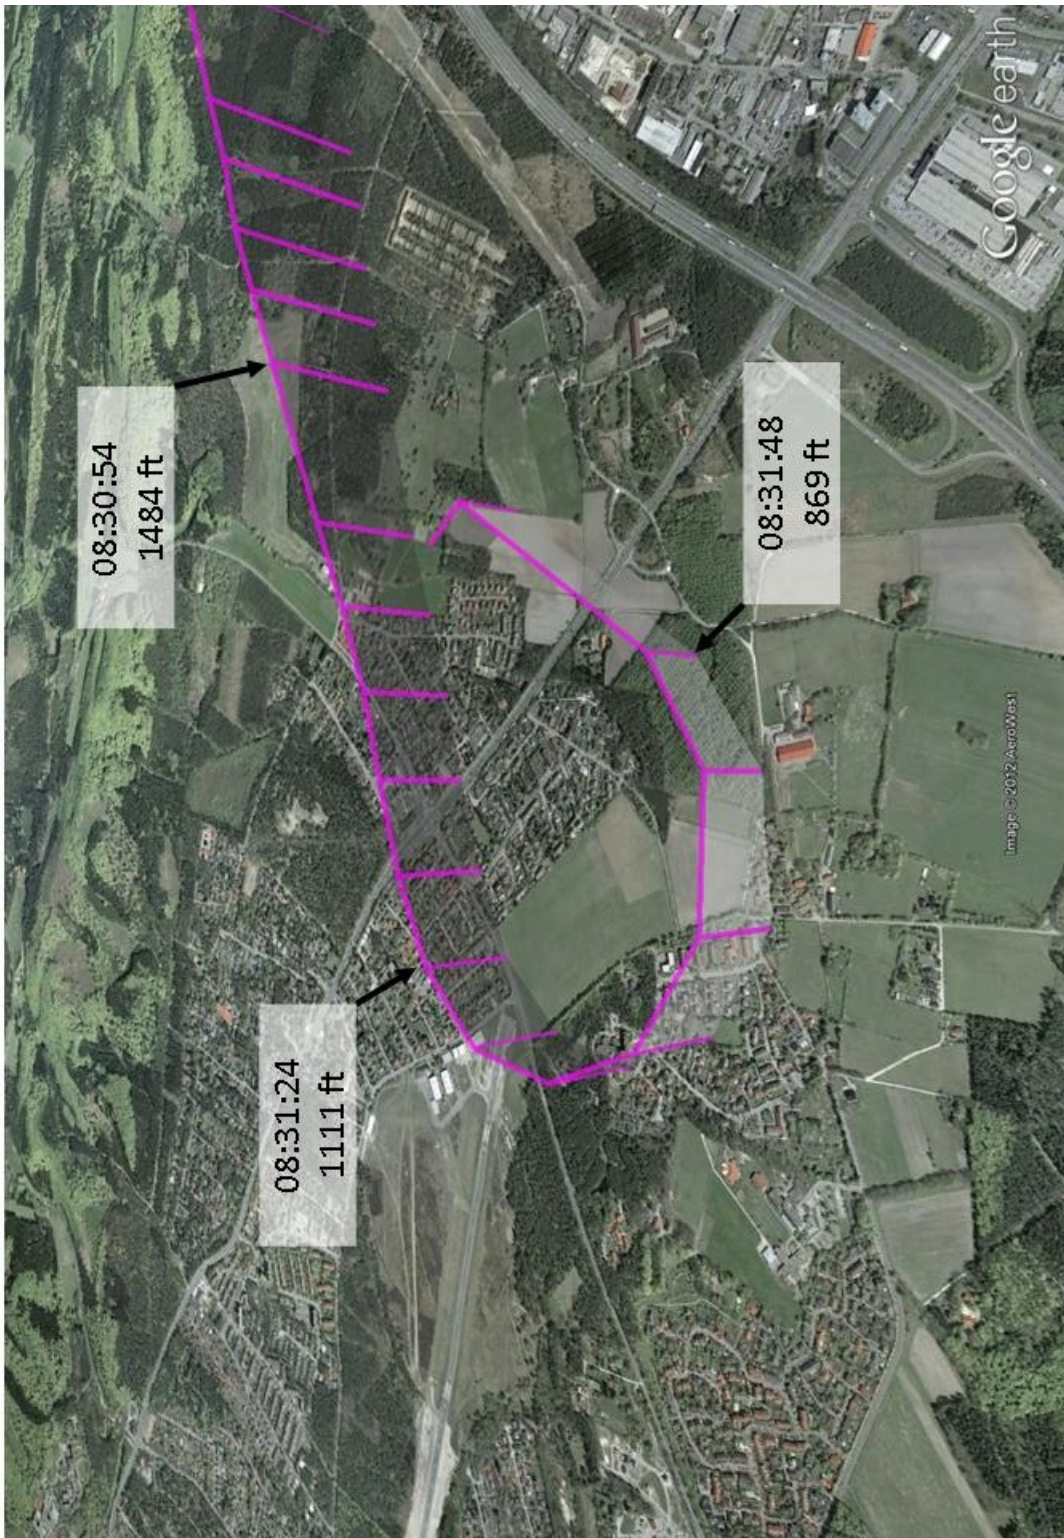
Appendix 1

At 1031:15 hrs the airplane was in about 1,200 ft and about 400 m from the threshold of runway 29. From a heading of 260° the airplane turned left. Within the next 20 seconds the bank angle increased to about 40° and Indicated Airspeed (IAS) fluctuated between 105 kt and 115 kt. At 1031:46 hrs the bank angle decreased to 5° and then increased again. At that time the power lever was selected to 25%. Thereby, IAS decreased from 105 kt to about 77 kt within 10 seconds. At 1031:52 hrs the airplane crossed the extended centre line of runway 29 toward the north. At 1031:57 hrs the power lever was at 100%, the bank angle was about 55° towards the left and the pitch was 15° downward at that time.

The recorded parameter show that in the last seconds prior to the accident the bank angle increased to up to 60° and the indicated airspeed decreased to 78 kt. Thereby, the speed fell below the stipulated stall speed of 99 kt for a bank angle of 60°.

Reconstruction of the flight path (Times in UTC, altitude in AMSL)

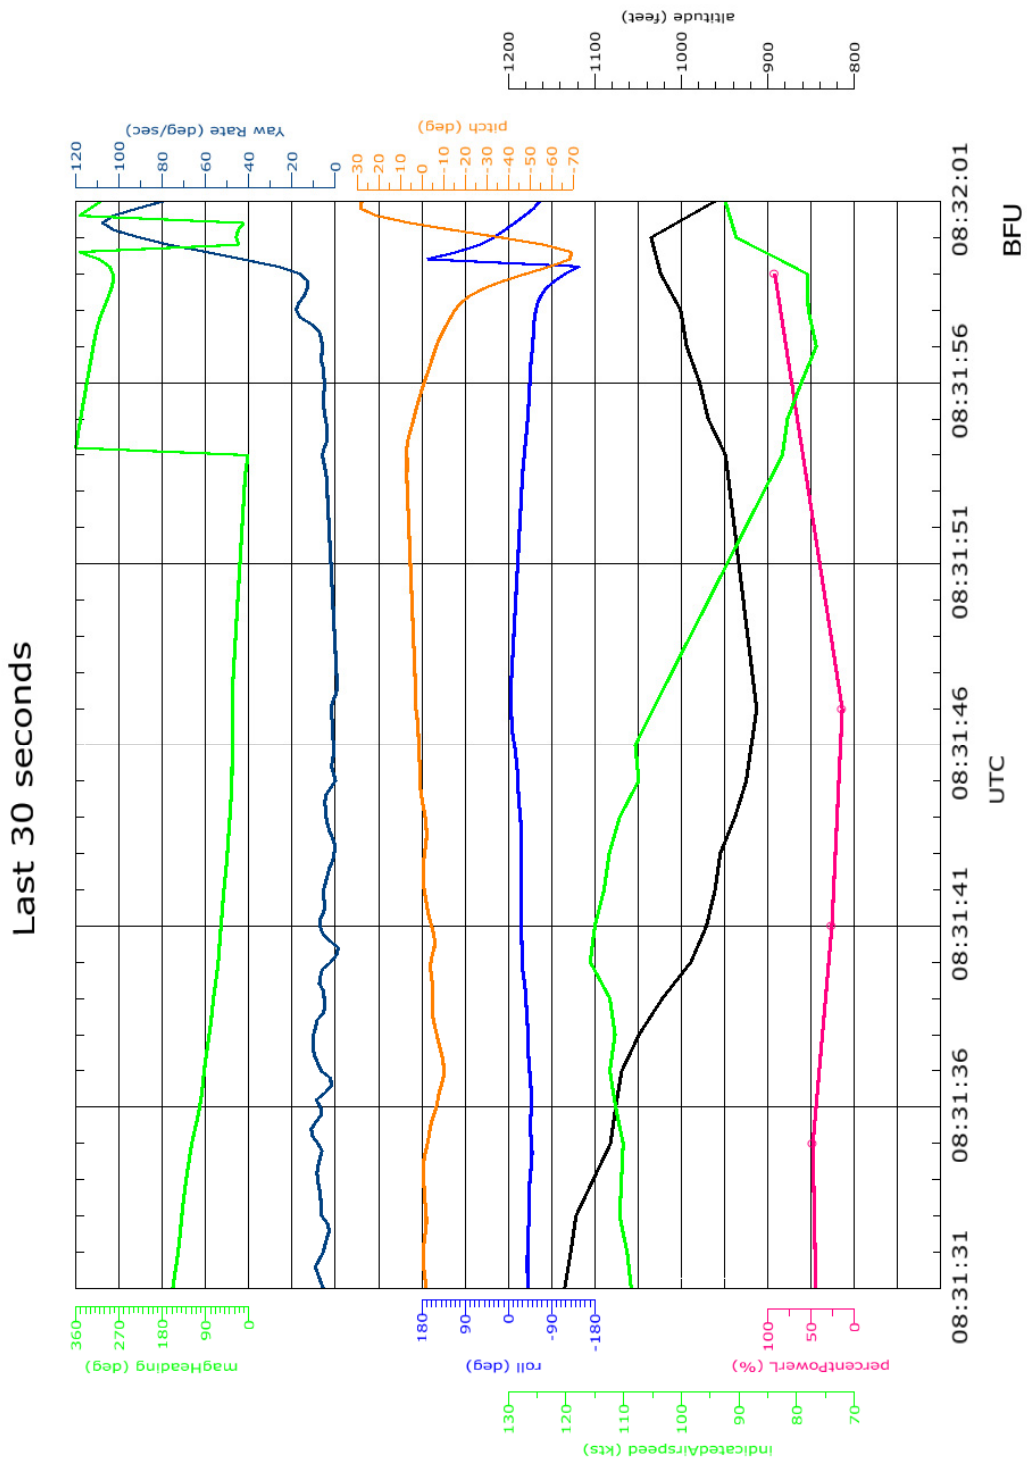
Appendix 2

Flight data (Times in UTC, altitude in AMSL)
