Investigation Report

Type of Occurrence:	Accident
Date:	10 May 2011
Location:	Near Engelsbrand
Aircraft:	Helicopter
Manufacturer / Model:	MD Helicopters, Inc. / MD 900 (902)
Injuries to Persons:	Three persons suffered severe injuries
Damage:	Airplane destroyed
Other Damage:	Crop damage
Information Source:	Investigation by BFU
State File Number:	BFU 3X050-11

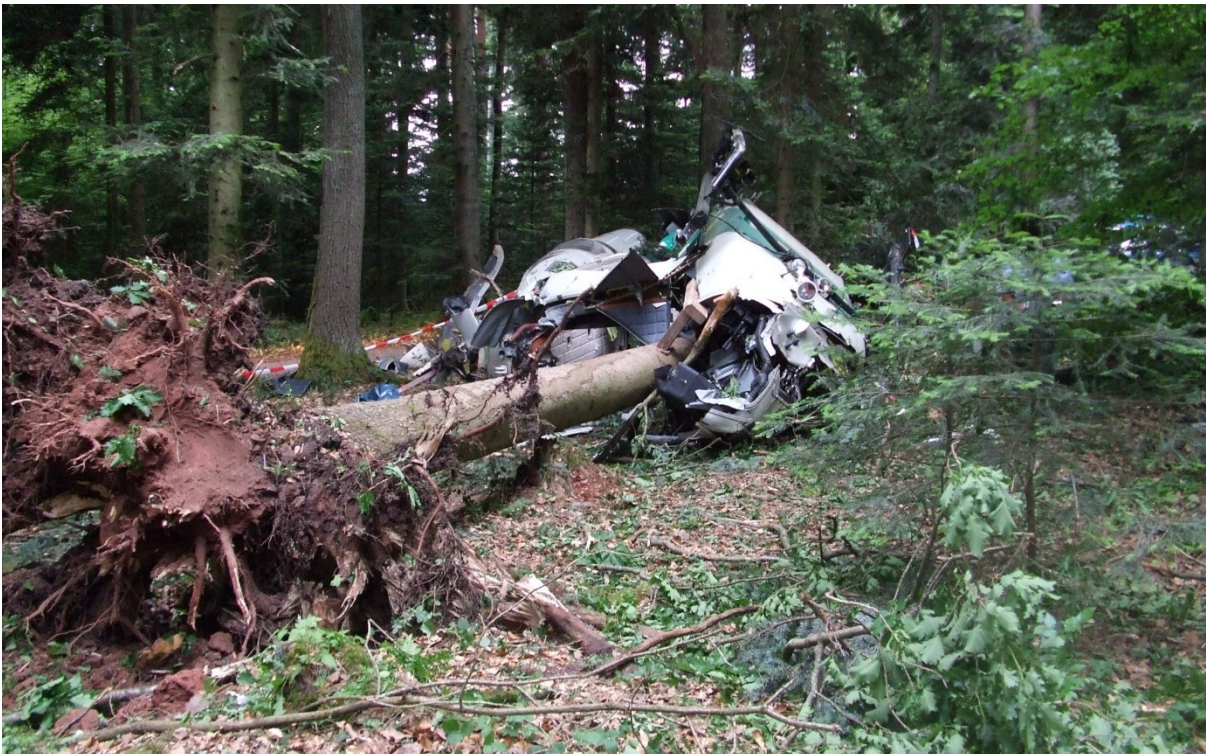
The accident site was located north of Engelsbrand in a forest on a hill. The main wreckage lay on its right fuselage side and pointed toward the south opposite to the direction of the flight. An uprooted tree rose from the cabin. From about the crown down to the final resting place of the wreckage tree limbs and bark had been scraped off the tree trunk. There was an additional tree south of the wreckage whose crown had been severed.

Main wreckage position with uprooted tree

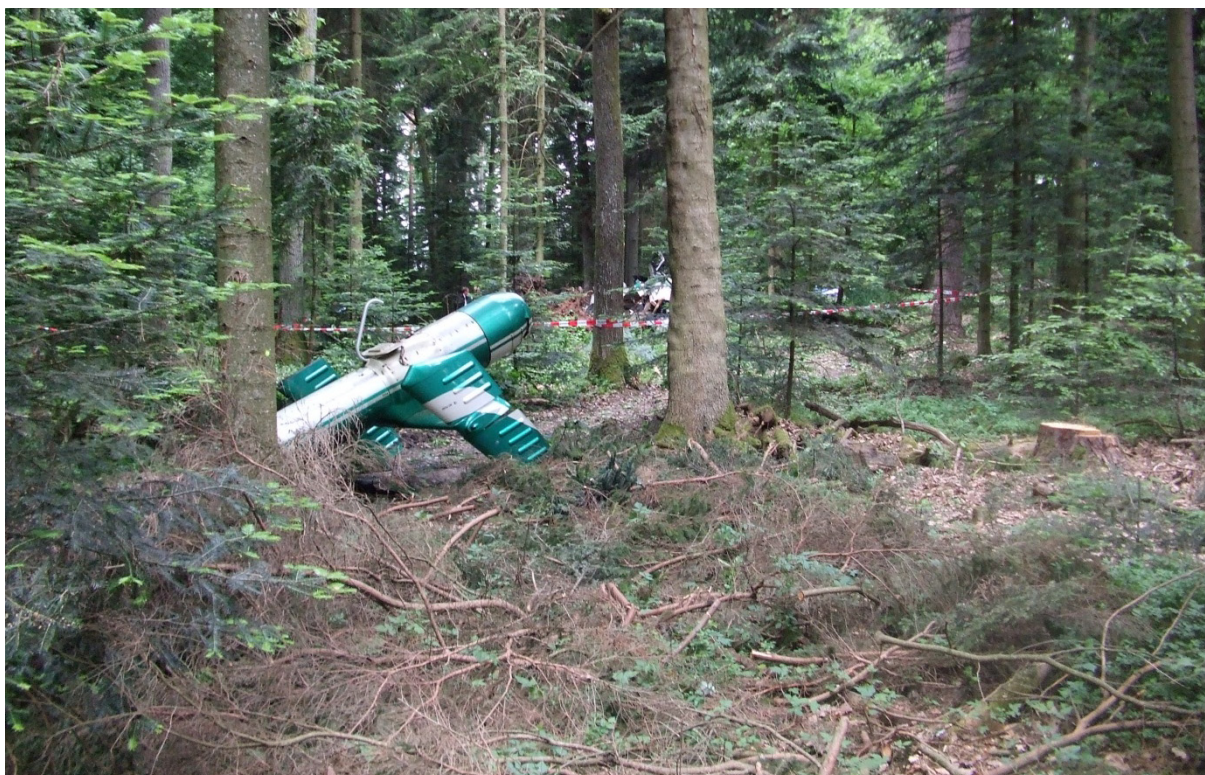
View from the direction of flight at the point of initial tree contact.

The tail boom of the helicopter was about 25 m away from the main wreckage in the direction of the initial tree contact. Three of the five main rotor blades were scattered around the helicopter; two were wrapped around the rotor head. The H4K Artex 406 emergency locator transmitter had deployed. Several night vision goggles were lying in front of the helicopter in the area of the cockpit. On the pilot's helmet the mounting for the night vision goggles and the batteries were fitted. On the helmet of the flight engineer the batteries were missing; they were found in the area of the accident site.
