Investigation Report

Type of Occurrence:	Serious incident
Date:	15 August 2011
Location:	Düsseldorf
Aircraft:	Airplane
Manufacturer / Model:	Airbus Industrie / A330-322
Injuries to Persons:	None
Damage:	Minor damage to aircraft
Other Damage:	None
Information Source:	Investigation by BFU
State File Number:	BFU 5X007-11

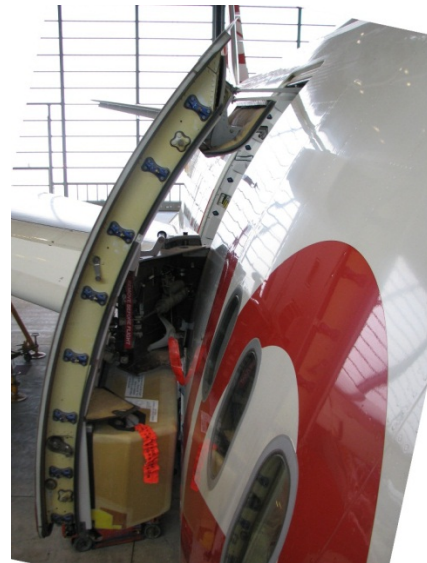
Door R2, in which the work light was installed, is opened almost always whenever the airplane is on the ground since it is used as a service door. The door is pushed outward when it is opened and all sides are exposed to the weather. The examination of an aircraft of the same type showed that the upper side of the door has openings through which water can flow unhindered into the door. Between the door structure and the inner lining there are no seals which would prevent the water from penetrating. When the door panel of this airplane was removed it was determined that the insulation mats had partially collected substantial amounts of water.

Open door R2

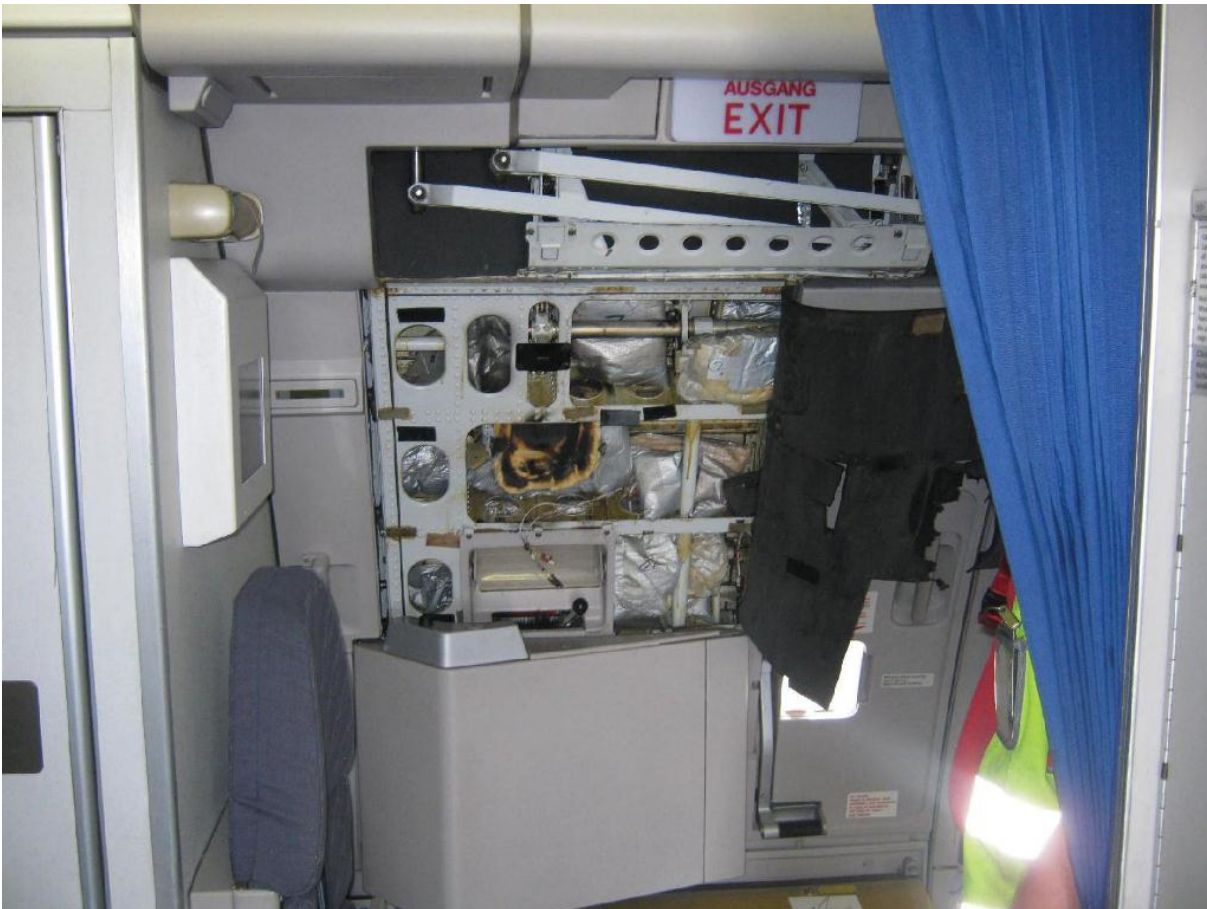
After the landing the interior panel of door 2R showed slight scorch marks in the area of the work light. After the lamp unit (P/N F925-90046-012-00-C) was removed it was determined that especially in the area of the power unit (P/N 8ES004692-10) heavy fire and heat traces were visible. The interior of the door showed fire and scorch marks on the insulation and the structure once the panel was removed.

Fire area on door R2 after the panelling was removed

The traces of high current flow on the circuit board of the power unit, the heat and fire traces on the lamp unit and on the insulation and the door panelling allow the conclusion that the short circuit in the power unit caused a fire which spread to the surrounding area. The fire was limited to a few square decimetres. The BFU is of the opinion that it cannot be determined conclusively if this was owed to the properties of the material used or the immediate use of the fire extinguisher. It is doubtful, however, that enough extinguishing agent could penetrate through the available openings to extinguish the fire. This is even more important because the fire extinguisher was

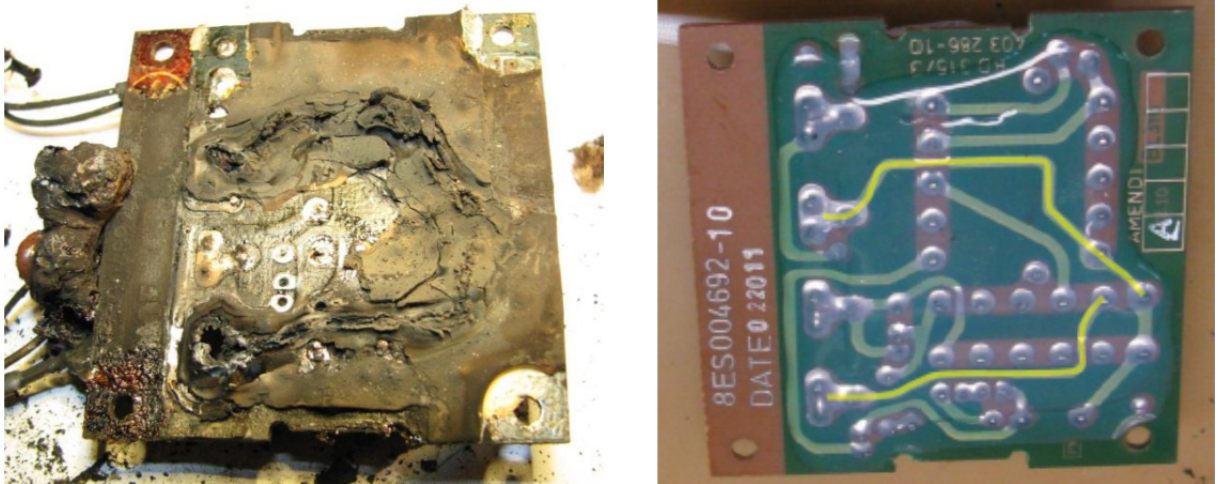
The lamp unit was examined in the BFU laboratory. The circuit board of the power unit showed signs of high current flow along two circuit paths. These circuit paths were directly connected with 115 VAC/400 Hz and AC Return/GND.

Comparison of damaged and new power unit

The BFU is of the opinion that the short circuit was definitely caused by water ingress in combination with a power unit coating insufficient for this particular environment since

In combination with the water the insulation resistance of the circuit board was reduced and resulted in a short circuit.
