Investigation Report

Type of Occurrence:	Accident
Date:	28 July 2011
Location:	Röhrhof
Aircraft:	Airplane
Manufacturer / Model:	Rutan Aircraft Factory / COZY III
Injuries to Persons:	Pilot seriously injured
Damage:	Airplane destroyed
Other Damage:	Crop damage
Information Source:	Investigation by BFU
State File Number:	BFU CX007-11

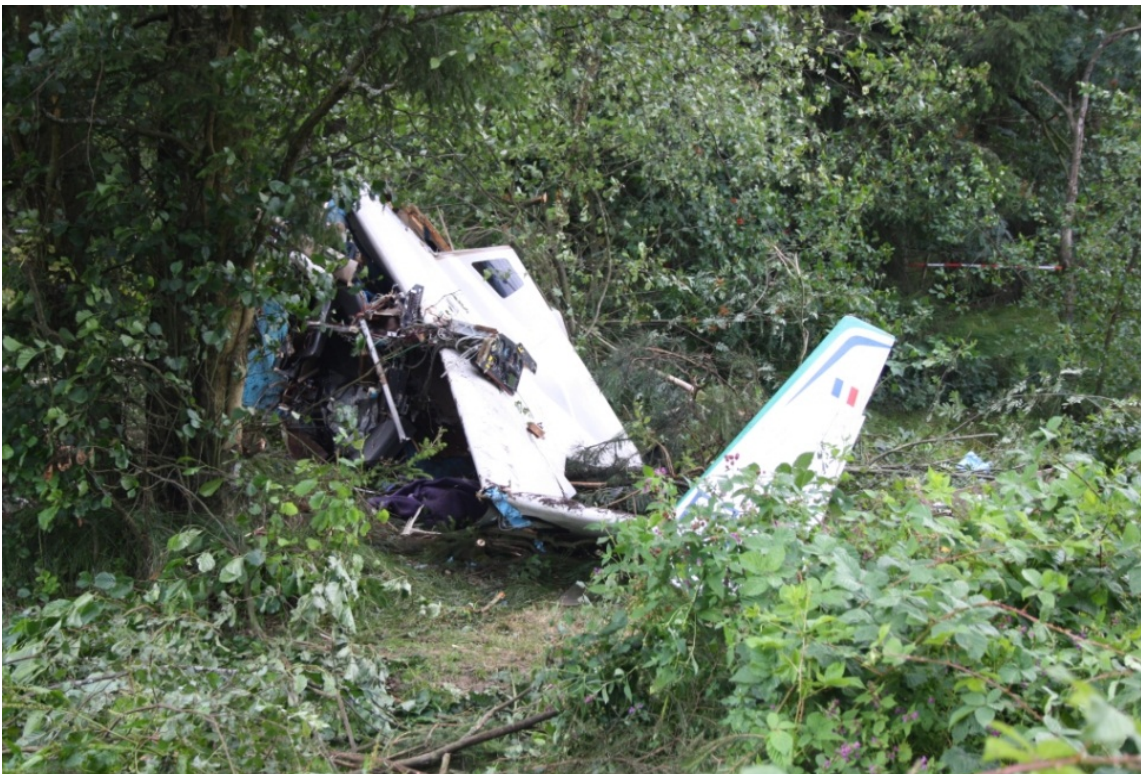
Accident site

The accident site was located south of Arnbruck Special Airfield about 1.3 km from the end of the runway in a forest. About 80 m prior to the accident site the aircraft had collided with trees of a coniferous forest which was about 30 m high.

During the impact with the ground the front part of the aircraft was smashed. The nose landing gear was found in the retracted position.

Due to the degree of damage, the position of the power levers could not be determined. Control elements could be checked. The wings had several fractures and one fuel tank was damaged. All three propeller blades had been fractured at the same length. Both wing tanks are lockable and each carried a sign with the label JET A-1 in its filling area. A large amount of fuel had leaked from the damaged tank. Samples were taken for further examination. The engine was also subjected to further examination. The examination of the wreckage at the accident site did not reveal any technical deficiencies.

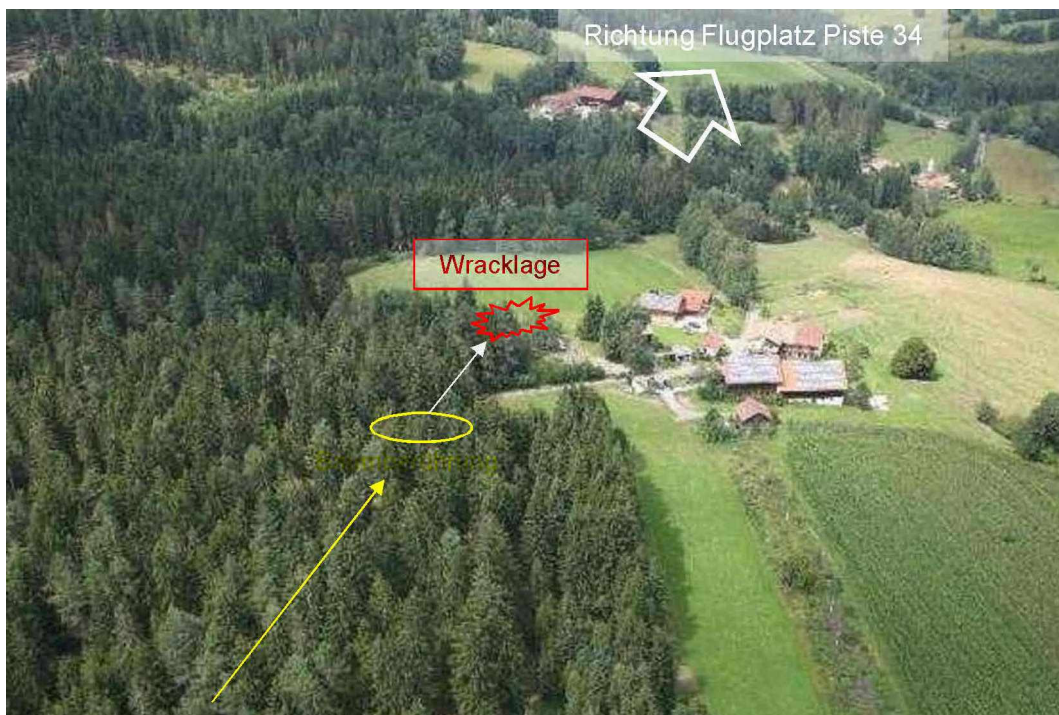
Position of the collision with trees and accident site

Examination of the engine revealed a malfunction of one outflow valve on the third cylinder. Based on this malfunction, a significant reduction in engine performance has to be assumed. Since the airplane was in the landing phase, there was no sufficient altitude reserve to reach a suitable off-field landing site. Due to the loss of power, the pilot could not retain the altitude and, therefore, the airplane flew in horizontal flight into the forest in front of the airfield.

The air accident is due to the fact that during the approach to Arnbruck Special Airfield the engine failed and the aircraft collided with obstacles prior to reaching the airfield.
