Investigation Report

Type of Occurrence:	Accident
Date:	14 November 2011
Location:	Gleisweiler
Aircraft:	Airplane
Manufacturer / Model:	Cirrus Design Corp. / SR 22
Injuries to Persons:	Two persons fatally injured
Damage:	Aircraft destroyed
Other Damage:	Minor crop damage
Information Source:	Investigation by BFU
State File Number:	BFU CX015-11

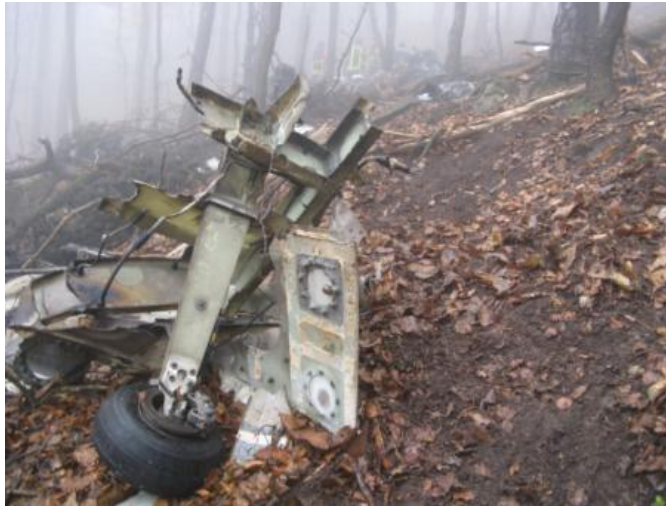
Accident site

North-west off Geisweiler the airplane collided with trees on a mountainside rising to the north-west. After the impact the airplane caught fire and was destroyed. Both occupants were fatally injured.

The accident site was located about 500 m north-west of Geisweiler on a forested mountain side in the district of Teufelsberg. The airplane had contact with the crown area of the approximately 20-metres-high tree population before impacting the

ground. Fracture pieces of the tail section got caught in the trees' crown area and the landing gear was torn out of the fuselage. Pieces of the sheeting of the fuselage and the wings were torn off during the impact and had scattered over an area with a radius of about 20 m. The main wreckage was destroyed by fire. Thereby, the structure, devices, instruments and systems were severely damaged. Due to the high degree of destruction a technical examination of the aircraft was only possible to a limited extent. Technical deficiencies were not determined. Components of the electronic equipment were seized for further investigations.

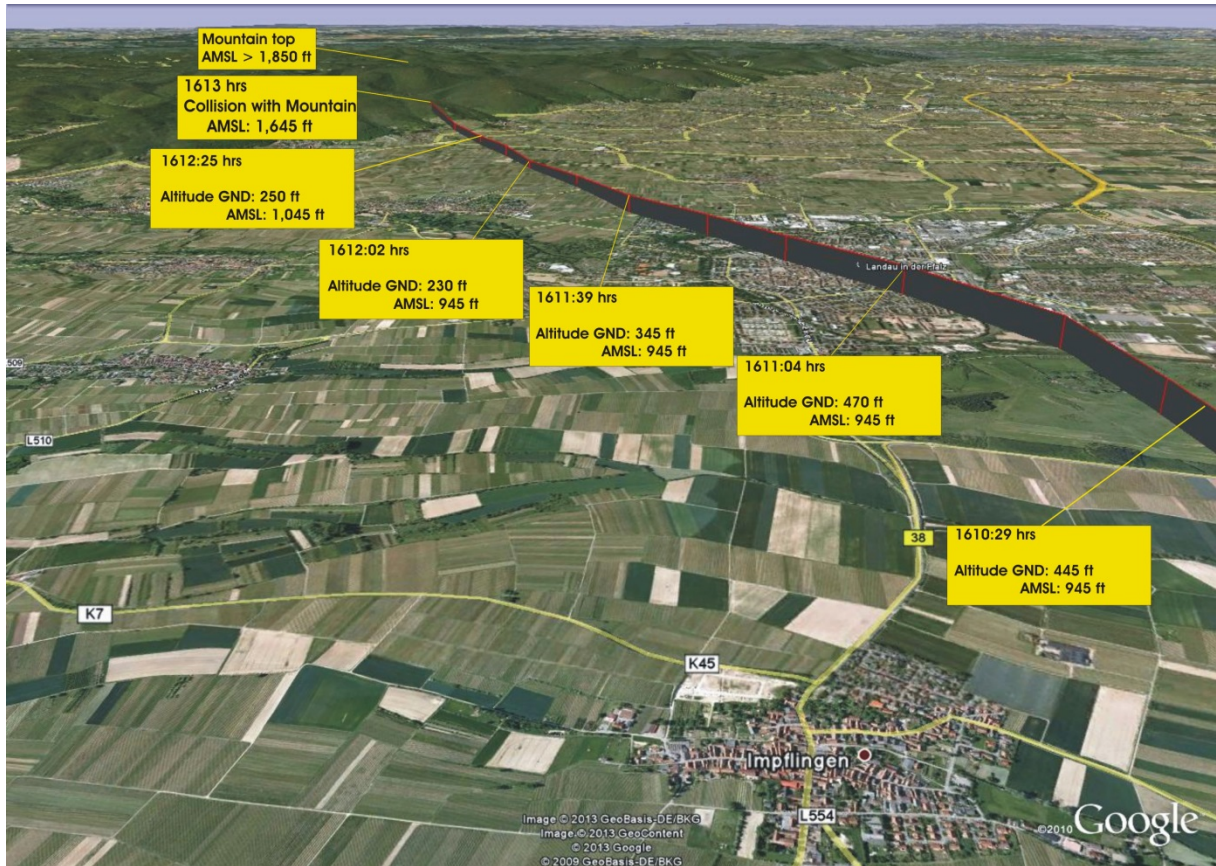
Flight path reconstruction

The read-out of the radar data showed that after the aircraft had taken off from runway 03 at Karlsruhe Baden-Baden Airport it climbed to 1,200 ft AMSL and entered French airspace with a northern heading.

After about 3 minutes of flight time the aircraft descended to 900 ft AMSL and re-entered German airspace at 1605 hrs. The northern heading continued and after about 6 minutes of flight time the transponder code changed from 4000 to 3702. The flight continued in 945 ft AMSL up until north-west of Landau; at about 1612 hrs the aircraft climbed to 1,045 ft AMSL. In the next 35 seconds it climbed from 1,100 ft AMSL to 1,600 ft AMSL.

Around the accident site the ground level rises to about 1,850 ft AMSL and further to the north-west the hills reach about 2,000 ft AMSL.
