# Investigation Report

Type of Occurrence:	Accident
Date:	18 February 2012
Location:	Lahr Special Airfield
Aircraft:	Helicopter
Manufacturer / Model:	Amateur-built aircraft / Safari
Injuries to Persons:	Pilot fatally injured
Damage:	Aircraft destroyed
Other Damage:	None
Information Source:	Investigation by BFU external experts for field investigation
State File Number:	BFU 3X006-12

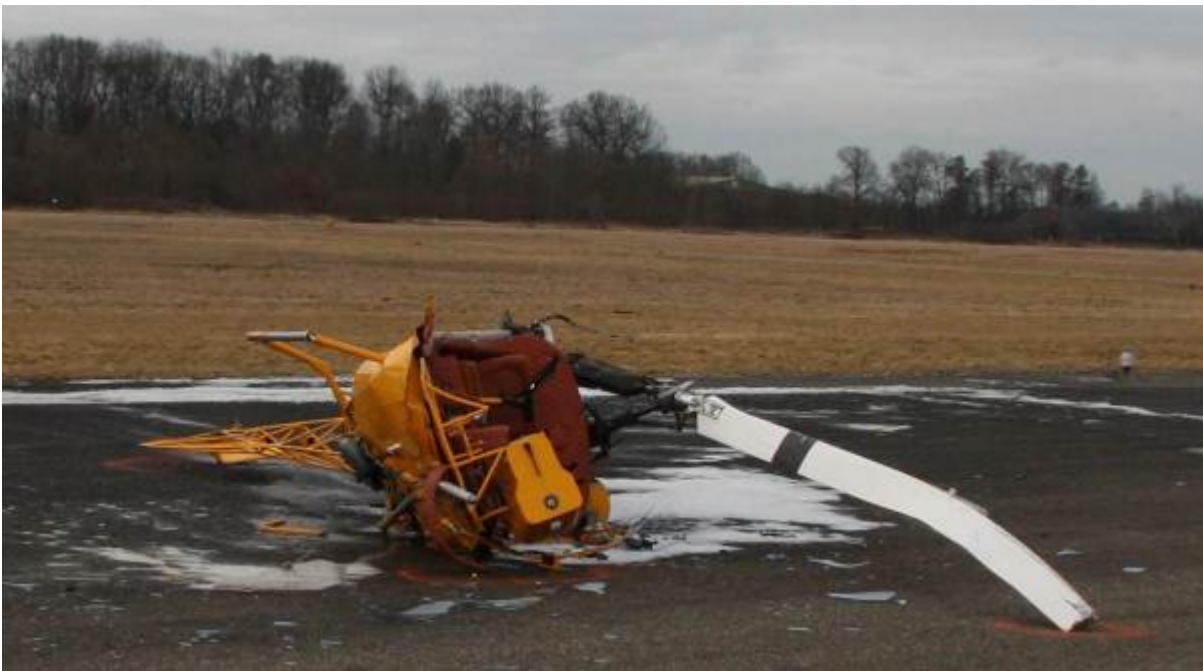
After the pilot had flown hover manoeuvres for a few minutes he started his first traffic circuit. He finished it with an autorotation exercise and landed in the grass west of the runway. The Flugleiter then observed the helicopter taking off again and in about 40 - 50 m abeam the tower it suddenly began to spin. During the spinning the nose of the helicopter dipped. At 1248 hrs<sup>1</sup> with the nose first and still yawning the helicopter impacted the runway of Lahr Special Airfield and caught fire immediately.

Helicopter wreckage

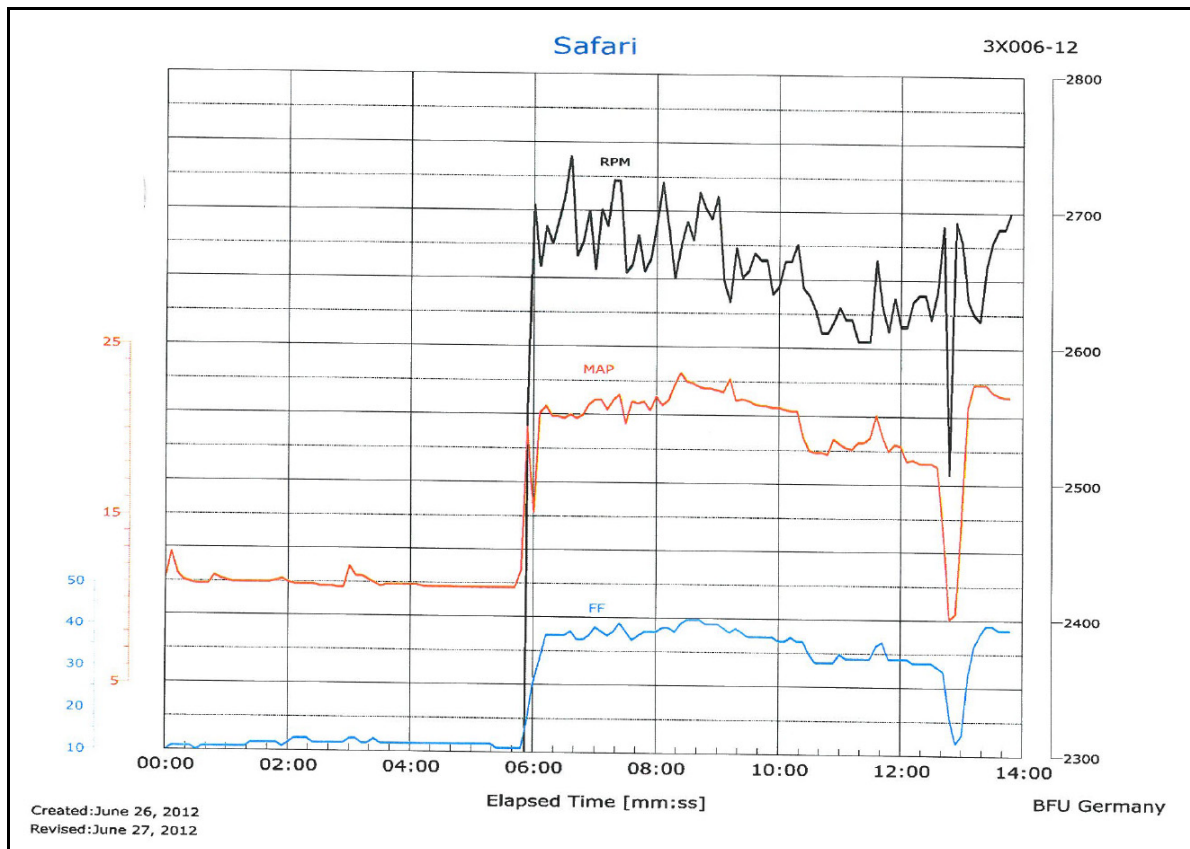
The helicopter was equipped with digital indication devices for engine and flight parameters. The engine indications system J.P. Instruments EDM-930 and the Dynon SV700 were read out. The EDM-930 had stored a total of 119 flights. The data shows that the engine had run about 13:40 minutes from engine start-up until the accident.

Excerpt from the recorded data of the accident flight

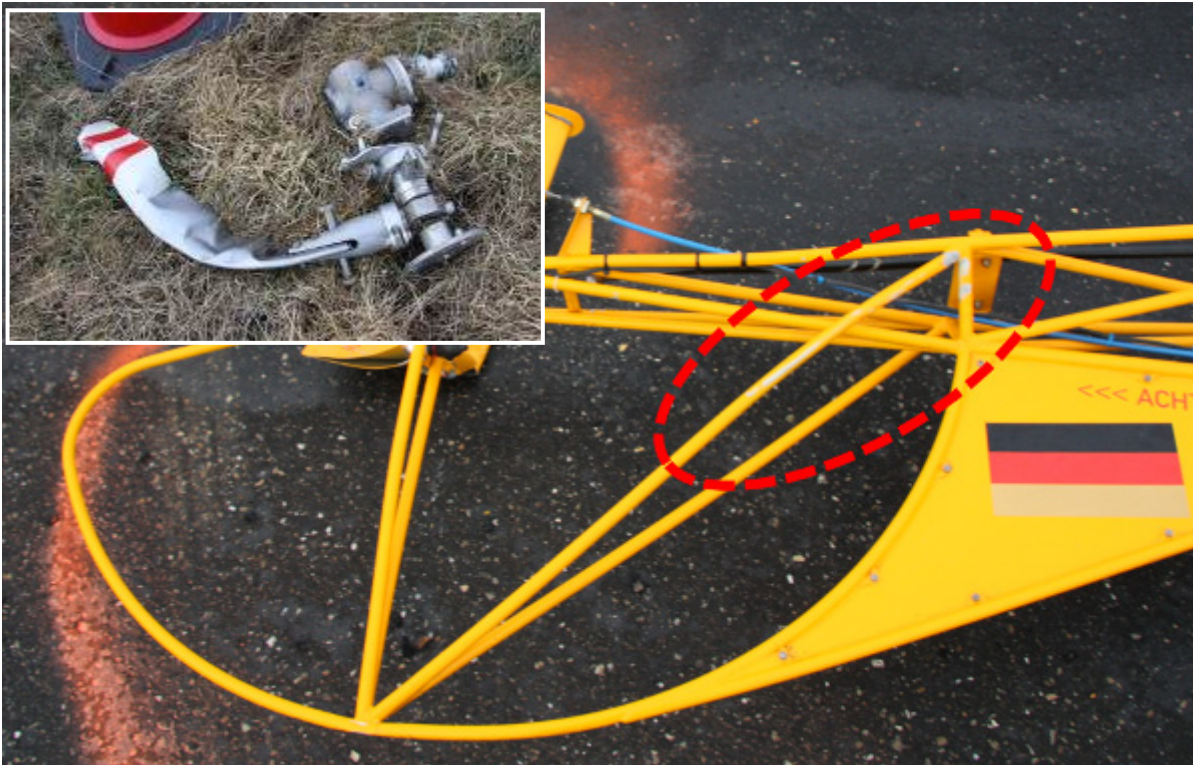
The tail rotor gear box including one tail rotor blade lay about 15 m north-west of the wreckage. The tail rotor blade was bent contrary to the rotational direction. It showed yellow paint traces on the blade side facing the fuselage structure; the tip of the blade showed a semi-circular dent. Corresponding defects in the paint work and impact traces were found on the yellow tail boom.

Tail rotor gear box including tail rotor blade and damages on the tail boom

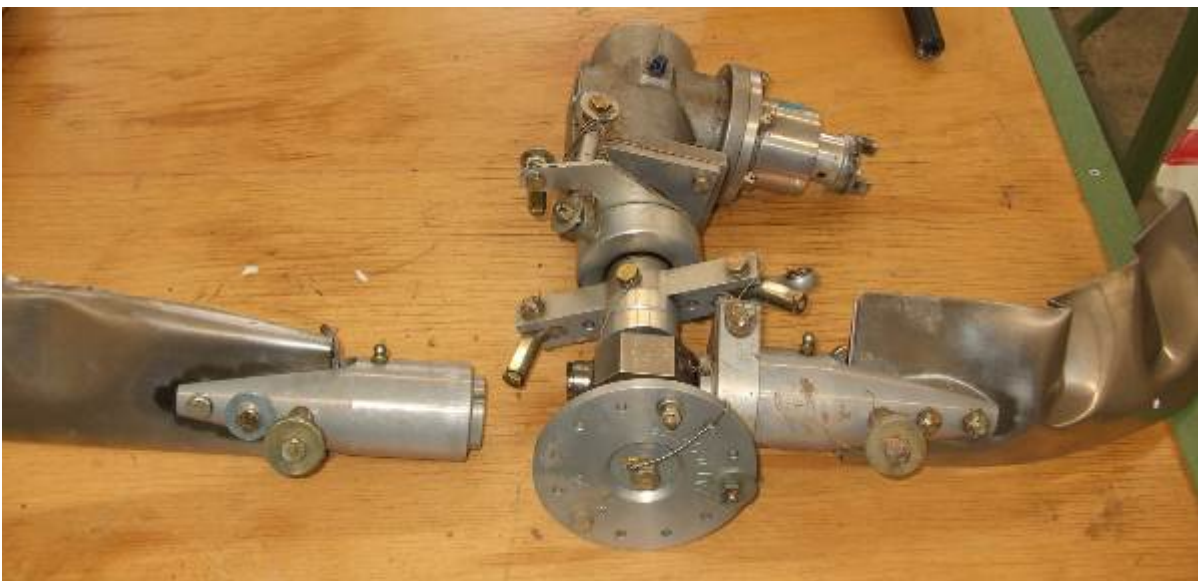
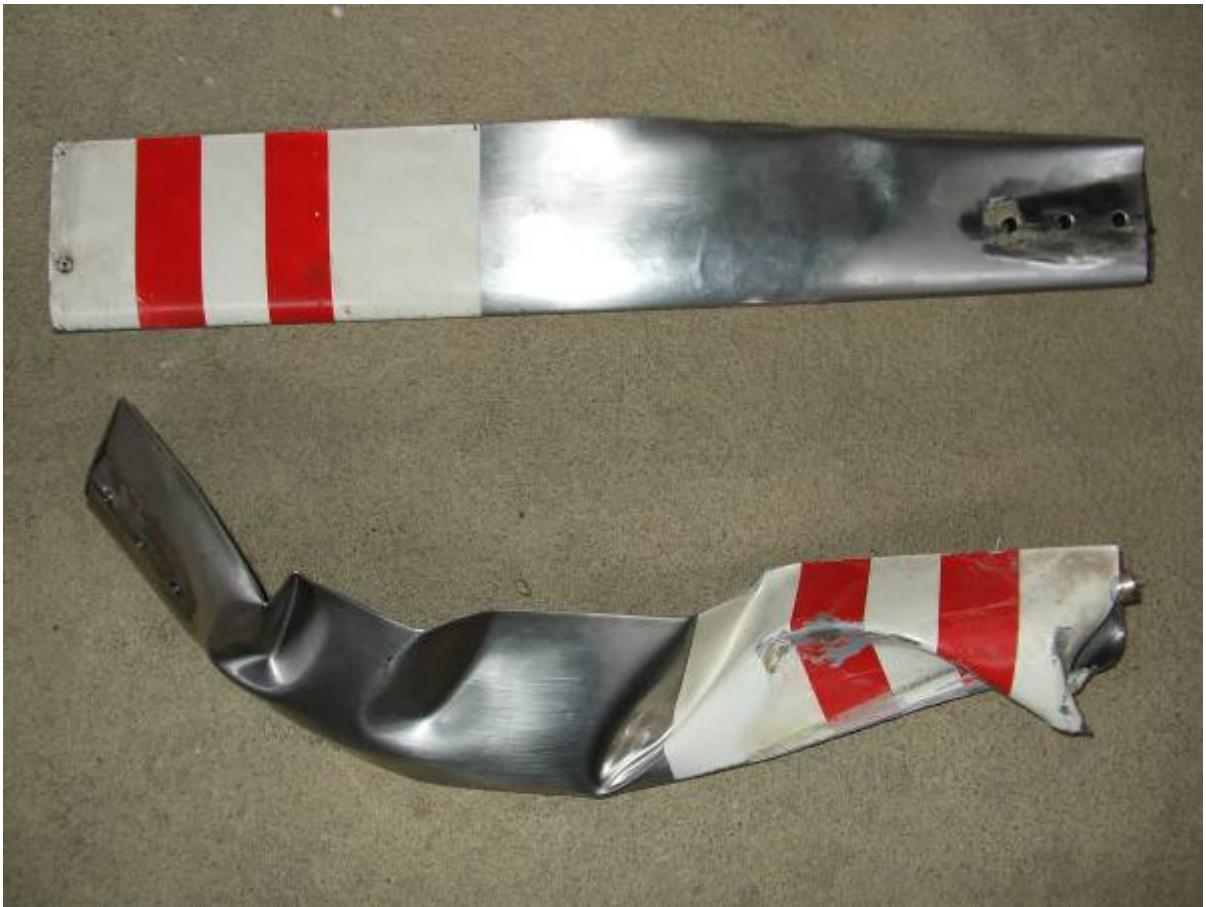
The second tail rotor blade lay about 80 m north-east of the wreckage. On this blade the upper half of the trailing edge was bent toward the blade grip. The leading edge was undamaged. The tail rotor pitch arm of the torn-off tail rotor blade was missing from the blade grip. It was found about 34 m south-east of the wreckage.

Fractured tail rotor spindle and the two tail rotor blades

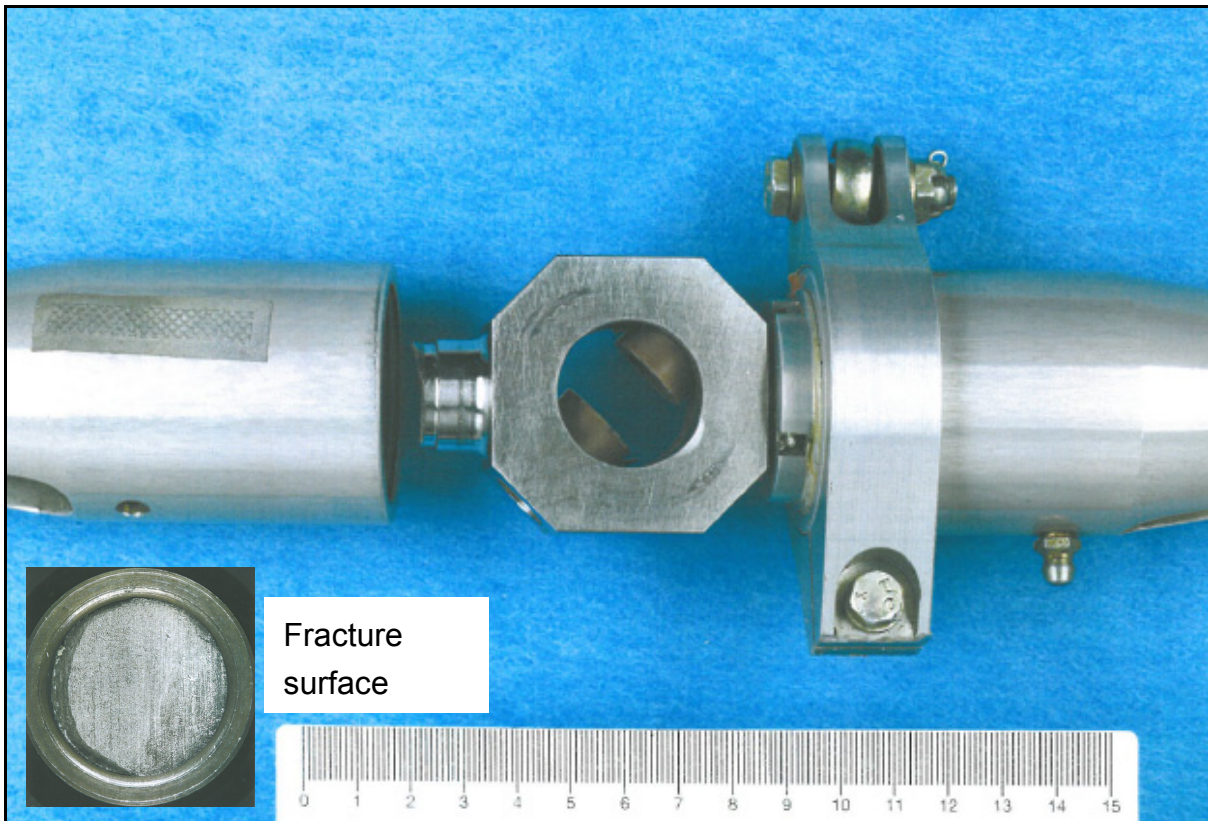
The expert of the Institut für Werkstoffkunde of the Technischen Universität Braunschweig concluded that the fracture of the tail rotor spindle occurred exactly on the radius of the tail rotor blade bearing seat. Here constructive change in stiffness and maximum bending moment meet. It is absolutely certain that it is a fatigue fracture.

Fractured tail rotor spindle

Due to the unusually clearly visible line structure on the fracture surface, a sample for the metallographic cut was prepared from the spindle. A structure unfavourable for fatigue strength in the raw material for the spindle was determined.

The expert opinion concludes *"[...] that the tail rotor spindle was destroyed by a fatigue fracture. The fatigue crack had propagated across half of the cross section area before the residual fracture occurred. The unfavourable structure of the material in regard to the vibration fatigue life has contributed to the development of the fatigue fracture."*

In addition, Safari Helicopter offers all German Safari helicopter operators replacement of the entire tail rotor spindle free of charge. Each replacement spindle will include material certifications and quality assessment of the raw material used and will be dynamically balanced and free of irregularities.

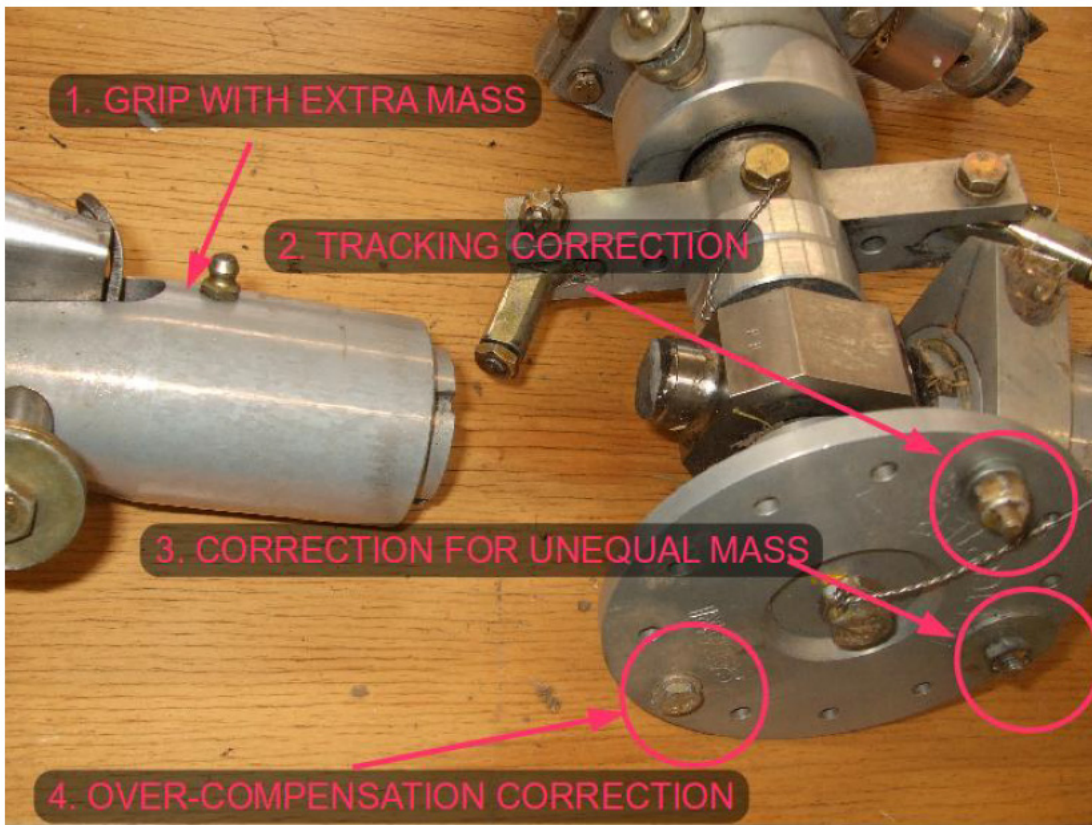
Picture 2

The balance ring of the incident aircraft displays several elements which are contrary to accepted practice and standards.

1. One grip has extra mass (30g) added to it. This increases the spindle load by roughly 360 N at 2750 RPM.
2. The balance ring has weight at 90° to the blades. This indicates a tracking error or severe lead / lag error which should be corrected by blade adjustment. While the output shaft may be balanced, the rotor head is not.
3. There is weight opposite the grip with extra mass on it. Rather than add mass to the balance ring, mass should have been removed from the grip instead to relieve spindle load.
4. A third balance weight is added opposite the other two, larger masses on the balance ring. This indicates that too much mass has been placed in the wrong position. Further correction is required.

Ideally, as little weight as possible is used to balance. This is not the case on this rotor. Weight has been added and then more weight has been added on the opposite side to counter it. Added weight should have been removed to obtain the proper correction.

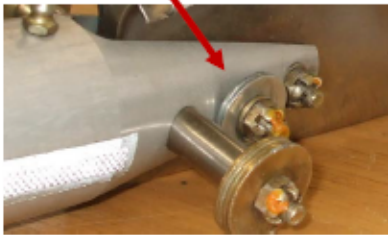
### IMPROPERLY PLACED WASHERS ON GRIP

The photo above left shows a tail rotor grip with additional weight added to the tail rotor grip using the tail rotor grip bolts. Under no circumstances should the tail rotor be balanced in this way. Addition of weight to the tail rotor grip increases the centrifugal load on the tail rotor head bearings and increases the amount of stress on the tail rotor spindle.

The bump balance (shown on the right) installed on the tail rotor provides a safe and effective location for weight needed to properly balance the tail rotor of the SAFARI. If the tail rotor cannot be balanced using weight installed on the bump balance, there is a serious underlying issue causing a dynamic out-of-balance condition which must be addressed. The photo above right shows the correct use of the bump balance to add weight.

If you have been operating your SAFARI with weight improperly installed on the tail rotor grips as shown above, please contact the factory before flying your helicopter again.
