Factual Report

Type of Occurrence:	Accident
Date:	29 December 2012
Location:	Near Rehagen
Aircraft:	Helicopter
Manufacturer / Model:	Eurocopter / AS 350B
Injuries to Persons:	Pilot and passenger suffered minor injuries
Damage:	Aircraft severely damaged
Other Damage:	Minor crop damage
Information Source:	Investigation by BFU
State File Number:	BFU 3X165-12

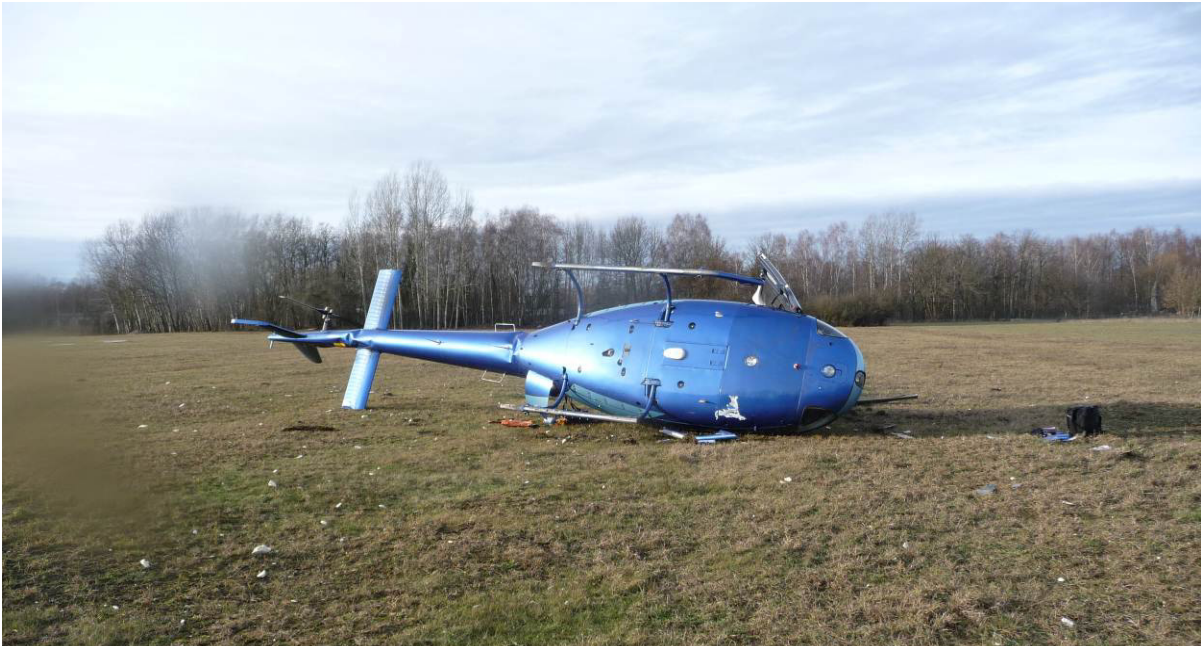
At about 1340 hrs¹ the helicopter landed hard, the left skid broke and the helicopter turned over. The pilot shut down the engine which was still running, all power users and the main switch. At the site fuel and oil leaked onto the ground.

Accident site and helicopter

The helicopter came to rest on its left fuselage side and the pilot and the passenger could leave the helicopter unaided. Both persons suffered minor injuries on one hand each.

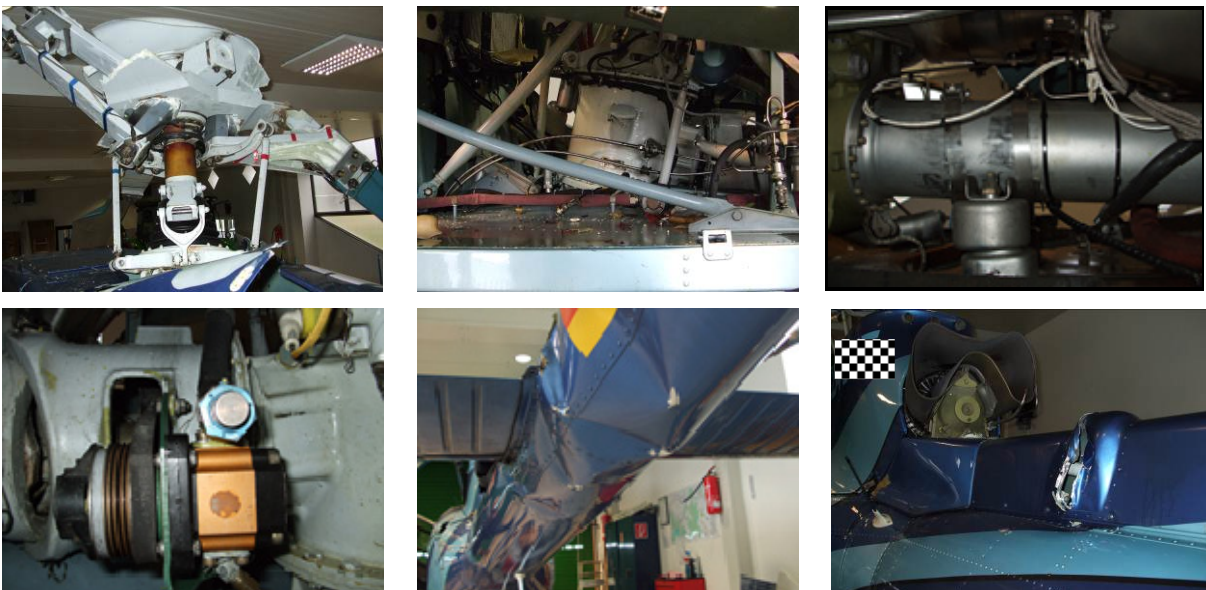
The helicopter stood on its skids in the hangar. Two of the three rotor blades had been removed from the rotor head. All three rotor blades showed damages to the outer area and the Star-Flex to all three blades was torn off. The mounting of the main gear box was severed. The coupling between the main drive shaft and the gearbox flange was sheared off. The turbine had slipped within the retaining clamps of the flexible fuselage mounting. The control rods to the main rotor hydraulic servo units were fractured in the area of the firewall gateway. The control rods from the servos to the swash-plate and to the blade grips had a frictional connection. The driving belt of the hydraulic pump was jammed between belt pulley and pump. The chip detectors in the engine, in the hydraulic system and in the tail rotor gear box were free of chips. The chip detector for the main gear box was torn off. The tail boom's underside showed folds. The area of the shaft coupling in the front segment of the tail rotor shaft cowling was milled from the inside out. The front short tail rotor drive shaft was severed from the long aft tail rotor drive shaft. The tail rotor control rod had been cut off below the tail rotor drive shaft coupling and was bent back. The tail rotor was undamaged and the tail rotor gear box was filled with oil. The left fuselage was oily and it smelled strongly of fuel.

Detailed images of the damages on the helicopter

The field investigation did not reveal any technical defect prior to the accident.
