Investigation Report

Type of Occurrence:	Accident
Date:	21 March 2013
Location:	Berlin
Type of aircraft:	Helicopter
Manufacturer / Model:	1. Eurocopter / EC155 B 2. Eurocopter / AS 332 L1
Injuries to Persons:	One person fatally, four people severely injured and five people with minor injuries
Damage:	Both aircraft seriously damaged
Other Damage:	Damages to fields and vehicles
Information Source:	Investigation by BFU
State File Number:	BFU 3X010-13

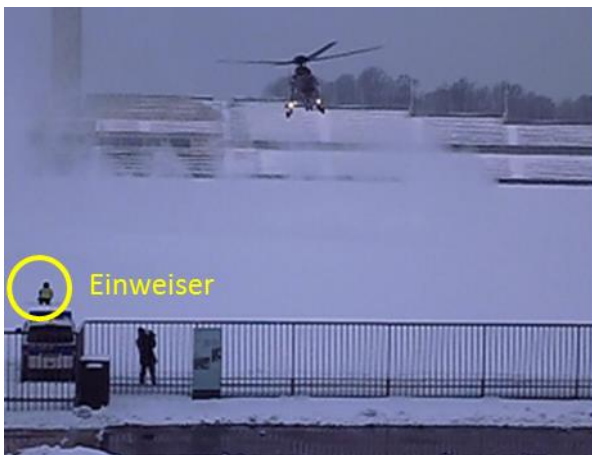
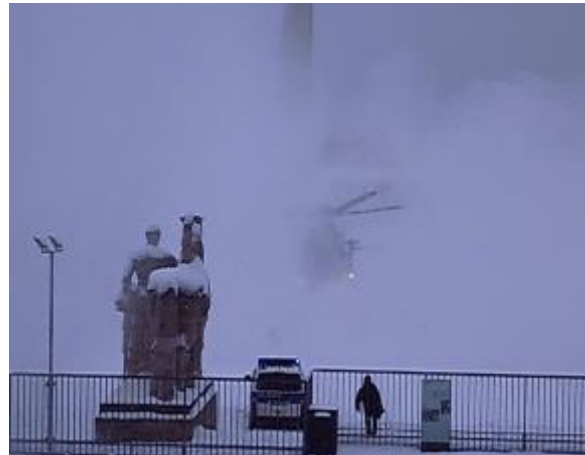
The marshaller of Tactical No 3 stated that he saw the approaching helicopter swing towards him. Then the re-circulating snow had reached him and he could no longer see the helicopter. He saw the landing light of the approaching helicopter about 2 m obliquely above him and then the downwash pushed him backwards to the right. Except for the landing light he had seen nothing, neither the fuselage nor the rotor of the helicopter (see series of photos in the appendix).

Approach and re-circulating snow during the landing of Tactical No 3

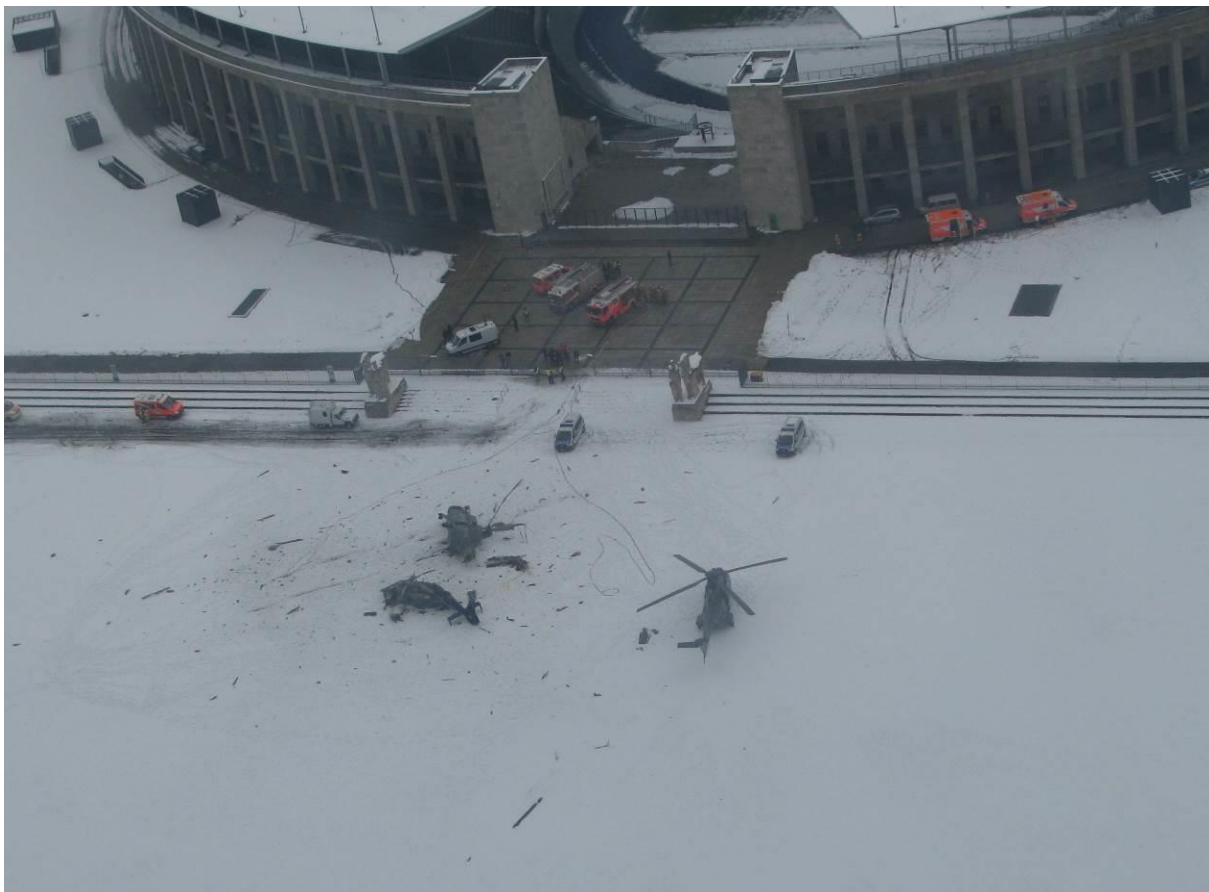
Overview accident site

After the re-circulating snow had settled again, Tactical No 3 was lying on its right fuselage side and was severely damaged. The rotor blades were destroyed and the tail was severed.

Tactical No 1 was severely damaged and was lying on the fuselage bottom in approximately 90° to the touch-down position. The rotor was destroyed and the tail bent.

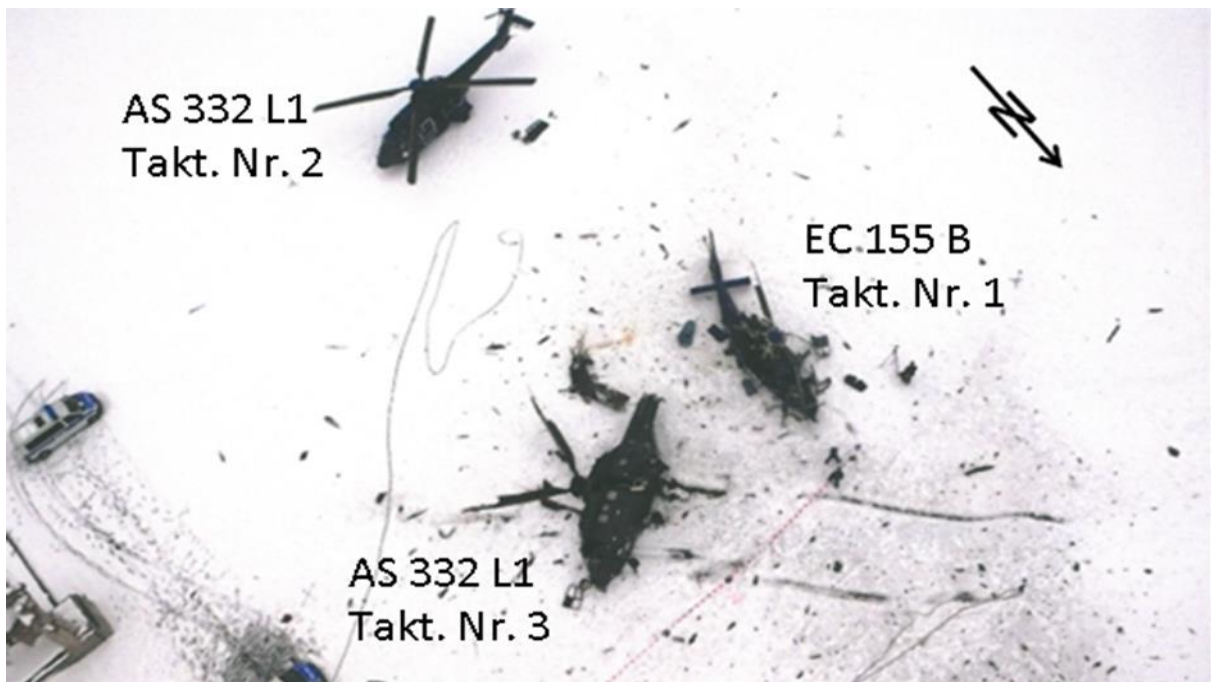
After the collision the right helicopter (Tactical No 2) stood on its wheel landing gear and was slightly damaged. The centre helicopter which had landed first (Tactical No 1) was lying upright on its fuselage in approximately 358°. About 10 m east, Tactical No 3 was lying on its right fuselage side towards 052°. Two approximately 20 m long traces in the snow connected the initial ground contact and the nose wheel and the main landing gear of the rolled over helicopter. Debris of the two helicopters was strewn across a very large radius.

Location of the helicopters and traces in the snow

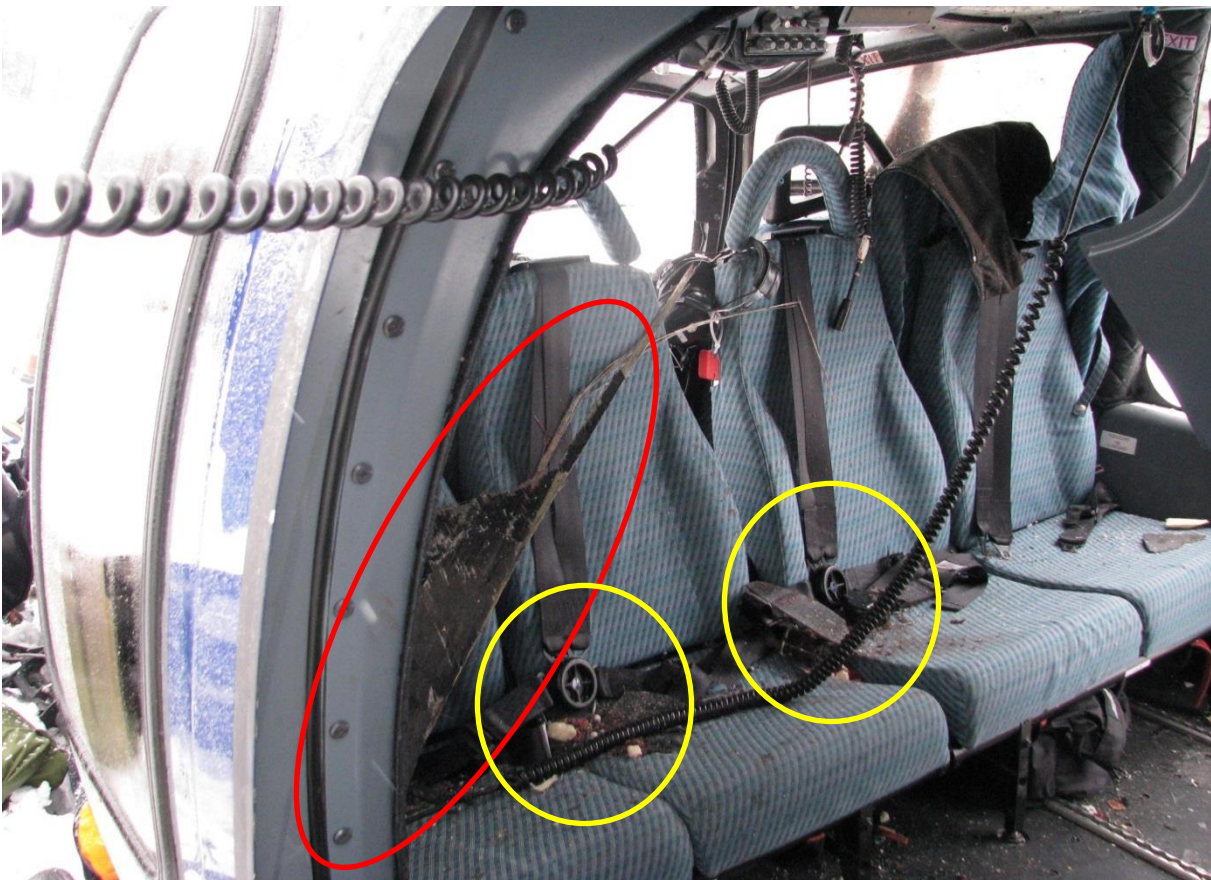
Tactical No 1, EC 155 B, was lying on the fuselage, the main rotor blades were destroyed, the cabin roof including the main gear box had been pushed inside the

cabin; the tail boom had been cut off the fuselage. The fairings of the main gear box and engines were missing. The radar dome was torn open, the left cockpit glazing and the left cockpit door including beam were torn out. On the ride side of the cockpit, the glazing of the sliding window of the door up to the lower door beam and the side window next to the instrument panel were punctured. On the front seat in the cabin, a torn-off main rotor blade piece of the rolled over helicopter AS 332 L1 was found. The safety belts of two of the eight seats were closed.

Rotor blade piece and fastened seat belts in the cabin

The pilot of the EC 155 B died at the accident site due to multiple injuries caused by a rotor blade piece which had penetrated the cockpit from the lower right front to the upper left side.

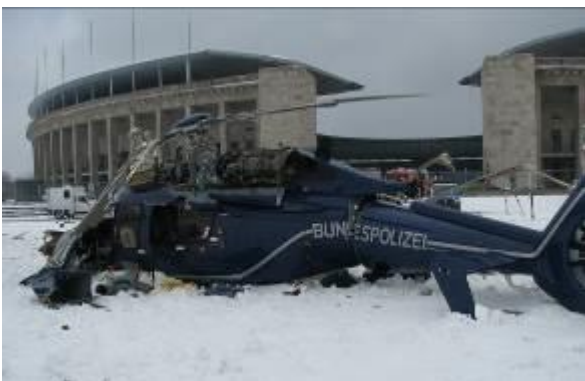
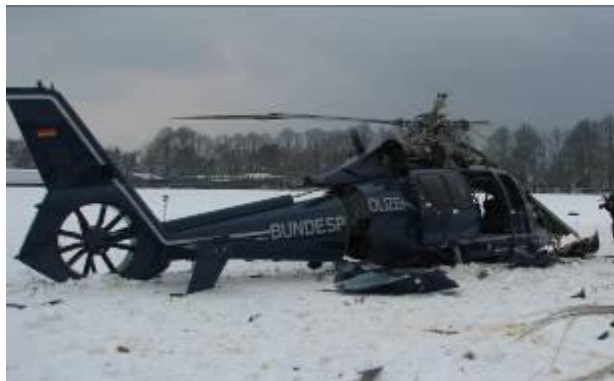
Damages on EC 155 B

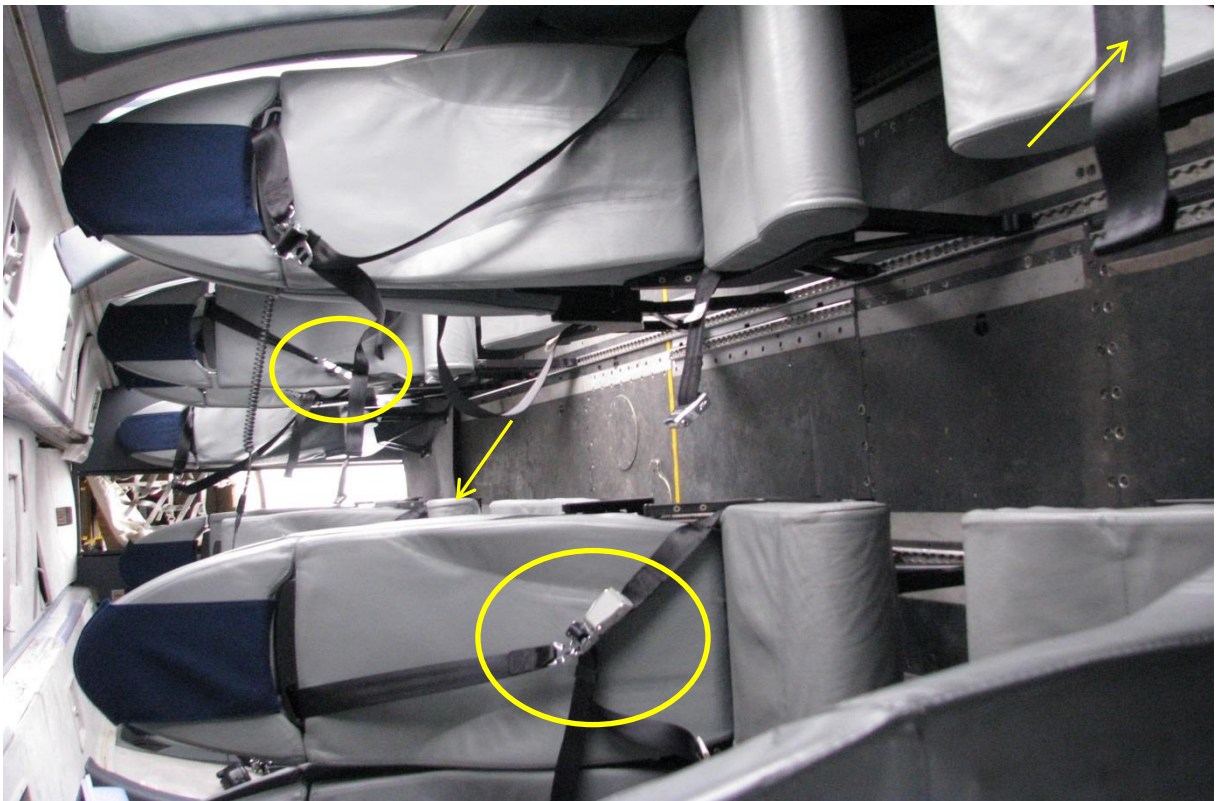
Tactical No 3, also an AS 332 L1, was lying on its right fuselage side. The aft part of the tail boom had been severed. It was found about 1 m south and perpendicular to the fuselage direction; the tail rotor pointing upward. The tail rotor blades had split; the control tube had been torn off. The horizontal stabilizer was found approximately 18 m away and in the vicinity of the other AS 332 L1 helicopter. The main rotor blades had been torn off and were destroyed. The connection between control column, pitch, hydraulic reservoir, swash-plate and main rotor blades was intact. The connection between the tail rotor and the end of the control cables of the torn-off tail boom was intact. On at least five seats the safety belts were closed.

Fastened seat belts in the cabin

Several safety belts in the accident helicopters were found closed. During the interview by police several passengers of Tactical No 3 stated they had been unable to secure their safety belts due to the protective clothing they were wearing or had already opened them to be able to disembark swiftly after landing.

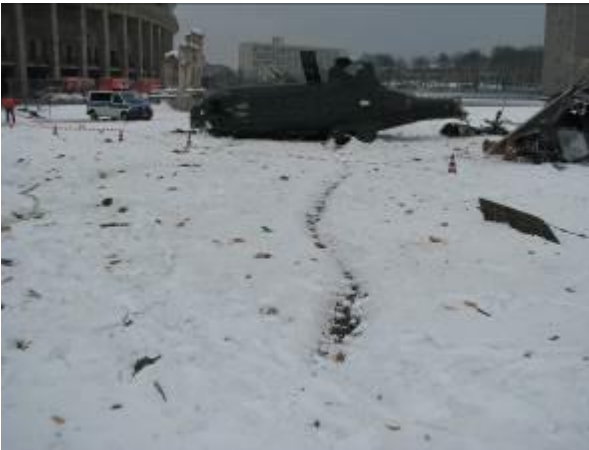
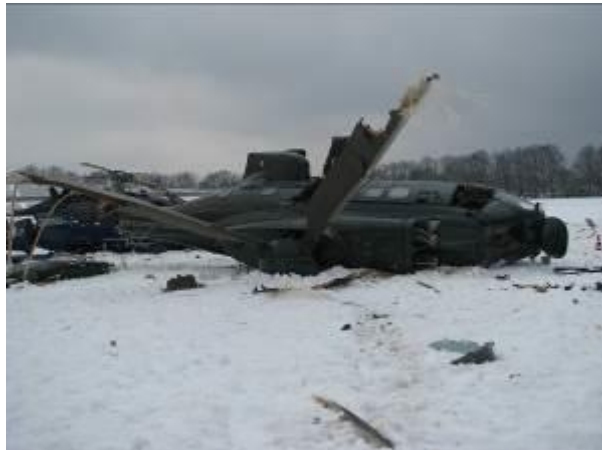
Damages on AS 332 L1

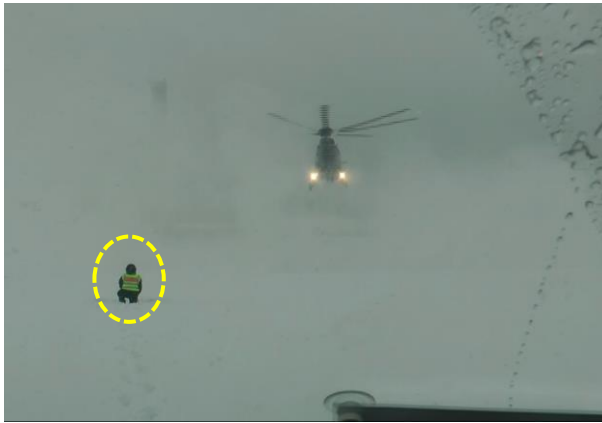
The recordings show that Tactical No 3 flew around the re-circulating snow of Tactical No 2 and during descent and deceleration hovered sideways with raised fuselage nose toward the marshaller. At the end of the approach, a few seconds prior to the accident, the visual contact to the marshaller was lost. This presumably occurred initially inside the re-circulating snow caused by the own helicopter and then because of the direction of the fuselage toward the marshaller and then past him to the right. The instrument panel and the cockpit floor could have contributed to the loss of visual contact. The marshaller stated he had seen the landing light about 2 m obliquely above him (the landing lights are mounted to the wheel housings right and left of the cabin) and then got pushed to the ground. The BFU is of the opinion that this did not influence the course of the accident. Analysis of the recordings show unambiguously that the marshaller remained in his position; eventually the pilot could no longer see him because of the fuselage position to the right (see series of photos of the approach in the appendix). The helicopter hovered sideways past the marshaller, had ground contact and entered a so-called dynamic rollover and rolled onto its right side. This is verified by traces at the accident site and the statements of several helicopter occupants. In this phase the rotor disc and the tail section of the AS 332 L1 intermeshed with the rotor disc of the EC 155 B.

Tactical No 3 avoiding the re-circulating snow of Tactical No 2 approaching the marshaller (About 7 seconds prior to the accident)

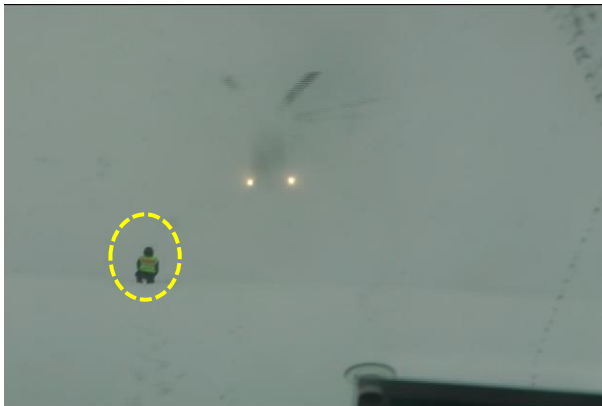
The helicopter hovers with almost constant altitude toward the marshaller (About 4 seconds prior to the accident)

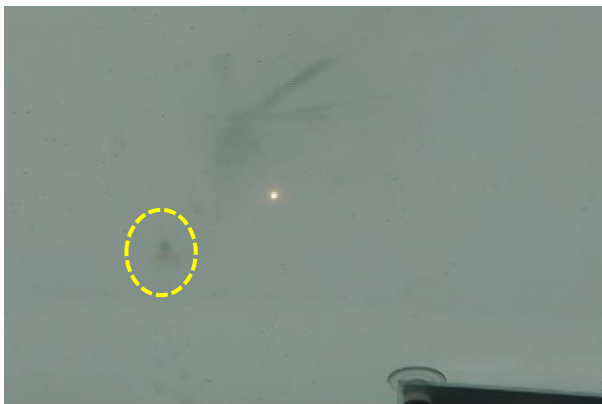
The fuselage of the helicopter is raised a little and turned slightly to the right (About 3 seconds prior to the accident)

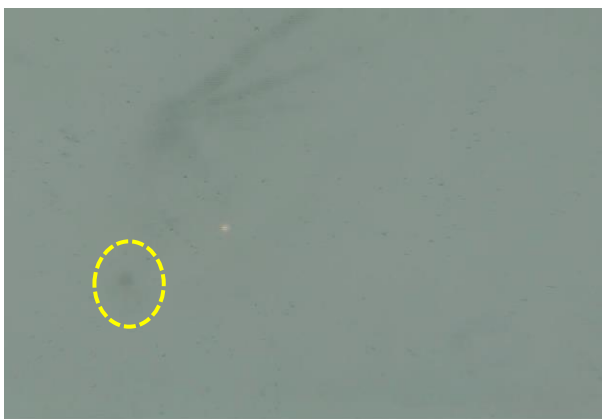
The marshaller is obliquely below the fuselage which is turned to the right (About 2 seconds prior to the accident)
