Investigation Report

Type of Occurrence:	Accident
Date:	26 April 2013
Location:	Bötersen
Aircraft:	Airplane
Manufacturer / Model:	EADS Socata / TBM 700 B
Injuries to Persons:	Four persons fatally injured
Damage:	Aircraft destroyed
Other Damage:	Crop damage
State File Number:	BFU 3X027-13

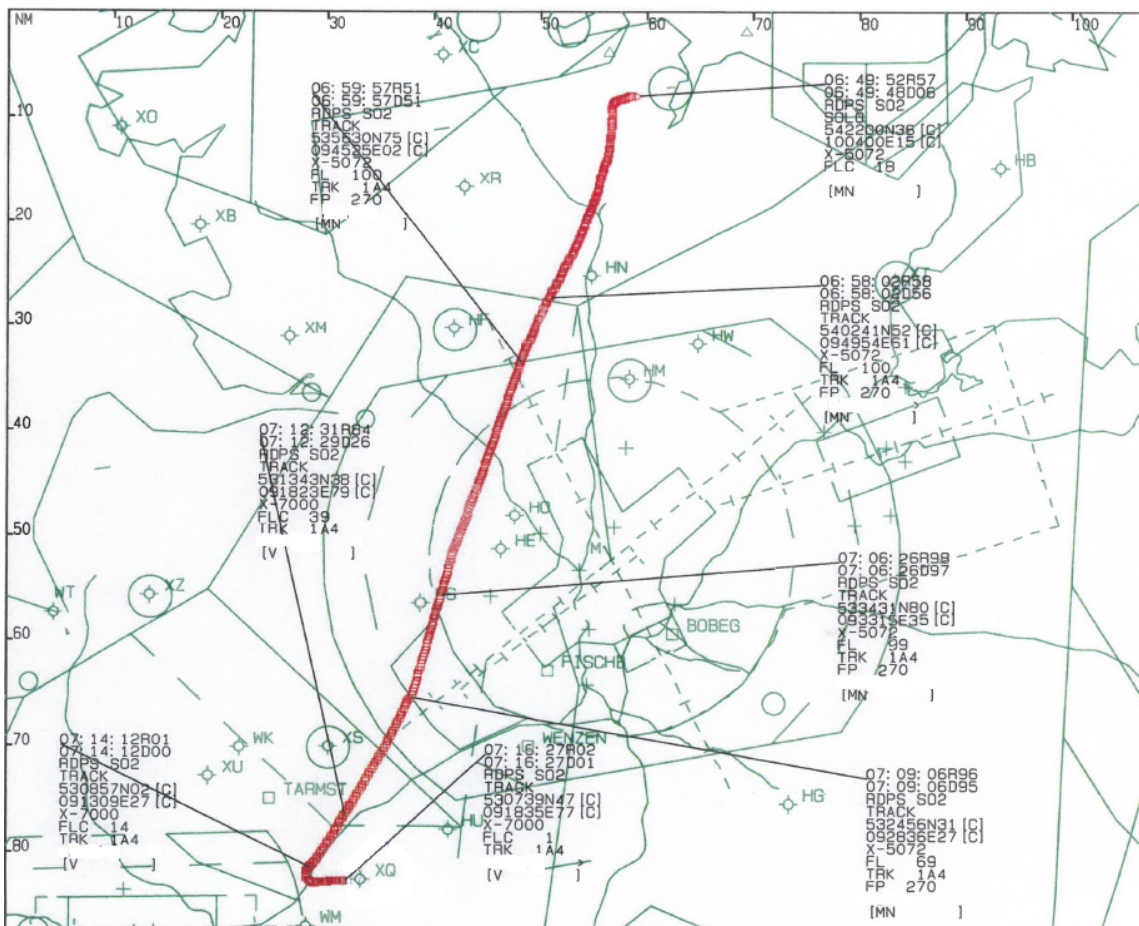
Radar data recording of the entire flight path between 0849:52 and 0916:27 hrs

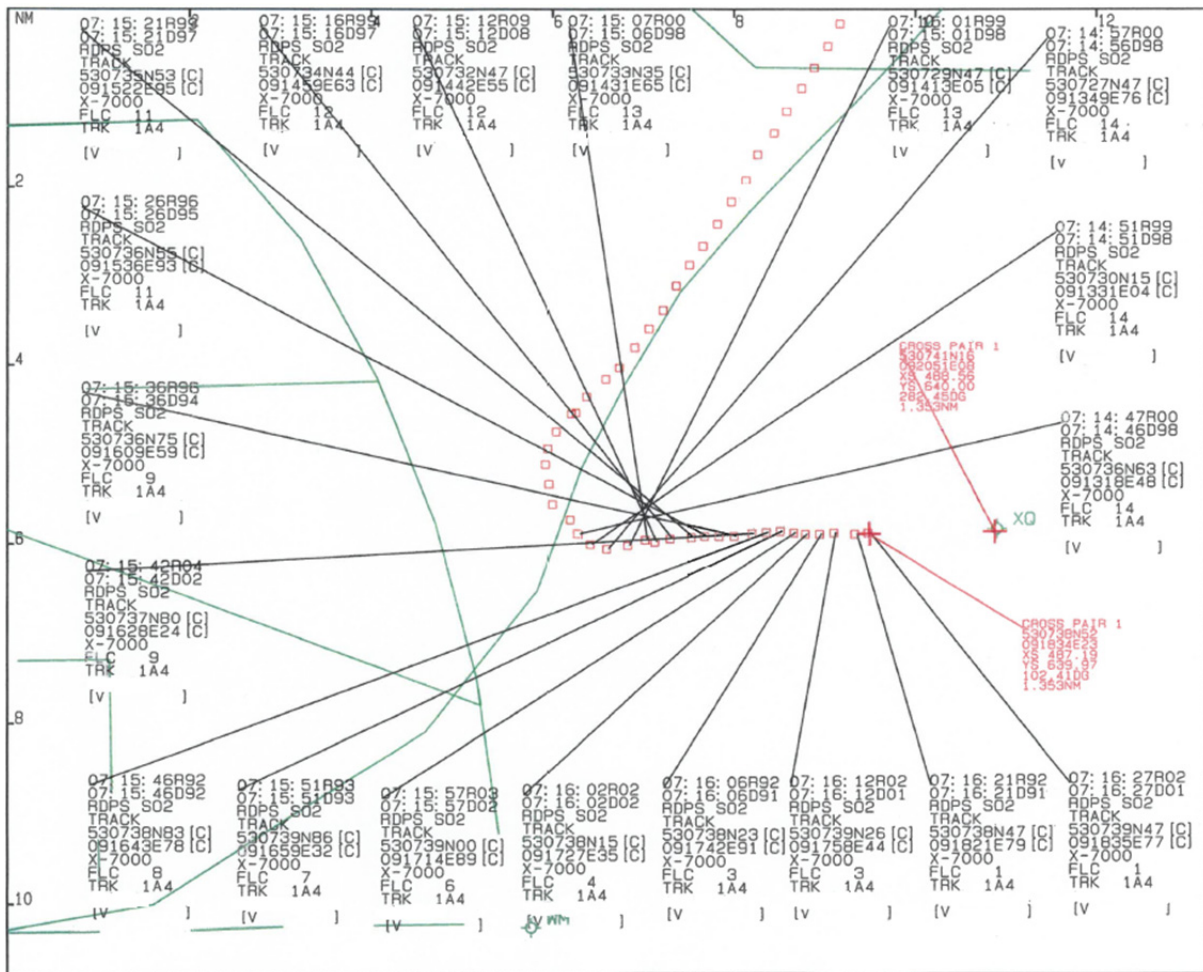
Flight path recording of the final approach between 0912:36 and 0916:27 hrs

At 1.24 NM ahead of the threshold of runway 08 and approximately 570 m left of the extended runway centre line the airplane collided with the ground. The position of the last recorded radar target is almost identical with the accident site.

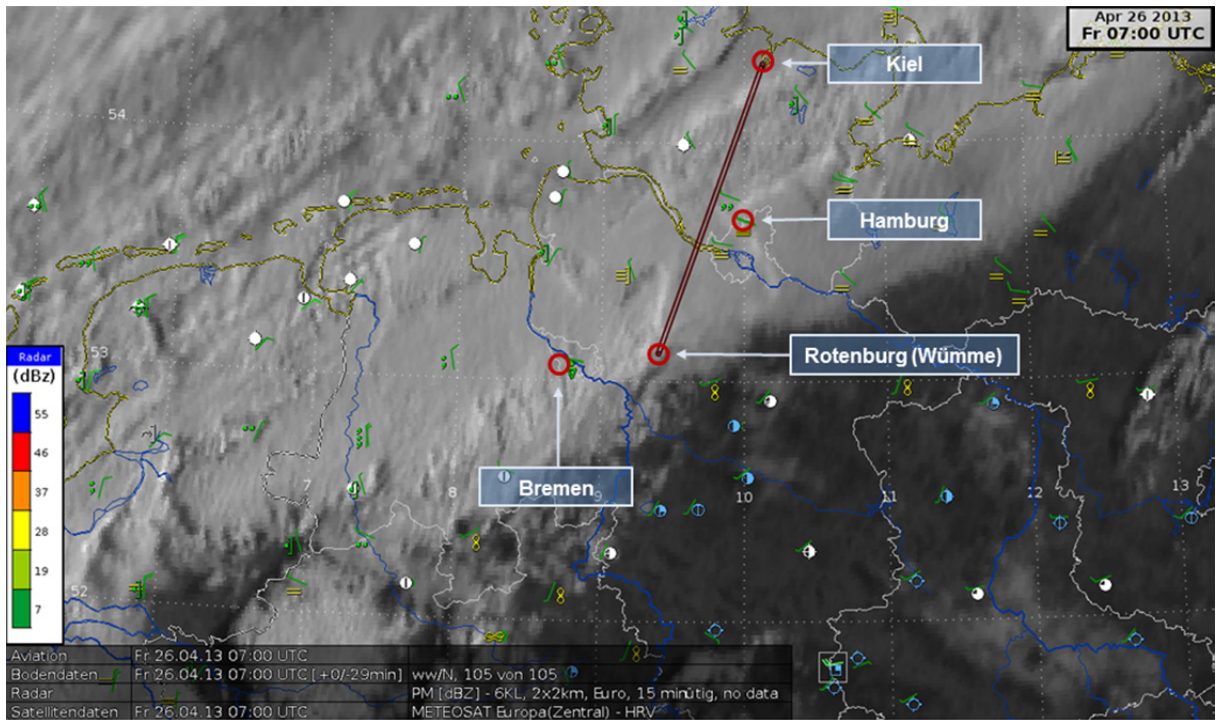
The satellite image of 0900 hrs shows a compact cloud cover from Bremen, to Rotenburg (Wümme), and up to Hamburg.

High-resolution satellite image

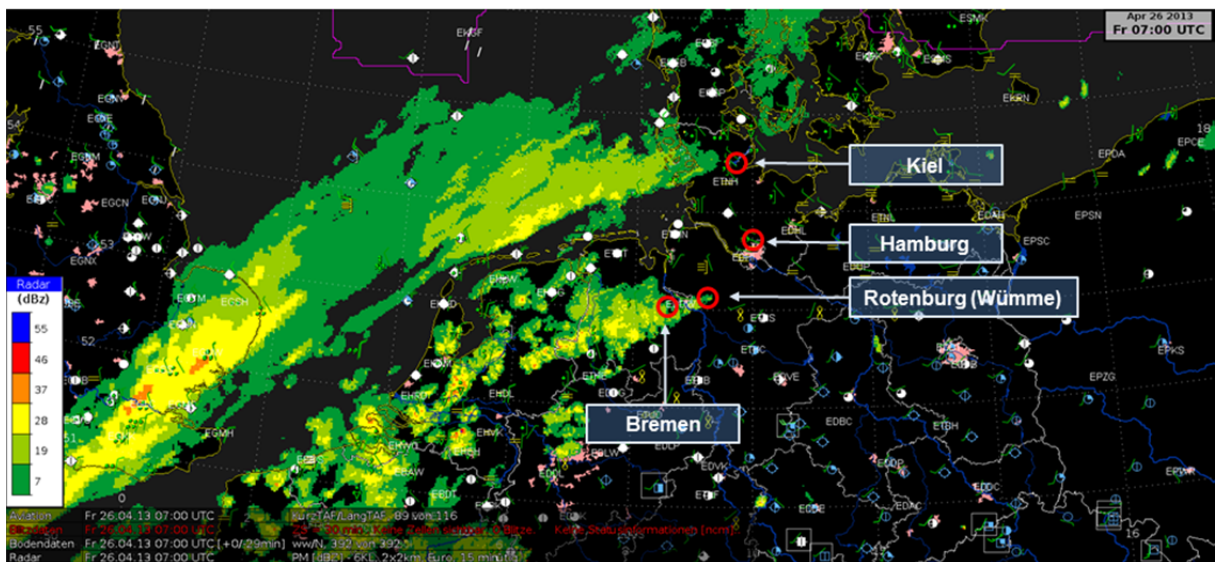
Rain radar

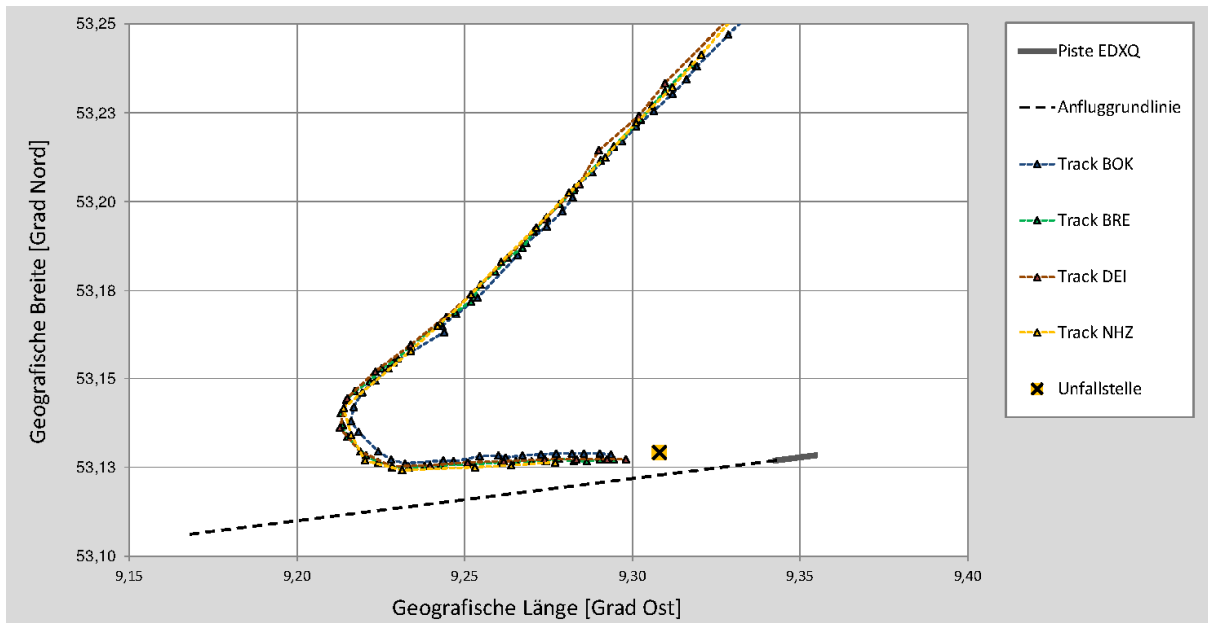
Flight path during the final approach according to radar data

The assessment of the radar recording shows that after the left-hand turn the airplane maintained a course over ground of about 90°.

Approximately 4.5 NM ahead of the threshold of runway 08 and a lateral deviation of about 1,400 m left of the extended runway centre line the descent began with a landing course of 90°.

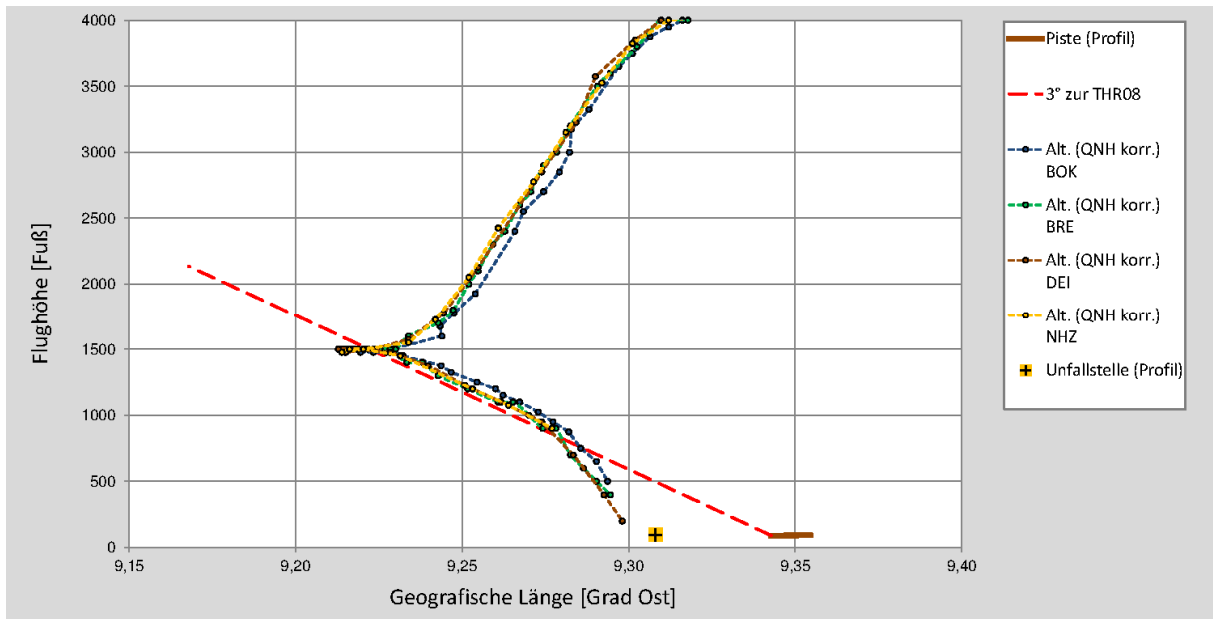
The glideslope was about 3° over a distance of approximately 1.5 NM and until about 800 ft AMSL.

Below 800 ft and at approximately 2.5 NM ahead of the threshold the rate of descent increased. The rate of descent had a maximum of about 1,400 ft/min and was therefore more than twice as high as during the 3° approach.

According to radar data, altitude of the airplane during final approach

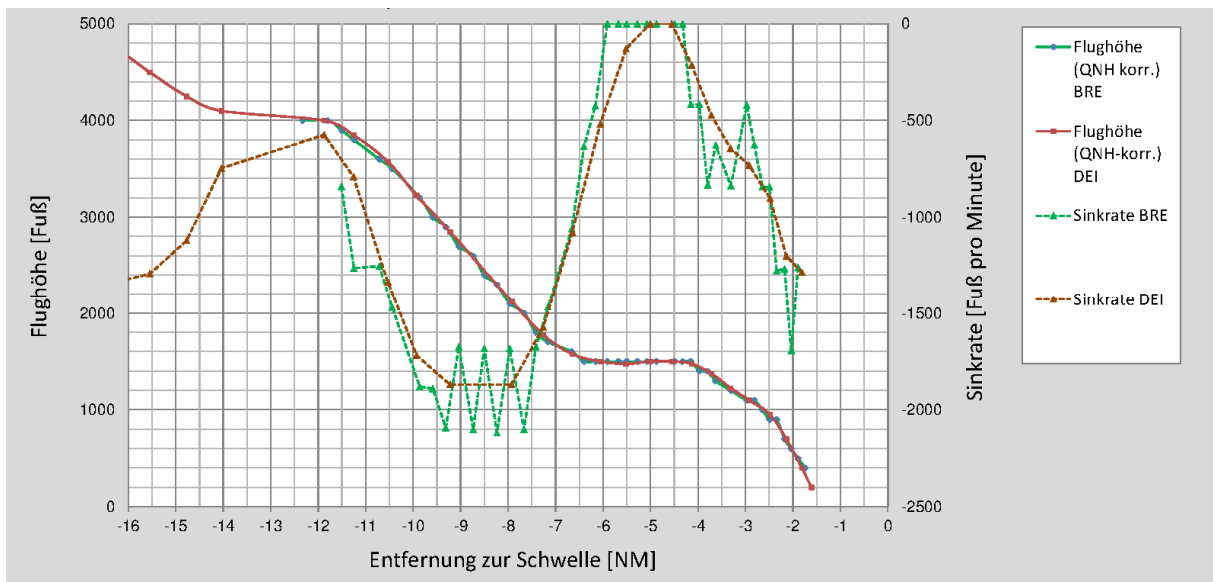
According to radar data, altitude and rate of descent

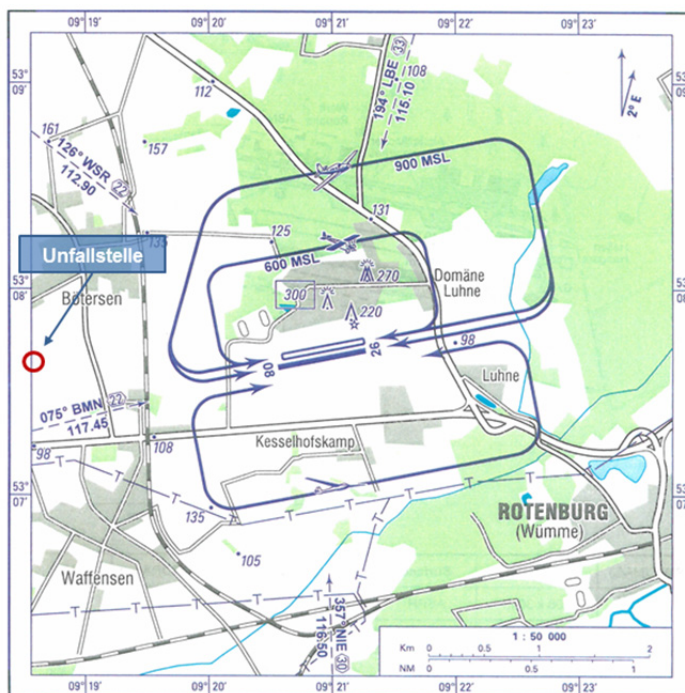
The accident site was located 1.24 NM ahead of the threshold of runway 08 of Rotenburg (Wümme) Airfield and approximately 570 m north of the extended runway centre line in about 100 ft AMSL on a plane, agricultural piece of land free of obstacles.

Excerpt visual operation chart (as of 08/2011) and accident site
 Source: DFS, adapted by BFU

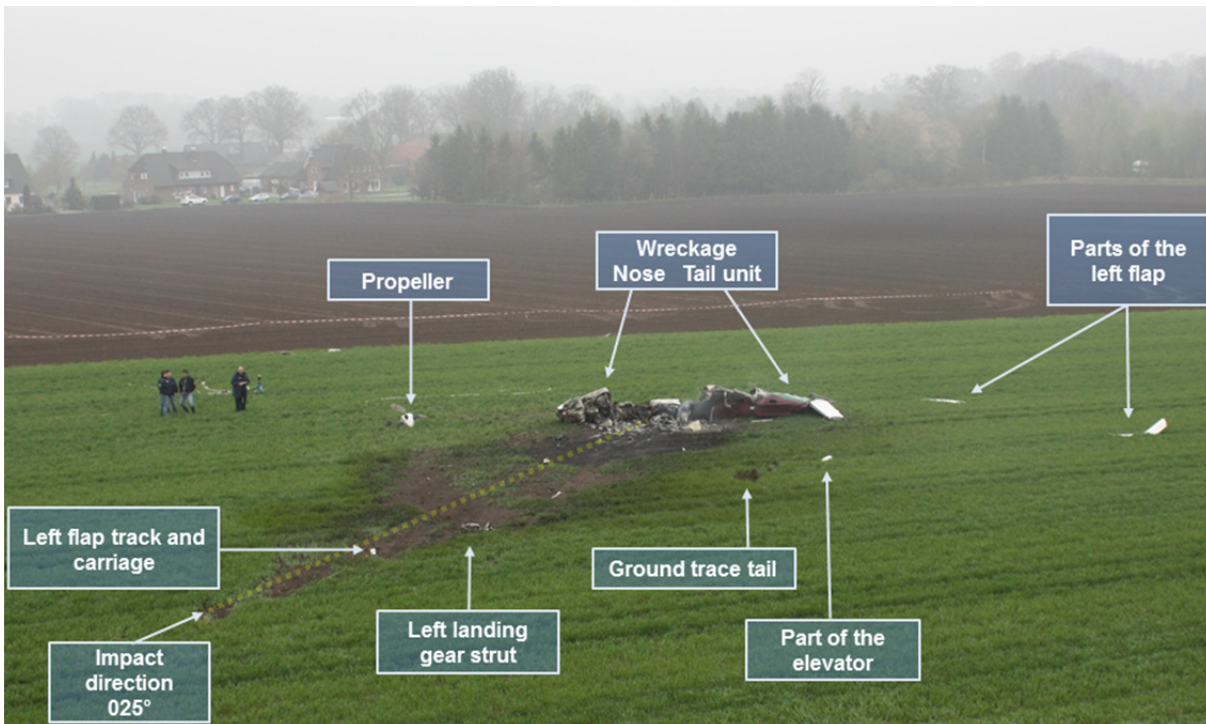
Accident site

The cabin area had burnt out completely. The entire tail section had been torn out of position by 180° and was lying on its back.

The left wing including the aileron had almost completely burnt. Parts of the left flap had separated from the wing. The right wing including aileron and flap had been severely damaged by fire.

The left landing gear strut had been torn off. The nose landing gear and the right main landing gear were bent, but still connected with the wreckage.

The propeller had been torn off at the flange. All four blades were bent.

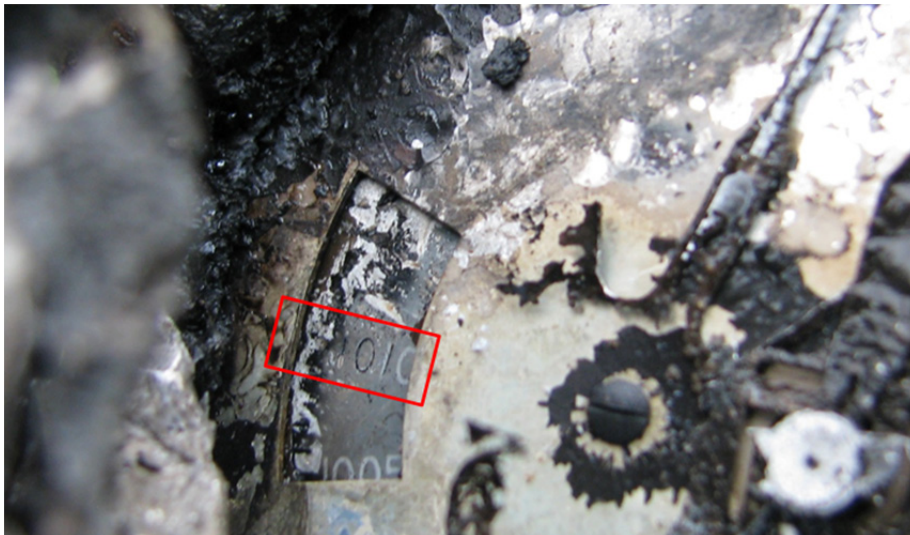
Due to the high degree of destruction, especially by fire, it was not possible to determine the indications of instruments, except for the QNH selection at one altimeter. This was also true for the positions of levers and selectors in the cockpit.

QNH selection at the altimeter about 1,010 hPa
