Investigation Report

Type of Occurrence:	Accident
Date:	28 February 2014
Location:	Baltic Sea, about 3 NM north of Prerow
Aircraft:	Helicopter
Manufacturer / Model:	Airbus Helicopters Deutschland GmbH / BK117 C-1
Injuries to Persons:	Three persons fatally injured, one person suffered minor injuries
Damage:	Aircraft severely damaged
Other Damage:	None
Information Source:	Investigation by BFU
State File Number:	BFU 3X006-14

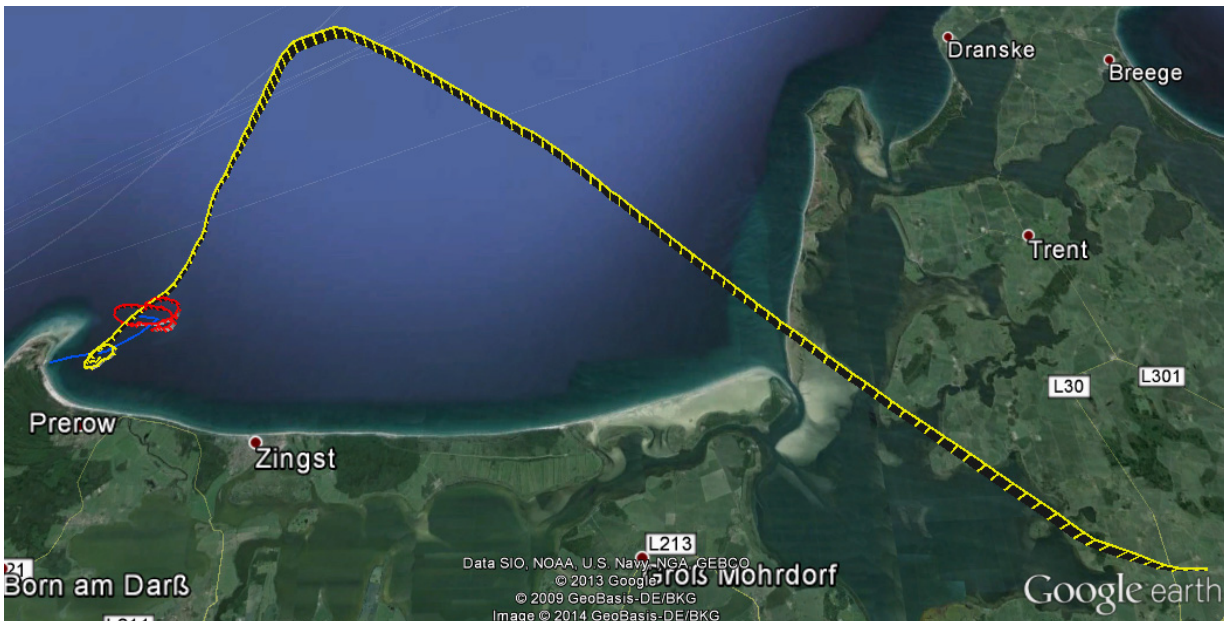
Flight path

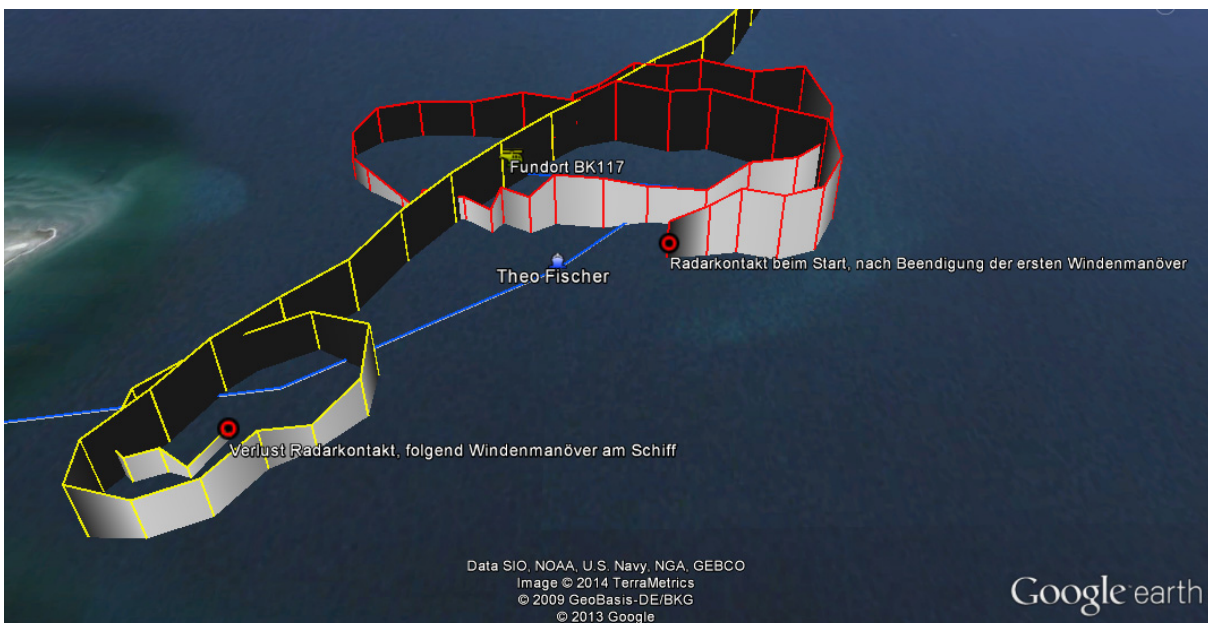
Approaches based on the radar data

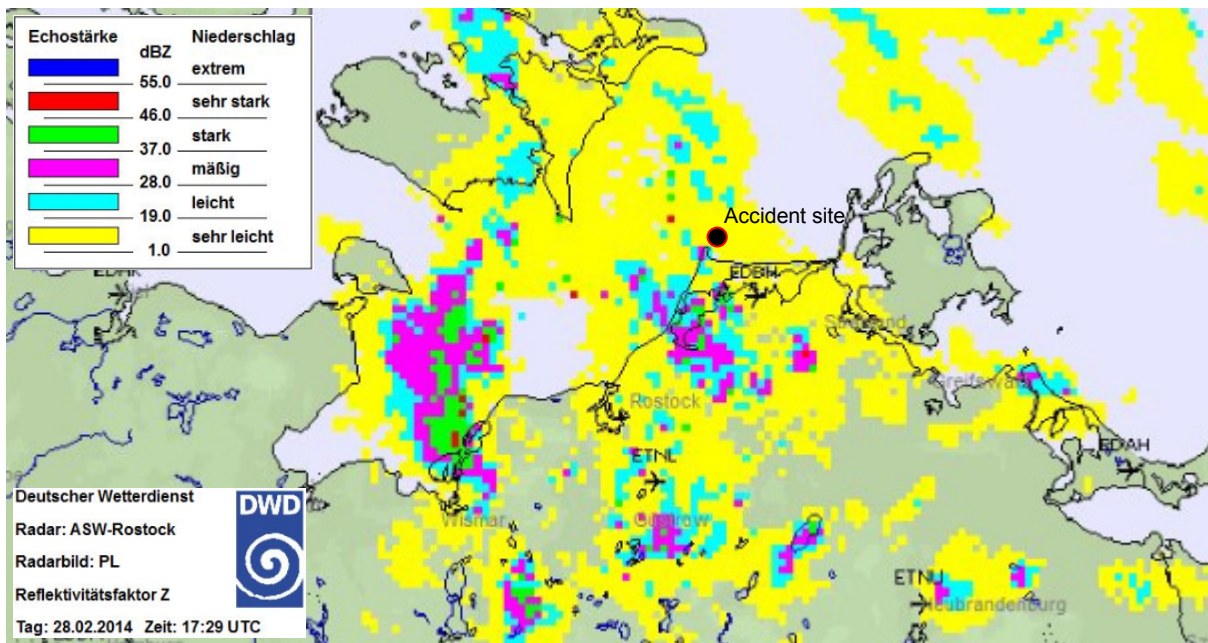
The radar images show at least slight rain at the time and the area of the accident. Above the water more humidity accumulated. Therefore ground visibility in Barth could have been below 3.8 km. Lower stratus clouds even below 1,000 ft, at least in shreds, cannot be ruled out. At the time of the accident it was night. Overcast sky with almost no moon increasing the remaining light means hardly any contrasts above the Baltic Sea.

Radar precipitation image (1829 hrs)

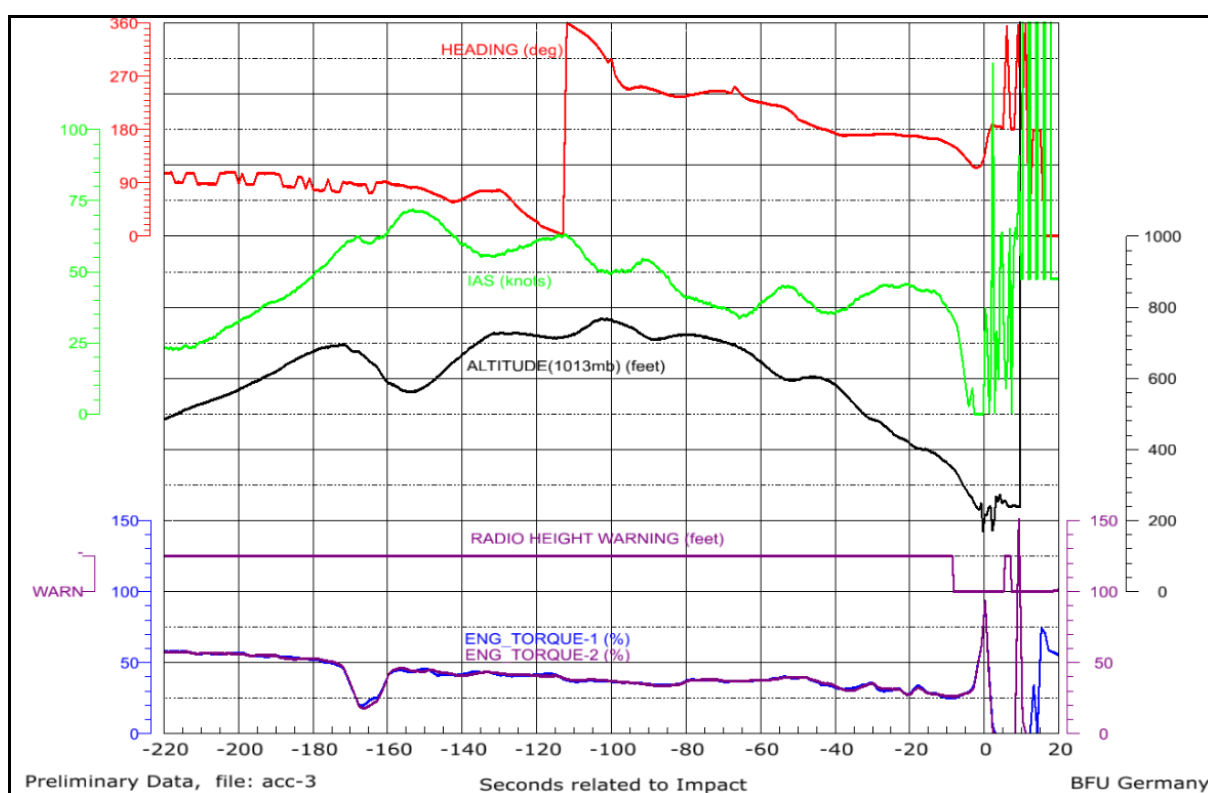
FDR excerpt of the last 220 seconds prior to the collision with the water

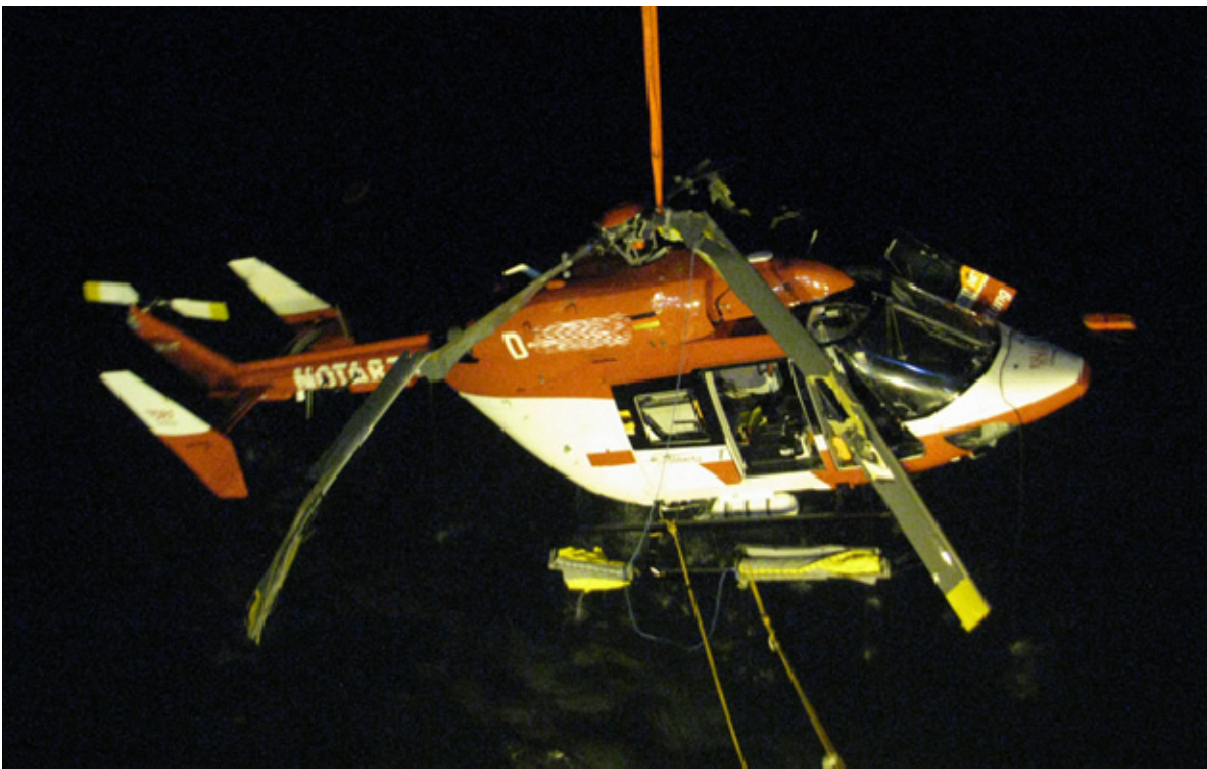
The helicopter was found approximately 3 NM north of Prerow in a water depth of about 7 m. The skids were pointing upward. The emergency floats had not been activated. The left cockpit door was open; the right door was found next to the helicopter. The left cabin door was open and the right closed. Of the four rotor blades, the one with the red marking had been torn off the blade grip and was found in the vicinity of the helicopter. The helicopter's position in the water was documented. Then the helicopter was recovered with the help of the multi-purpose ship "Arkona" and police divers.

Condition of the helicopter during recovery

After recovery it was determined that the fuselage was almost intact. All cowlings and maintenance hatches were closed and no components missing except for the torn-off rotor blade. After initial technical examination and documentation on board the ship "Arkona" the helicopter was transported to the naval base "Hohe Düne" in Rostock.
