Factual Report

Type of Occurrence:	Accident
Date:	26 July 2014
Location:	Glider airfield Sultmer Berg, Northeim
Aircraft:	Glider
Manufacturer / Model:	Rolladen Schneider, LS4a
Injuries to Persons:	Pilot fatally injured
Damage:	Aircraft destroyed
Other Damage:	Crop damage
State File Number:	BFU CX010-14

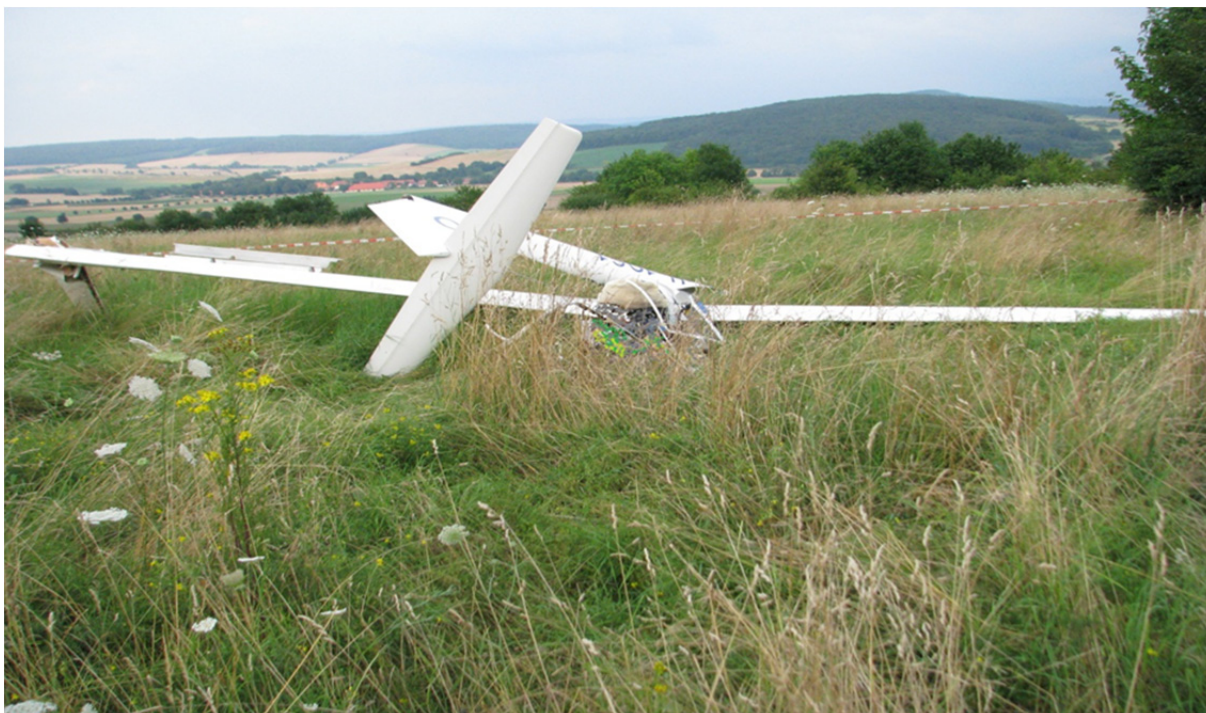
Accident site

The accident site was located about 40 m east of the 18/36 runway centre line of the glider airfield Sultmer Berg. The glider was lying approximately 340 m from the beginning of runway 36 and at right angle to the take-off direction.

The wings were still attached to the fuselage, which pointed with the cockpit toward the runway.

The cockpit had been severed in front of the wings and the right side had been destroyed up to the middle of the seat bucket. The left side had been destroyed up to the seat bucket.

The tail boom had been ruptured at approximately the middle and the empennage had tipped forward over the right wing.

The right wing had been severed about 2 m away from the wing tip. The wing tip of the severed part of the wing stuck in the ground and been torn out of position. It was kept in place by the water bags and the control rods. The right aileron had also been severed at the same place. The severed part of the aileron was lying behind the wing. The speed brake of the right wing was extended.

Outward appearances showed the left wing was almost undamaged. The wing leading edge showed traces of ground impact. The area of the wing root was delaminated.
